# Power Back Door System Has Abnormal Closing Operation

YEAR(S)	MODEL(S)	ADDITIONAL INFORMATION
2008 - 2013	Highlander, Highlander HV

## Power Back Door System Has Abnormal Closing Operation

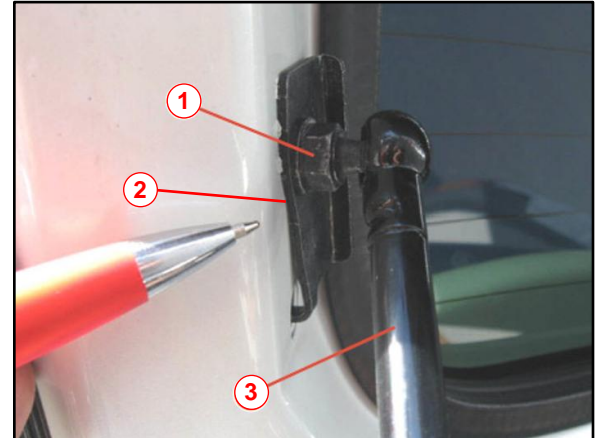
Figure 1.

1. Visually inspect the Lift Arm Stud and Power Back Door Bracket for bends or damage as shown.

Are the Power Back Door Bracket and Lift Arm Stud damaged?

1	Lift Arm Stud
2	Power Back Door Bracket
3	Back Door Upper Rod

- **YES** — Go to the Repair Procedure.
- **NO** — Continue to step 2.

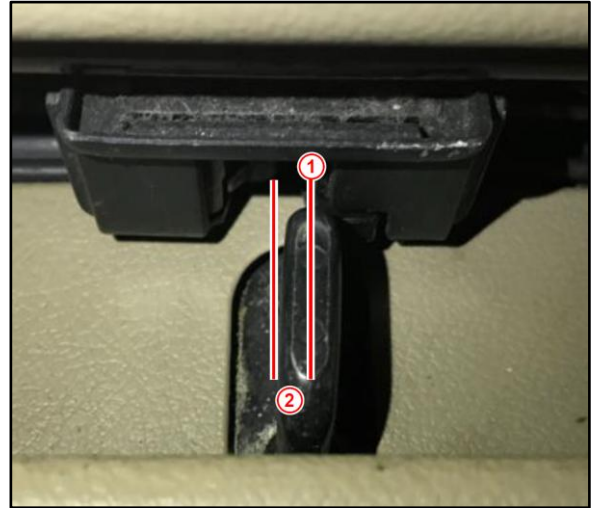
Figure 3.

- B. Measure the center mark of the latch opening and compare it to the center line of the striker.

Is the latch < or = 3.1 mm from the center line of the striker?

1	Striker Center Line
2	Gap

- **YES** — This bulletin does NOT apply. Continue diagnosis using the applicable Repair Manual.
- **NO** — Continue to the Repair Procedure.

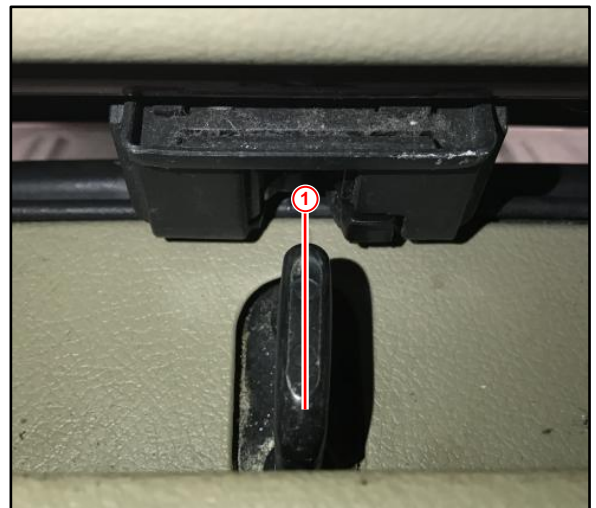
Figure 4. OK Condition

1	Striker Center Line
---	---------------------
