ECM Calibration: Transmission Software Enhancements

YEAR(S)	MODEL(S)	ADDITIONAL INFORMATION
2016 - 2017	Land Cruiser

Some 2016 – 2017 model year Land Cruiser vehicles may exhibit one or all of the following conditions:

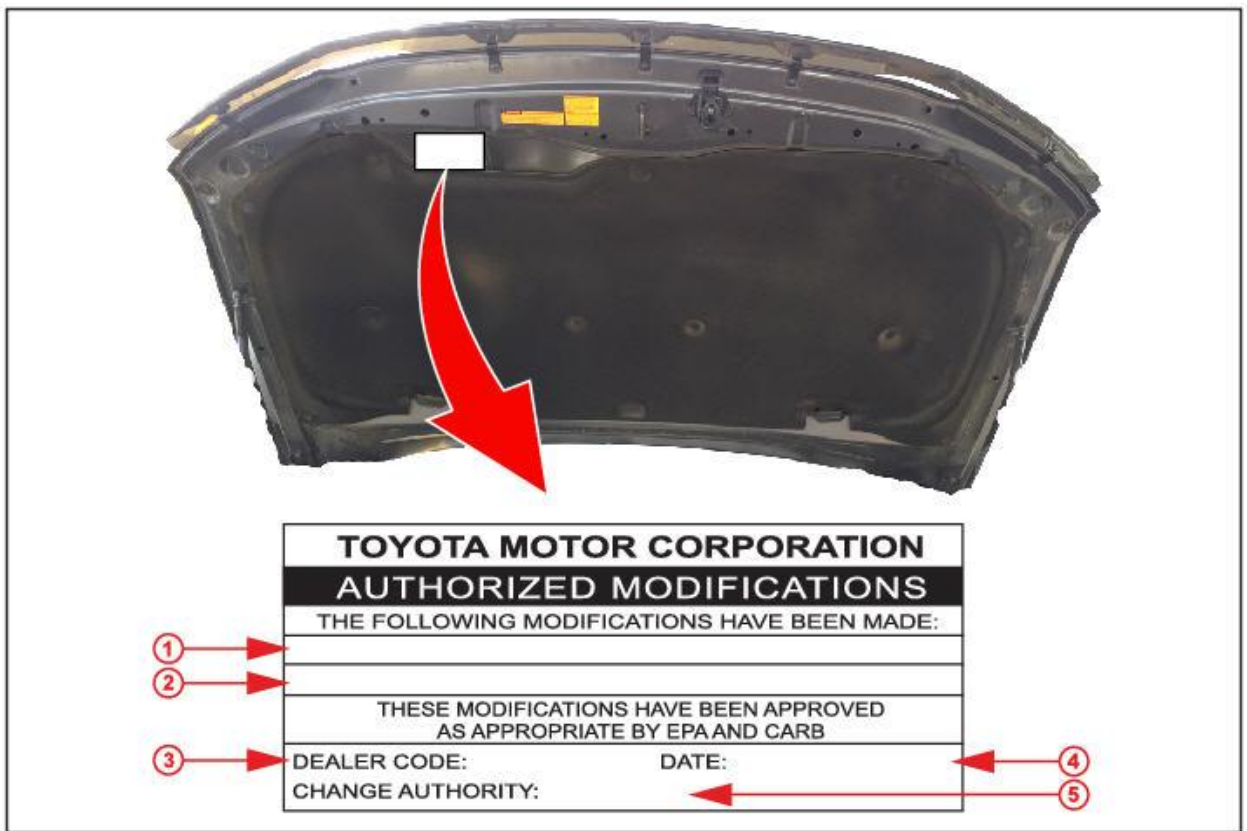
Figure 1. Location of Authorized Modification Label for 2016 – 2017 Land Cruiser

- Check for the Authorized Modifications Label affixed to the vehicle in the location shown below. Confirm if the ECM (PCM) calibration has been updated.

4. Install the Authorized Modifications Label.
 - A. Using a permanent marker, enter the following information on the label:
 - ECM part number [Refer to the **Parts Information** section for the **NEW PART NUMBER**]
 - Calibration ID(s) [Refer to the **Calibration Information** section for the **NEW CALIBRATION ID**]
 - Dealer Code
 - Repair Date
 - Change Authority [**This bulletin number**]
 - B. Affix the Authorized Modifications Label to the vehicle at the location shown in Figure 1. The Authorized Modifications Label is available through the MDC, P/N 00451-00001-LBL.
5. Perform transmission initialization.
