Authorized Field Change

AFC 16906

Subject: ProStar® Fusion Camera

Model: Certain ProStar® models equipped with Bendix Fusion cameras

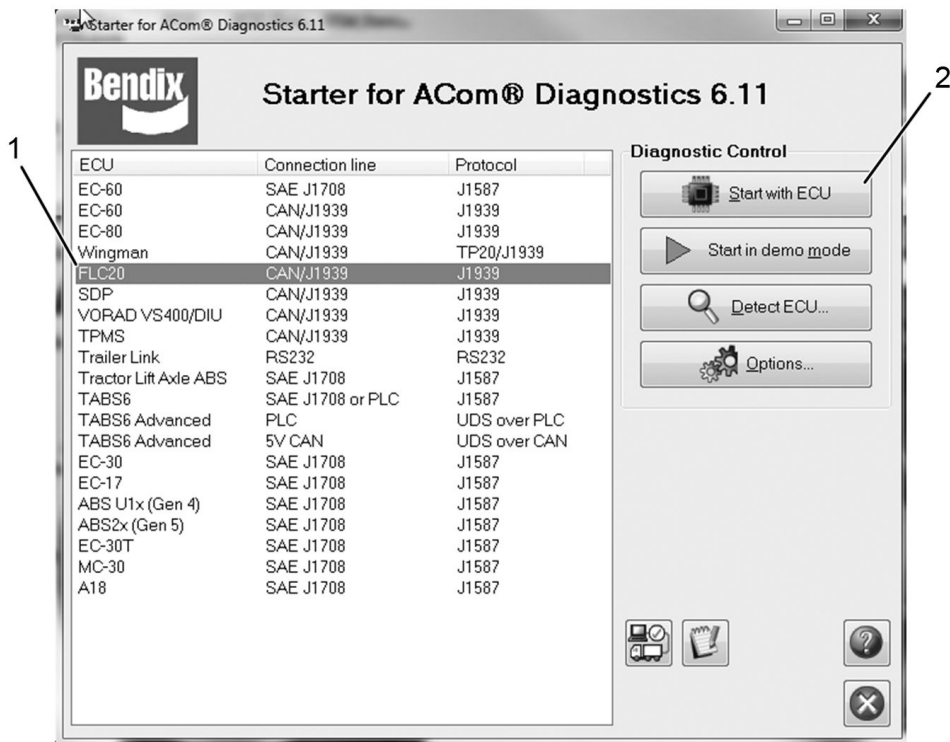
Figure 1. ACom Diagnostics: Main window

1. FLC20
2. Start with ECU button

7. Select FLC20 (Figure 1, Item 1), then click START WITH ECU button (Figure 1, Item 2).

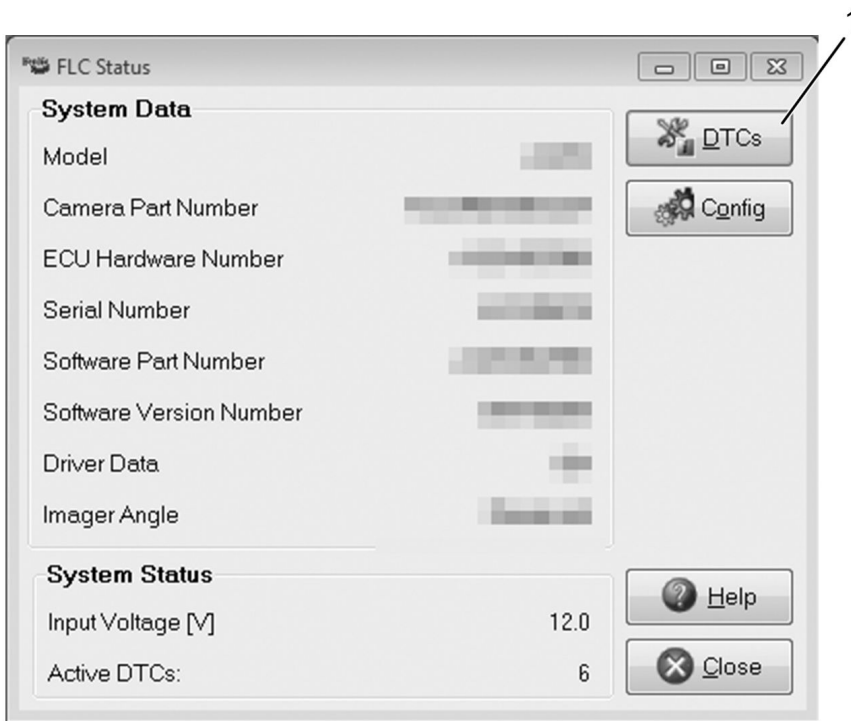
Figure 2. ACom Diagnostics: FLC Status Window

1. DTCs button

8. Click the DTCs button (Figure 2, Item 1).

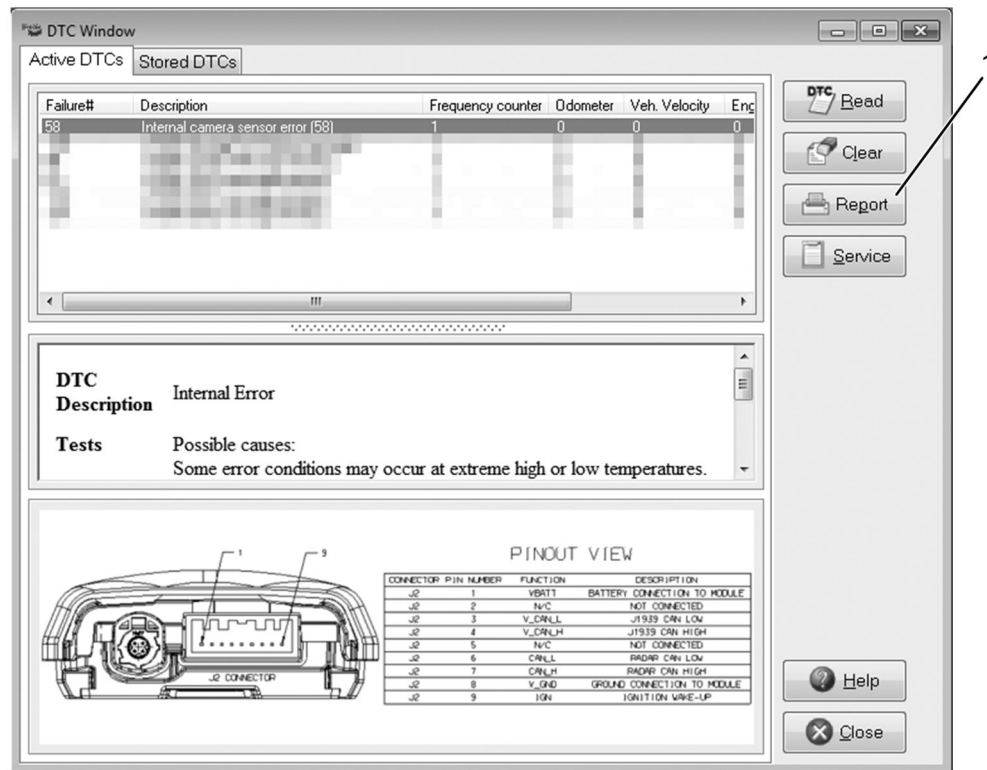
Figure 3. ACom Diagnostics: DTC Window

1. Report button

9. Click REPORT button (Figure 3, Item 1).

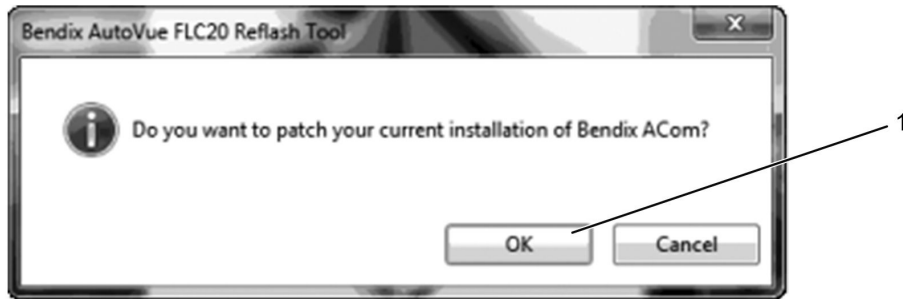
Figure 5. Prompt to Confirm Patch Installation

1. OK button

14. Click OK (Figure 5, Item 1) to install the patch.

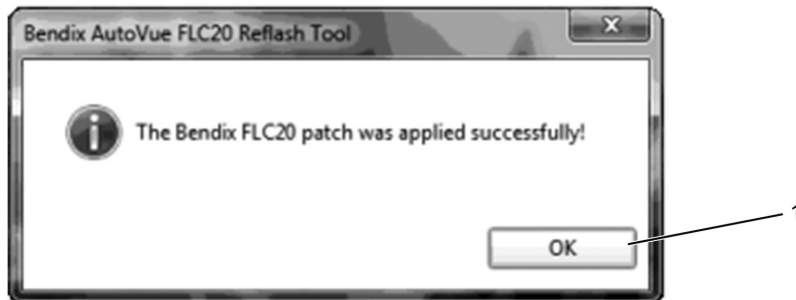
Figure 6. Successful Patch Installation

1. OK button

15. Click OK (Figure 6, Item 1).

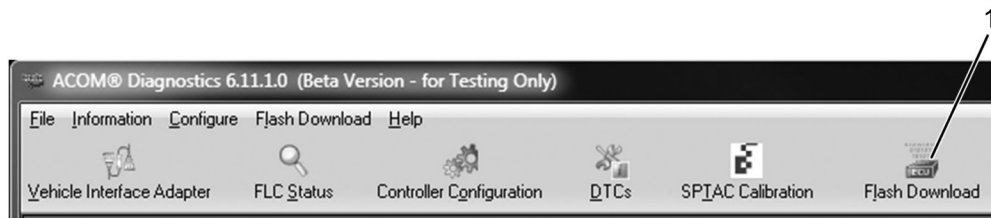
Figure 7. Tool Bar

1. Flash Download button

17. Click FLASH DOWNLOAD (Figure 7, Item 1) in the tool bar.

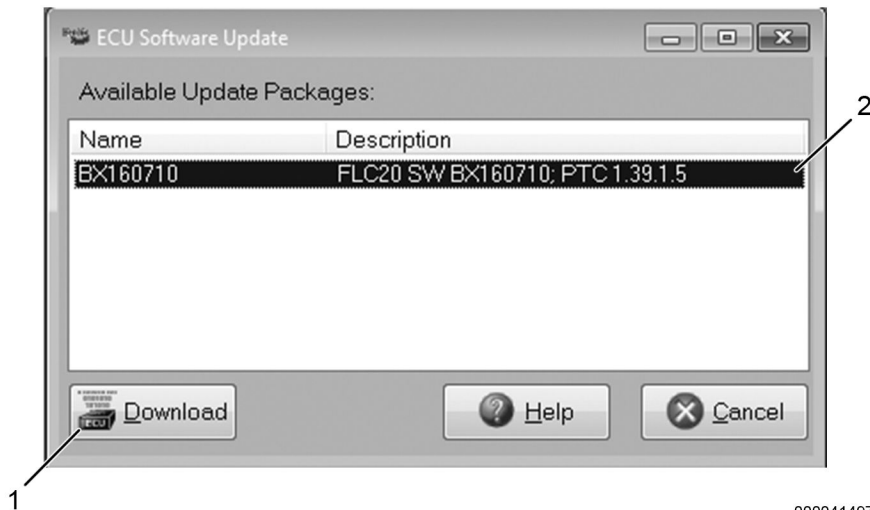
Figure 8. ECU Software Update Window

1. Download button
2. Update package

18. Select update package to be installed (Figure 8, Item 2). Make note of selected update's NAME. (This information is required for Step 26.)

19. Click DOWNLOAD button (Figure 8, Item 1). A progress bar will be displayed

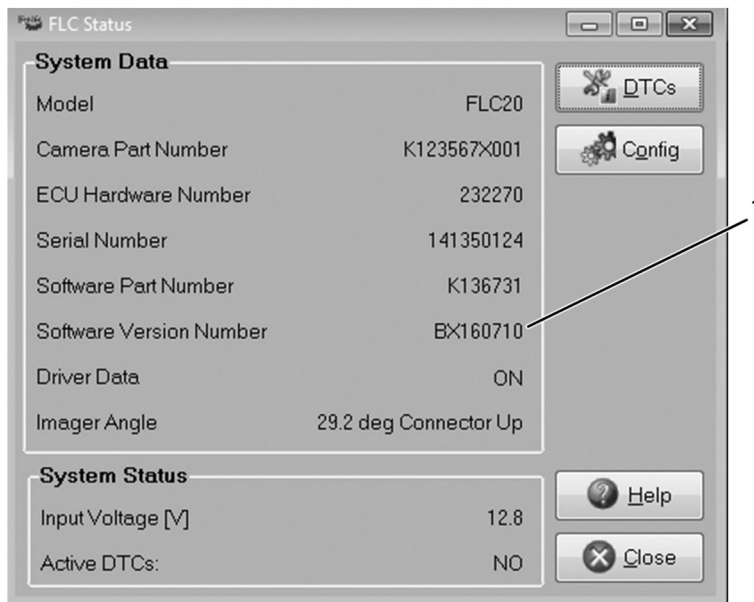
Figure 9. FLC Status Window (After Update)

1. Software version number

26. Verify that Software Version Number displayed (Figure 9, Item 1) matches update Name noted in Step 18.
27. Turn vehicle ignition OFF, close ACom, and disconnect EZ-Tech® from vehicle.
28. Remove wheel chocks.
