Countries:	AUSTRALIA, CANADA, UNITED STATES	Document ID:	IK1201260
Availability:	ISIS, IsSIR	Revision:	10
Major System:	ENGINES	Created:	1/21/2015
Current Language:	English	Last Modified:	5/24/2017
Other Languages:	NONE	Author:	Greg Scheff
Viewed:	2616

Title: 2015+ N13 Cylinder Pack - Update for Excessive Lubrication Oil Consumption

Applies To: 2015+ N13 ESN: 4400000-4401769

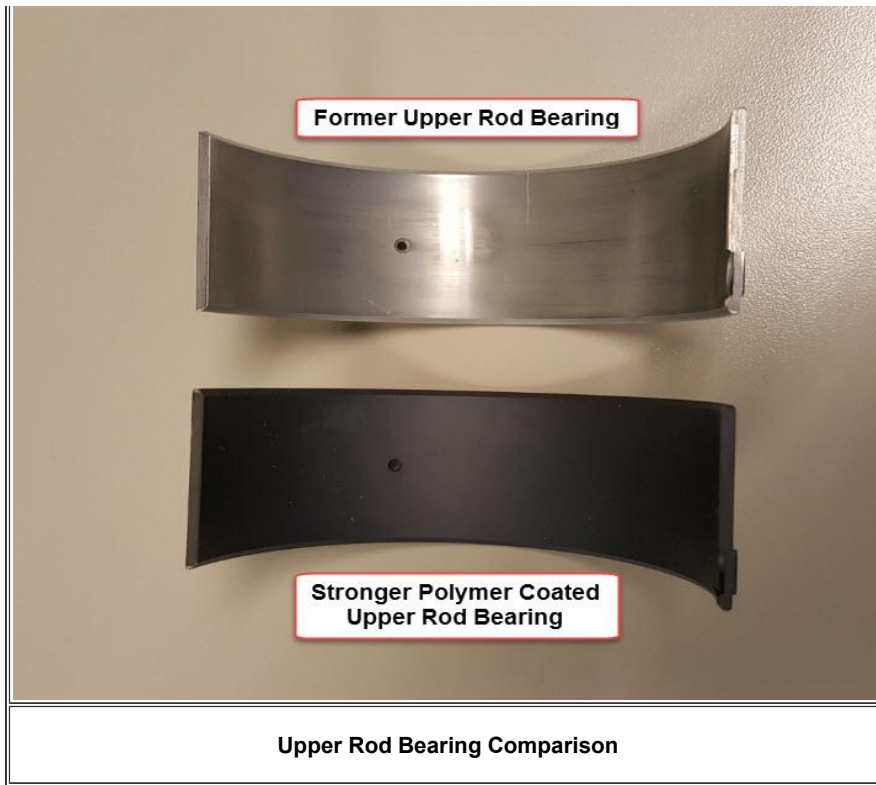
The 2513433C91 rod bearing set contains a stronger polymer coated upper bearing which is darker in color. This bearing replaces the former 3004714C91 and has been in service since 2015. The coating was added due to increased cylinder pressures found in the 2015 N13. There are no dimensional changes in the bearing, and it is backward compatible to all MaxxForce and N13 engines.
