| DOC # | PROCESS NAME | PAGE | REVISION | STATION | BY | DATE |
| <b>AR843</b> | <b>Securing Rear Wall To Floor</b> | <b>1 OF 1</b> | | <b>SER-E</b> | <b>C.WARD</b> | <b>7/14/2017</b> |

**Complaint:** Rear Wall gapping at wood floor connection

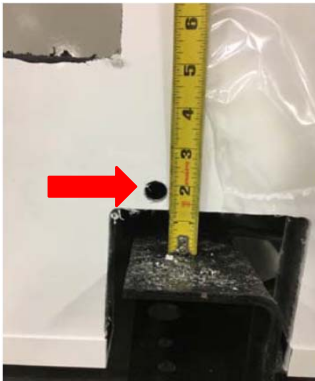
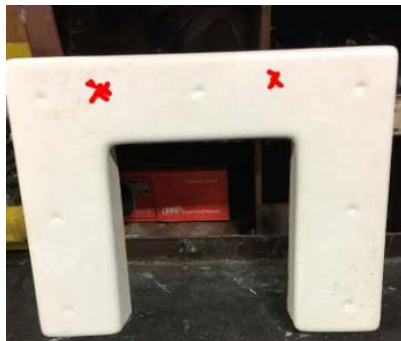
**Cause:** Securement Fasteners missing

Step 3: Approximately 1-3/4" above the frame rail, drill a 1/2" hole through the exterior skin and tube on rear wall (1 above each bumper mount)

NOTE: Approximate location of the hole is either side of the bumper to the bezel dimples

**Correction:** Add 993561 (Self-Tapping Screws) to secure center of wall to structural steel floor at bumper connections

Step 4: Inside the 1/2" hole, drill a 7/32" through the rear wall and floor framing (1 above each bumper mount)

Step 5: Install self-tapping screws to close the gaps (1 above each bumper mount)
