**SUBJECT:**

Information on the XL T@G / 5W T@G chassis

2016 – 2018 XL T@G / 5W T@G

# T@G TECHNICAL SERVICE BULLETIN

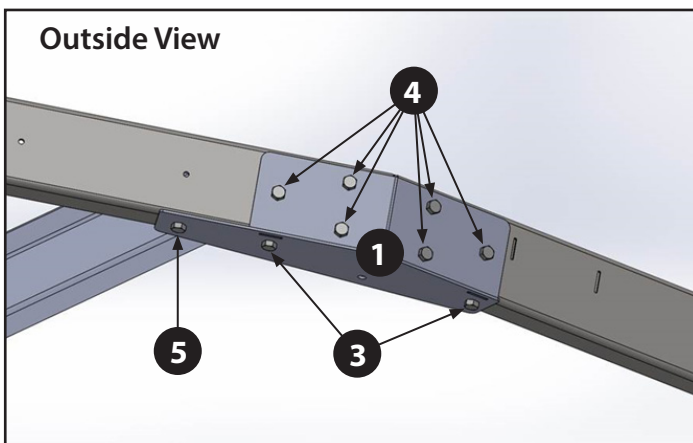
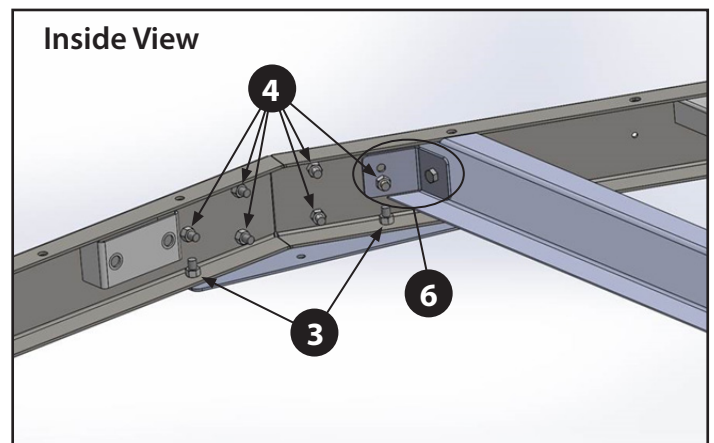
### P/N 20100408

It has been determined that a few of the XL T@G / 5W T@G trailers have been strapped down too tightly to the flatbed truck during transport causing a few of the chassis to crack. Therefore, dealers / owners should inspect the chassis of their trailers. If cracks are found, see repair procedure.

1. Position Reinforcement Bracket to outside of Frame Rail.  
(Roadside Rail shown. Repeat for Curbside.)
2. Clamp Reinforcement to the Rail so both surfaces are tight against the sides of the Rail and to the bottom flange.  
(Bend in Rail and in Reinforcement are lined up with each other)

3. Attach Reinforcement to the bottom flange of the Frame Rail through two existing holes in Rail using supplied 3/8" hardware.
4. Using a 3/8" Drill bit, transfer the six holes from the Reinforcement Bracket into the vertical web of the Frame Rail and fasten with supplied 3/8" hardware.

5. Transfer one hole at the front of the Reinforcement through the bottom flange of the Rail and fasten with supplied 3/8" hardware.
6. Locate Angle Plate to inside of the Frame Rail with forwardmost hole drilled in Step 4. Transfer hole into Cross Member and attached with supplied 3/8" hardware.

7. Torque all fasteners to 33 ft-lbs.
