DOC #	PROCESS NAME	PAGE	REVISION	STATION	BY	DATE
<b>AR841</b>	Replace Dedicated Micro Box Bracket	1 OF 1		SER-E	C.WARD	6/23/2017

**Complaint:** Dedicated Micros Box Bracket cracking

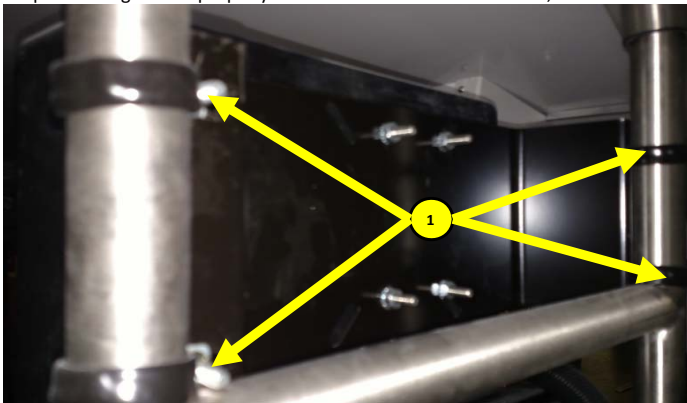
Step 1: Making sure to properly secure the Dedicated Micros Box, remove from driver stanchion by unbolting the (4) P-Clamps.

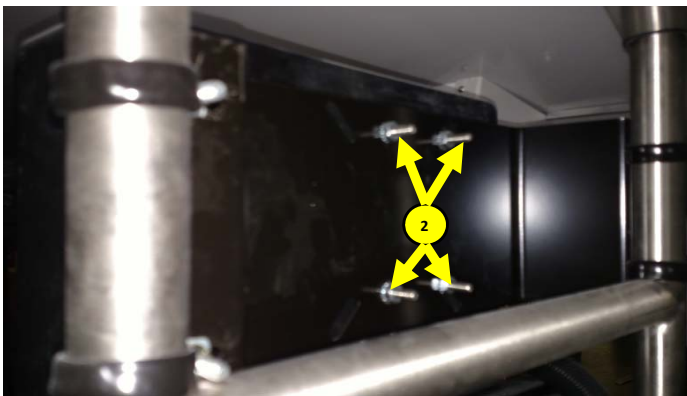
Step 2: Remove bracket from Dedicated Micros Box.

Step 3: Install new bracket to Dedicated Micros Box.

Step 4: Re-install Dedicated Micros Box with new bracket to Driver Stanchion with previously removed fasteners.
