TSB #	TSB 17-002		
Description/Title:	Axis/Vegas Hood Bracket Modification for Wiper System Clearance		
Affected Product Line(s):	Certain 2018 Axis/Vegas Motorhomes		
Service Campaign # :	RC000139	Released Date:	7/12/2017
Failure Code:	TMCTS80293W	Document Date:	7/12/2017
Time Allowed:	0.5 hr	Document Revision:	A

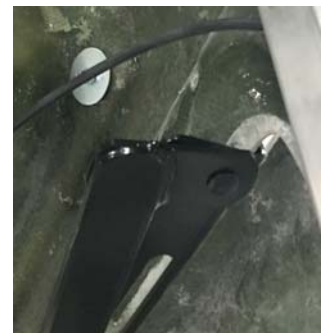
Figure 1

On certain 2018 Axis/ Vegas units the wiper linkage may brush against the driver's side hood hinge bracket causing noise.

- 1. Open the hood.**
- 2. Access the driver's side hood hinge bracket. It will be just beneath the lower right hand corner of the hood opening. See figure 1/**
