TECHNICAL SERVICE BULLETIN

Wind And/Or Whistle Noise From Exterior Mirror(s) At Highway Speed - Built On Or Before 1-Dec-2016

17-2119

| Ford 2017 Escape | Build Date: Up to 1-Dec-2016 |

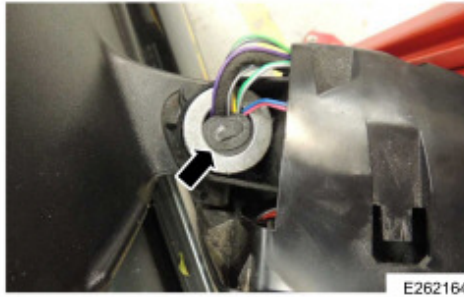
Figure 1

Issue: Some 2017 Escape vehicles built on or before 1-Dec-2016 may exhibit a wind and/or whistle noise from the exterior mirror(s) at highway speed.

5. Insert the rolled soft foam tape into the mirror pivot point positioning the wires to one side. (Figure 1)
6. To install, reverse the removal procedure. Refer to WSM, Section 501-09.
