# TECHNICAL SERVICE BULLETIN

| Bulletin No: | SB-17-002 |

## COE WATER INTRUSION INTO RELAY BOX

**SUBJECT VEHICLES:** 13MY-16MY COE Trucks equipped with a J05 engine.

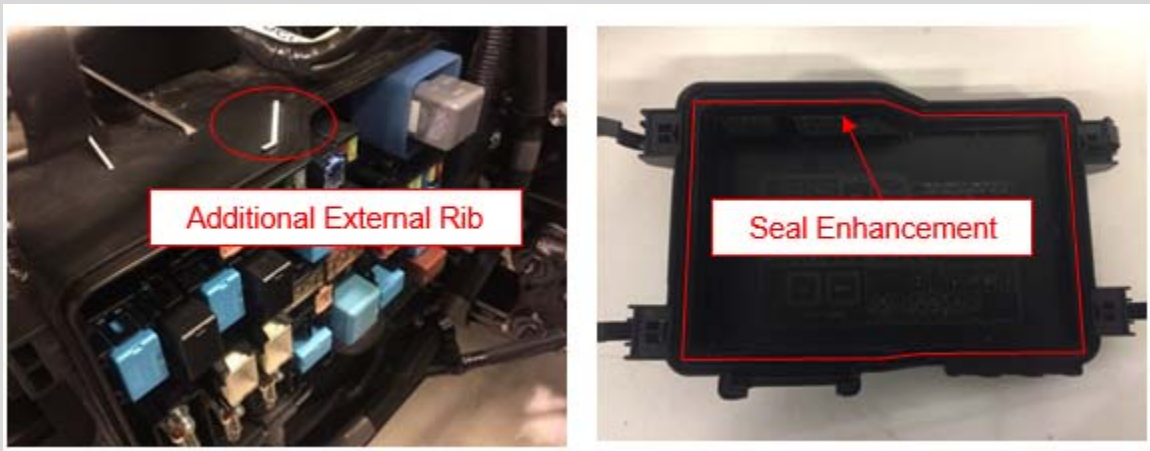
In rare cases, a small volume of water may enter the relay box when high pressure water is sprayed directly at the relay box. An enhanced relay box and cover are available to provide improved sealing.
