# VOLUNTARY SERVICE CAMPAIGN

## AA550 PM SENSOR REPROGRAMMING

| Bulletin No.: | SCB-001-17 |
| Affected Models: | Certain 17MYCOE Trucks equipped with a J05 engine |

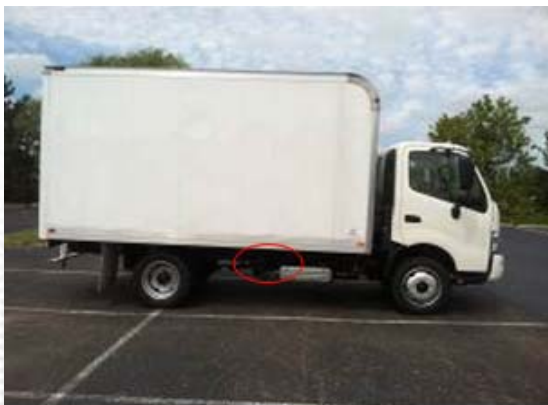
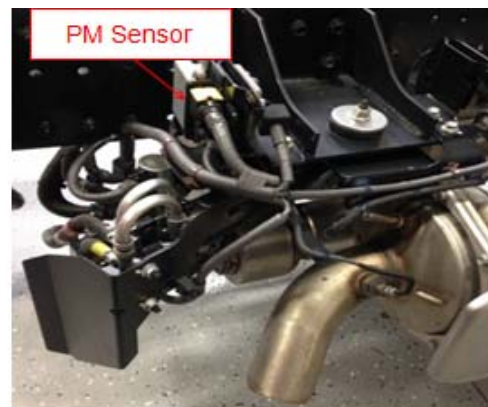
2. Locate the PM sensor on the passenger side frame rail, above the tailpipe.

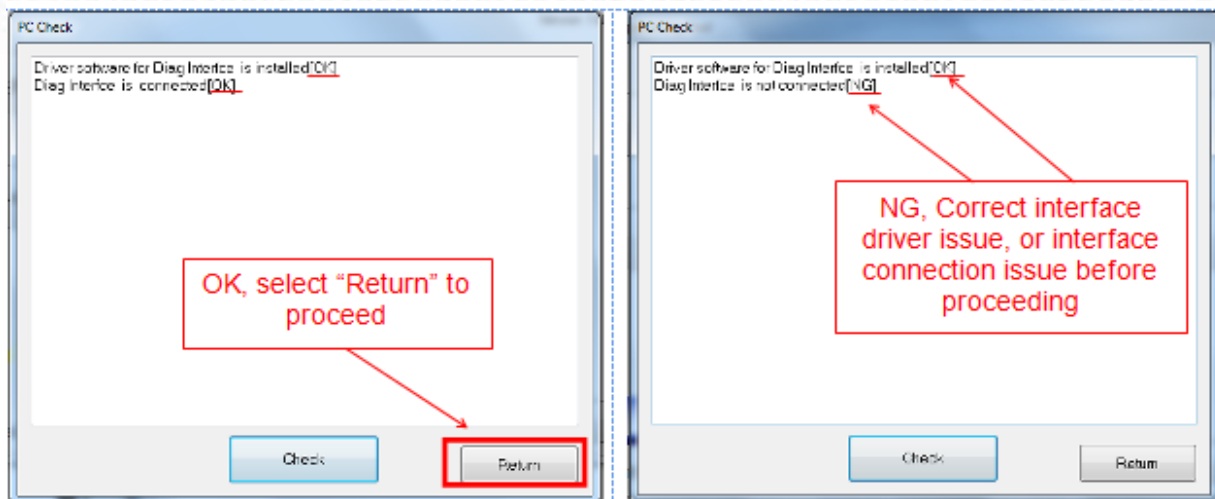
“[NG]” will be displayed on the top row if the driver of the interface device is not installed.

“[NG]” will be displayed on the bottom row if the interface device is not properly connected.

Install the driver as per the manual for the interface and then perform the “PC Check” again.

Ensure that the cables are connected and the interface device is turned on (DST-i has an ON/OFF switch). Ensure that the correct device is selected for “Used device” under “Configuration” (step 7, above). Select the “Return” icon to go back to the main menu.

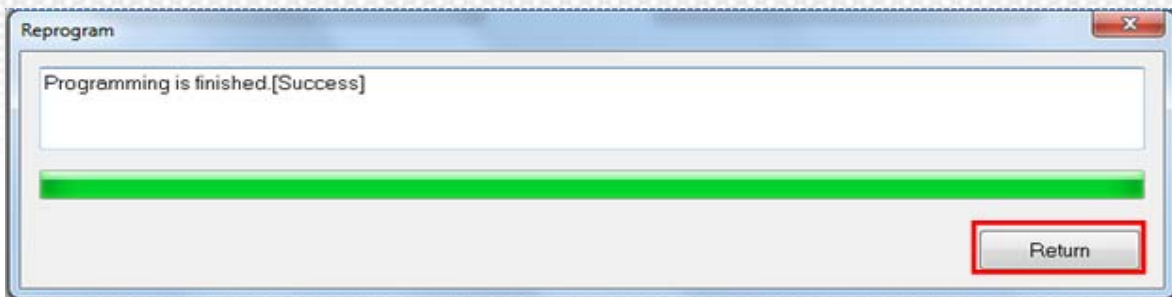
”Writing error [Time out]” will be displayed if the programming fails. Close the window and proceed to step 23a, below.

**23.** Monitor the programming progress bar. If the progress bar reaches 100% and no errors are shown, select the “Return” icon and proceed to step 24, below.

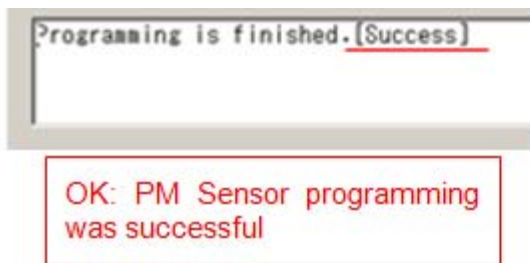
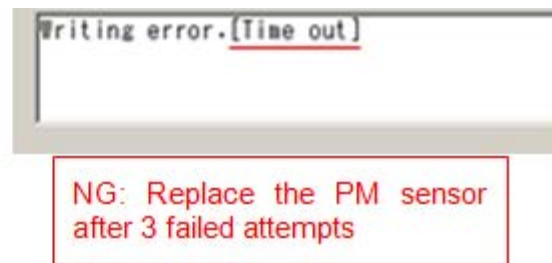
If programming fails again, repeat steps 23a through 23d once more. If you receive a “Writing Error, [time out]” after three failed reprogramming attempts, the PM sensor is faulty and will require replacement. After replacing the PM sensor, validate it has the latest software by performing steps 25 through 28, below. If the new sensor is not at the latest software level, repeat this procedure from the beginning to update the software on the replacement PM sensor.

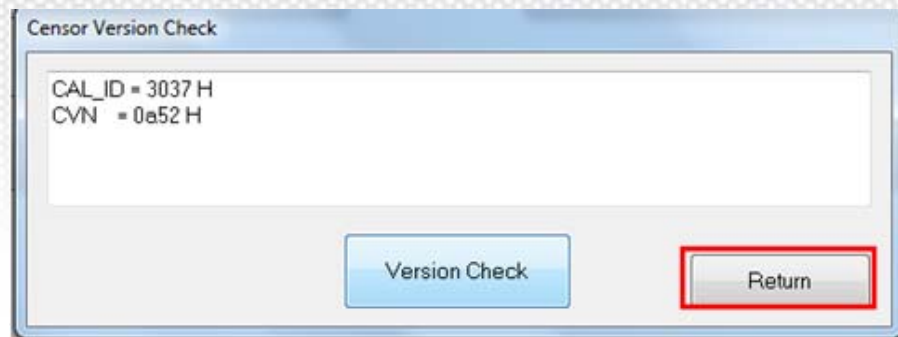
**CAL\_ID= 3037H**  
**CVN=0a52H**

27. Verify that the PM sensor software version was updated to the correct level. Refer to the image below for the proper CAL\_ID and CVN of the updated PM sensor software. If the CAL\_ID and CVN match the image shown below, reprogramming was successful. Select the “Return” icon to go back to the main menu and exit the program.
