GROUP Electrical	MODEL 2017MY Sportage (QL)
	NUMBER PS453 (Rev 1, 6/21/2017)	DATE June 2016

SUBJECT: INTERMITTENT AM/FM RADIO STATIC

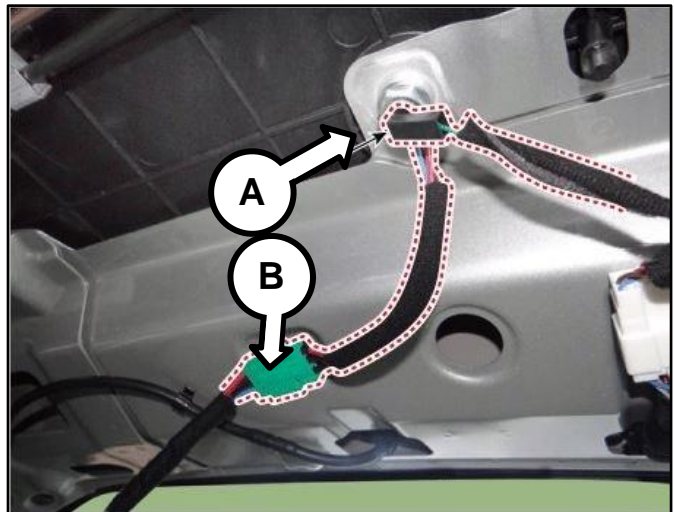
Some 2017MY Sportage (QL) vehicles may experience AM/FM radio static, especially when the vehicle drives over bumps. This condition can be caused by loose connections at the base of the antenna and/or at the antenna cable connector located at the right front A pillar. Follow the procedure outlined below to resolve the concern.

2. Check the indicated connectors A and B.
