GROUP <b>ENG</b>	MODEL <b>2017MY Optima Hybrid / Optima Plug-In Hybrid</b>
	NUMBER <b>PS508</b>	DATE <b>June 2017</b>

<b>SUBJECT: "FILL INVERTER COOLANT" MESSAGE AFTER REPAIR</b>

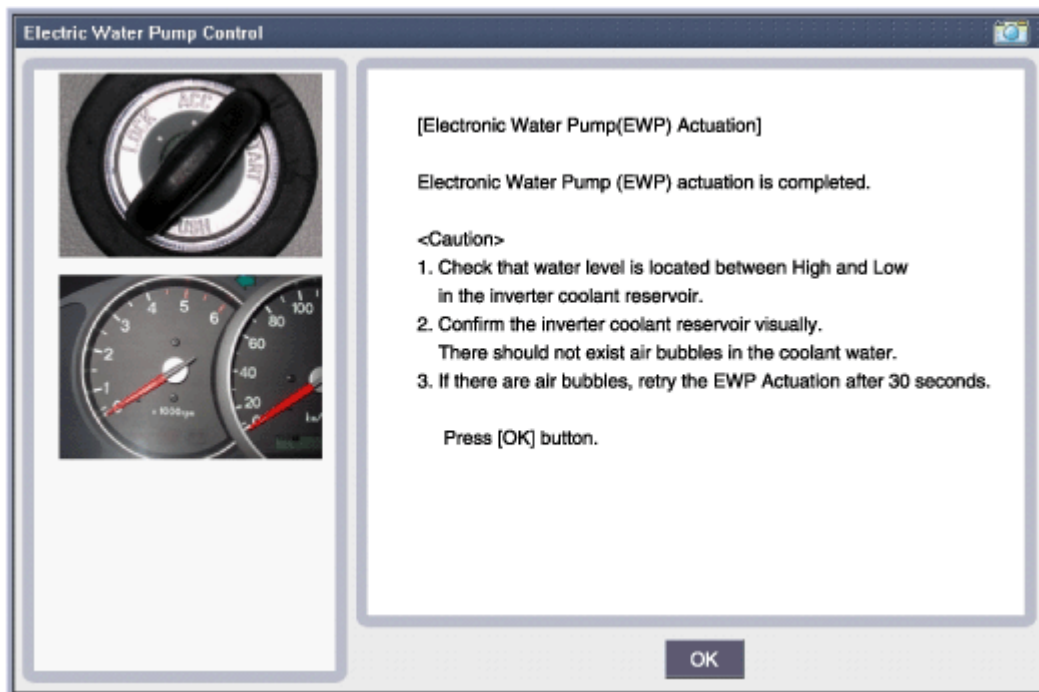
Some technicians may report seeing the “fill inverter coolant” message on the cluster after performing an HEV system service requiring the coolant to be drained. The logic for this message is such that it will be displayed when the RPM of the EWP climbs while line load goes down, indicating a possible cavitation. This is due to air in the system. Much like bleeding any fluid system utilizing a pump, the hybrid cooling system must be bled in a particular manner to avoid aeration. To accomplish this, you would first follow the instructions in KGIS: Shop manual section → Hybrid Motor System → Hybrid Motor Cooling System → Coolant → Repair procedures. If this message is still displayed after completing the procedure, cycle the pump with KDS, on for five (5) seconds, and off for five (5) seconds ten (10) times. Let it settle for one (1) minute, then repeat the on/off cycle five (5) more times.

Allow the coolant to settle for another minute. Then run the pump the full run time of 90 seconds and listen to the pump. You can hear a gurgling/sloshing sound if air is still present. If no sound is emitted and coolant circulation without air bubbles is visually verified, bleeding is complete and the message should no longer be present.
