MODEL  
2016MY  
Sorento (UMa)

NUMBER  
125 (Rev 2, 6/13/2017)

## TECHNICAL SERVICE BULLETIN

SUBJECT: PANORAMIC SUNROOF SLOW TO CLOSE AND/OR  
ABNORMAL NOISE WHEN CLOSING

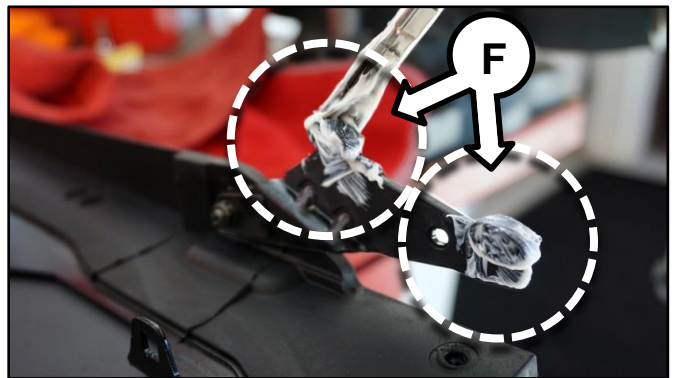
Failure to use the lubricant specified on page 7 of this bulletin may result in an ineffective or repeat repair.

Do not use Kia Dampening Grease (P/N UM011-CHA052), as it is not compatible with the grease used by the factory.

7. Lightly coat the tilt lever shoes (F) using the specified lubricant.

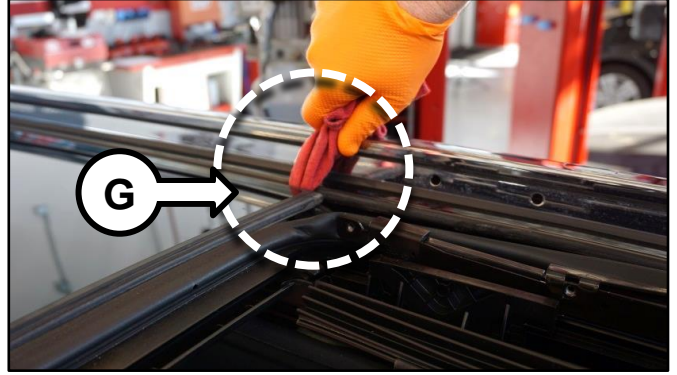
Failure to thoroughly remove any old grease or foreign material from the guides may result in an ineffective or repeat repair.

8. Using a non-marring trim panel tool and a clean shop towel, clean the rear guide rails (G) on both sides until there are no foreign materials present on the rag.
