L734-
A.07.17

CarPlay Activation

Aventador S Coupè:

From HLA04772 to VIN HLA06479.

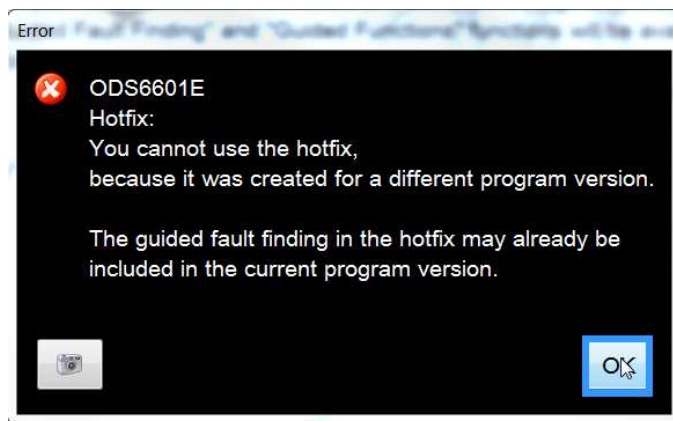
- If the following error page occurs, it means that you shall update ODIS Service at the last database Lamborghini 2.11.5. Click “Ok”.

Please update ODIS Service at the current database Lamborghini version 2.11.5.

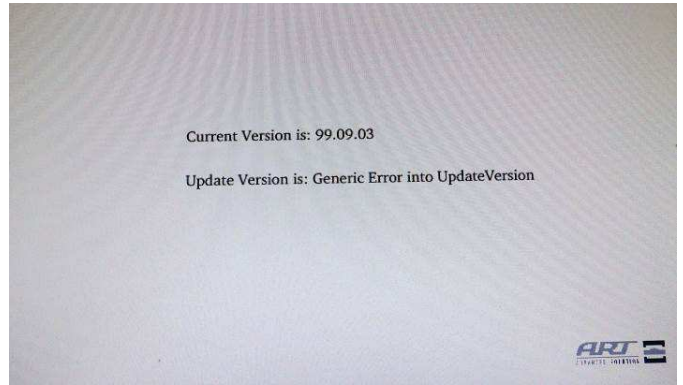
A. During TSU update procedure, if the following page is shown in MMI display:

Quit from “TSU Engineering Menu”, remove USB stick from USB port and then switch ignition off.

Then switch again ignition on, insert again USB stick into USB port and access again into “TSU Engineering Menu”.

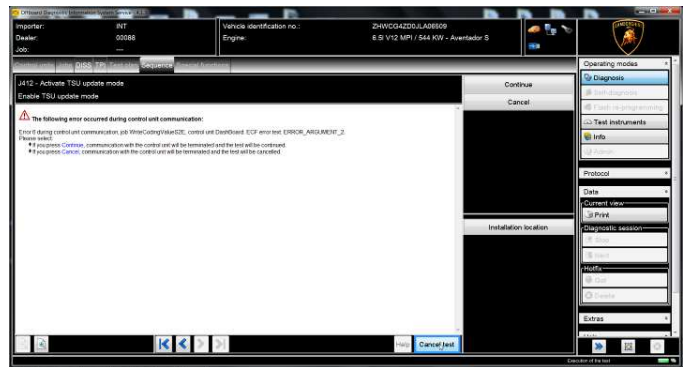
B. If the following error page is shown, you shall abort the procedure clicking on “Cancel Test” and contact the Technical Support.

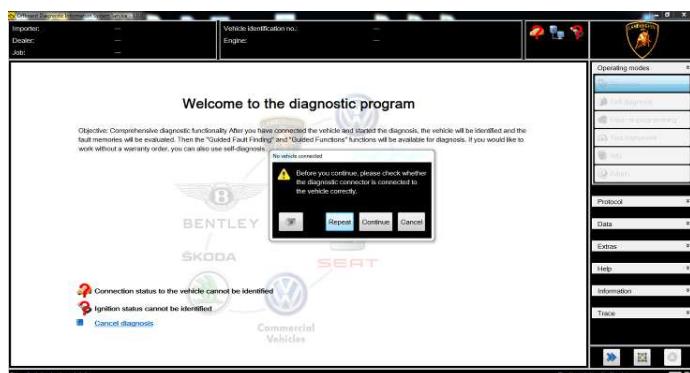
C. If the error message regarding the VAS5054 interface and the two icons for status of on board connection and key ON are shown as in the picture below:

- Click “Cancel”;
- Repeat the VAS5054 HW interface installation following the procedure (*) “VCI Manager v2.0”, by entering in the menu “Extras” on the right side and clicking on “Diagnostic interface”.

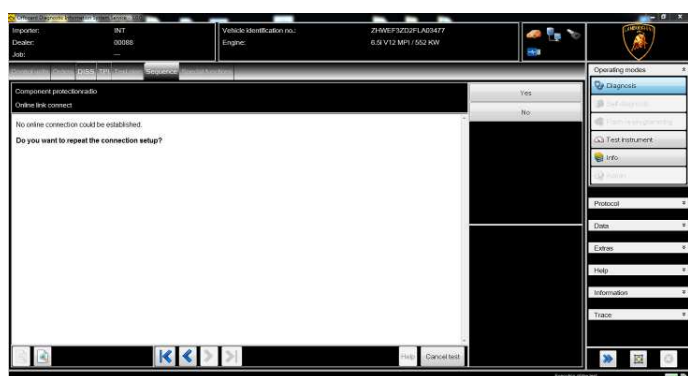
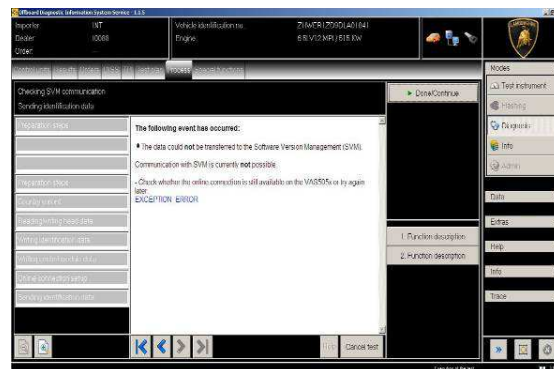
D. If one of the connection error screens is shown as in the pictures below:

- it is not possible to establish a connection with the central server. Please check carefully that the diagnosis laptop is properly connected to the internet network and retry clicking “Yes” or “Done/Continue”.

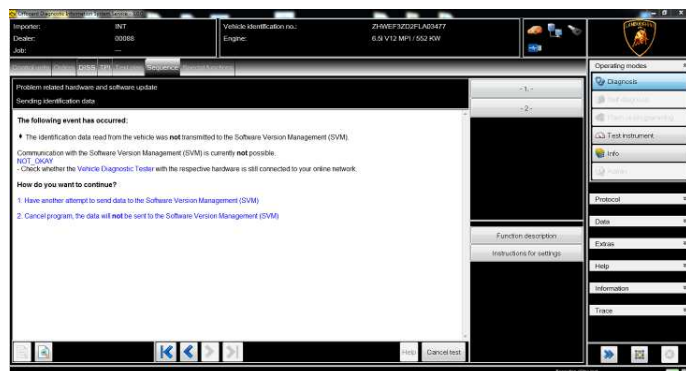
E. If the loss of connection happens during the target/actual comparison during SVM procedure:

- It is not possible to connect to central server, check the working connection of internet and retry by clicking “1”.

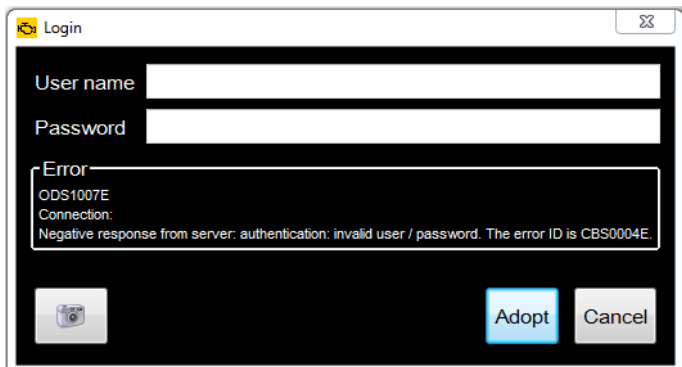
F. If the incorrect identification message is shown as in the picture below (error code: ODS1007E):

- be sure that your Geko account is valid;
- be sure that the label “Geko” is written on the token that you are using for the authentication;
- be sure the Password inserted is correct;
- click on Cancel and perform the application test (see document “ODIS_Checking_ConnectionServer_SVM_2.0” (*)).

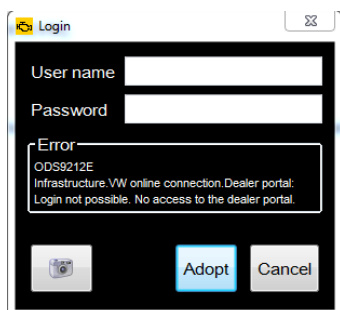
G. If the infrastructure error message is shown as in the picture below (error code: ODS9212E):

- be sure that your Geko account is valid
- be sure that the label “Geko” is written on the token that you are using for the authentication
- verify in ODIS settings you have “Internet” instead of “CPN” (see document “ODIS_Initial_Setup_2.0” (*))
- click on Cancel and perform the application test (see document “ODIS_Checking_ConnectionServer_SVM_2.0” (*))
