LTB00604NAS7

TECHNICAL BULLETIN

06 FEB 2017

SUBJECT/CONCERN:Front Air Spring Damper Hydraulic Fluid Leak

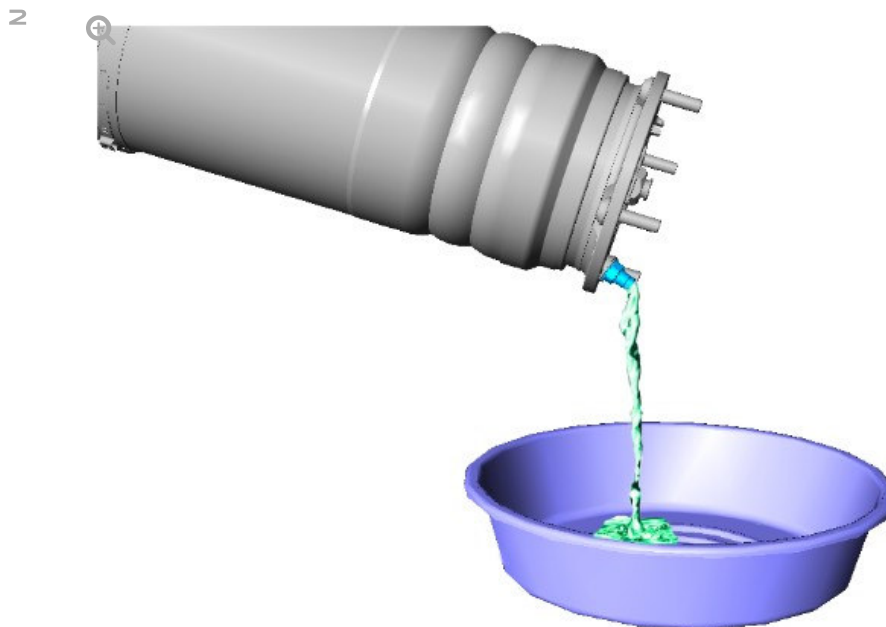
E192260

A 'knock' sound from one or both front air springs when traveling over speed bumps at low speed may be evident. Upon diagnosis, including removal of the air spring and inverting it for a period of approximately one minute, hydraulic fluid is found to flow from the air suspension pipe 'VOSS' connector.

This may be caused by a leak from the hydraulic damper chamber of the air spring.

Using a suitable container, invert the shock absorber and air spring assembly for one minute and check for hydraulic fluid leaking from the air suspension pipe 'VOSS' connector.

- Repeat this step with the other shock absorber and air spring assembly.
 - If hydraulic fluid is leaking from the air suspension pipe 'VOSS' connector of either shock absorber and air spring assembly, go to Step 3.
 - If hydraulic fluid is not leaking from the air suspension pipe 'VOSS' connector of either shock absorber and air spring assembly, the concern is not likely to be related to the damper.
 - Refer to TOPIx for additional related diagnosis / repair information.
 - Install the front left and right air springs (see TOPIx Workshop Manual section 204-05: Vehicle Dynamic Suspension - Front Air Spring).

-
- 3 Replace the front left and right air springs (see TOPIx Workshop Manual section 204-05: Vehicle Dynamic Suspension - Front Air Spring).
