Q663 UPS10016-2BNAS1

TECHNICAL BULLETIN

Update Prior to Sale: Negative Battery Cable Connection

MODEL:	MODEL YEAR:	VIN:	ASSEMBLY PLANT:	APPLICABILITY:
Range Rover Sport (LW)	2017	666892-670469	Solihull	Vehicles Without: 7 Seats

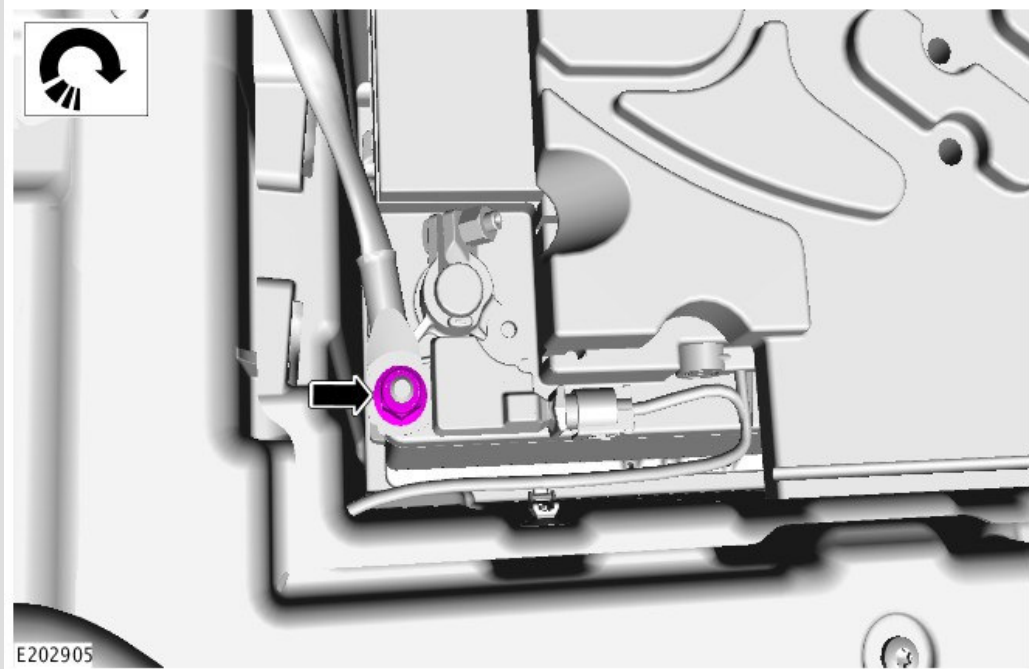
7

An issue has been identified on certain vehicles within the listed Affected Vehicle Range where the negative battery cable connection is under torqued.

Tighten the nut on the cable connection to the negative terminal bracket.

Torque: **12 Nm** .
