Reference	SSM55997
Models	Range Rover / L322 Range Rover Sport / L320
Title	Front Brake Pad Retaining Pins Difficult To Remove.
Category	Chassis
Last modified	27-Feb-2017 00:00:00
Symptom	301000 Service Brake System
Attachments	1Brake pad retaining pins.pdf (1Brake pad retaining pins.pdf)

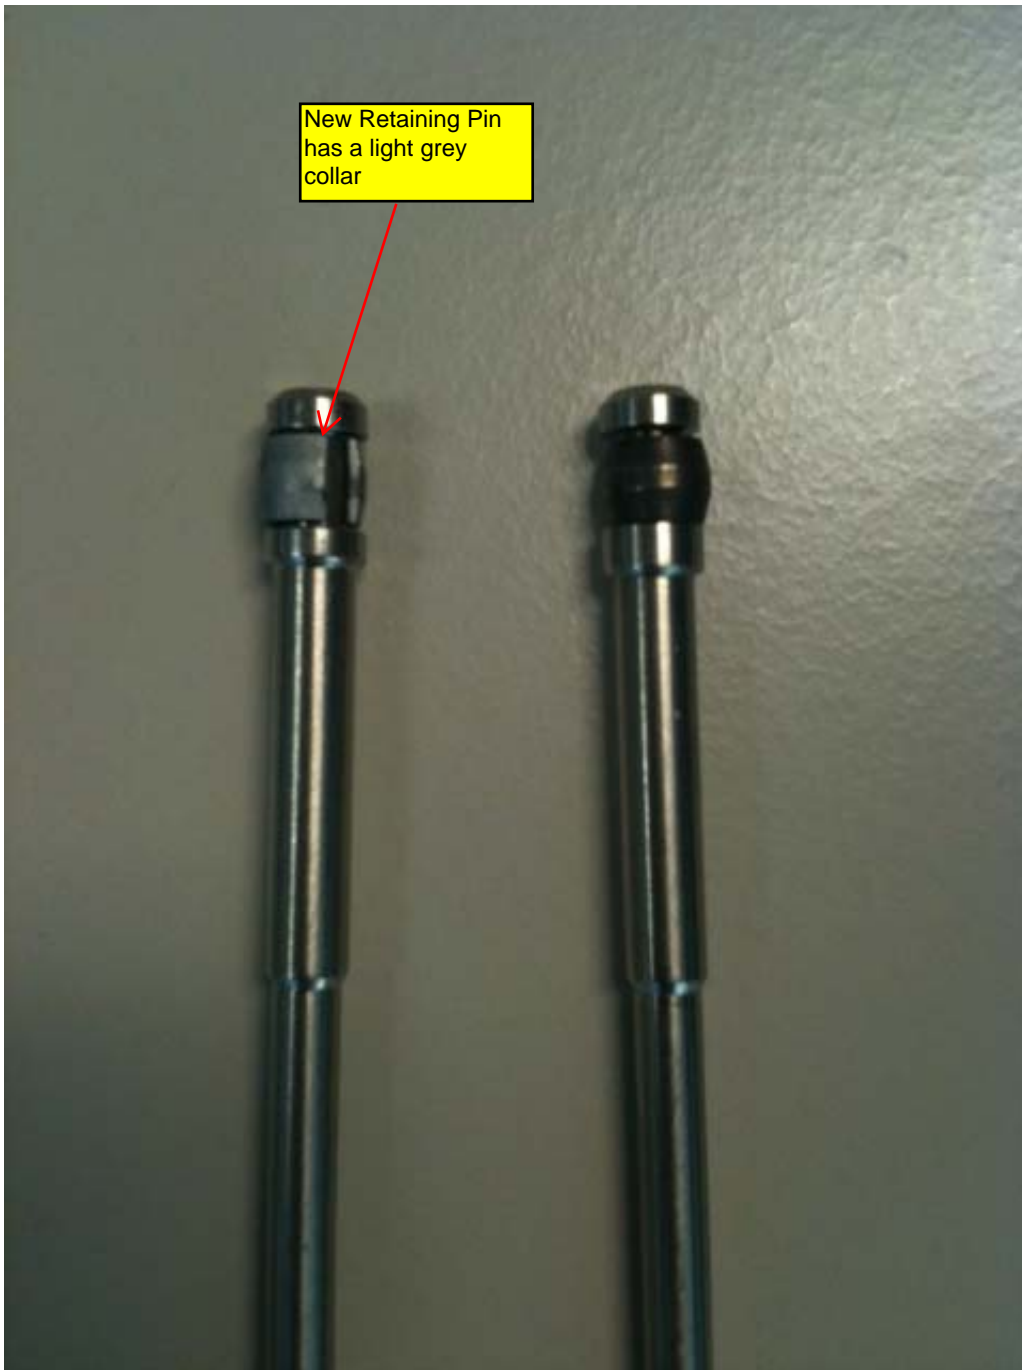
Galvanic corrosion of the retaining pins. The pins now have a new plating which is more resistant to corrosion.

New Retaining Pin
has a light grey
collar

The service part number LR016683 has not changed. All remaining stock of the current pins should be used. The new design retaining pins can be identified by the collar which is now light grey in appearance. Please see attached photo showing the new design pin on the left hand side. Also when removing/replacing the pins please ensure that a coating of Molykote CU7439+ is applied (LR020972).
