Reference	SSM68097
Models	Discovery Sport / L550 Range Rover Evoque / L538
Title	Range Rover Evoque and Discovery Sport Front wheel bearing contamination
Category	Chassis
Last modified	01-Feb-2017 00:00:00
Symptom	301000 Service Brake System
Attachments	111L538 tone ring contamination.jpg (111L538 tone ring contamination.jpg) 11Remove Debris1.pdf (11Remove Debris1.pdf)

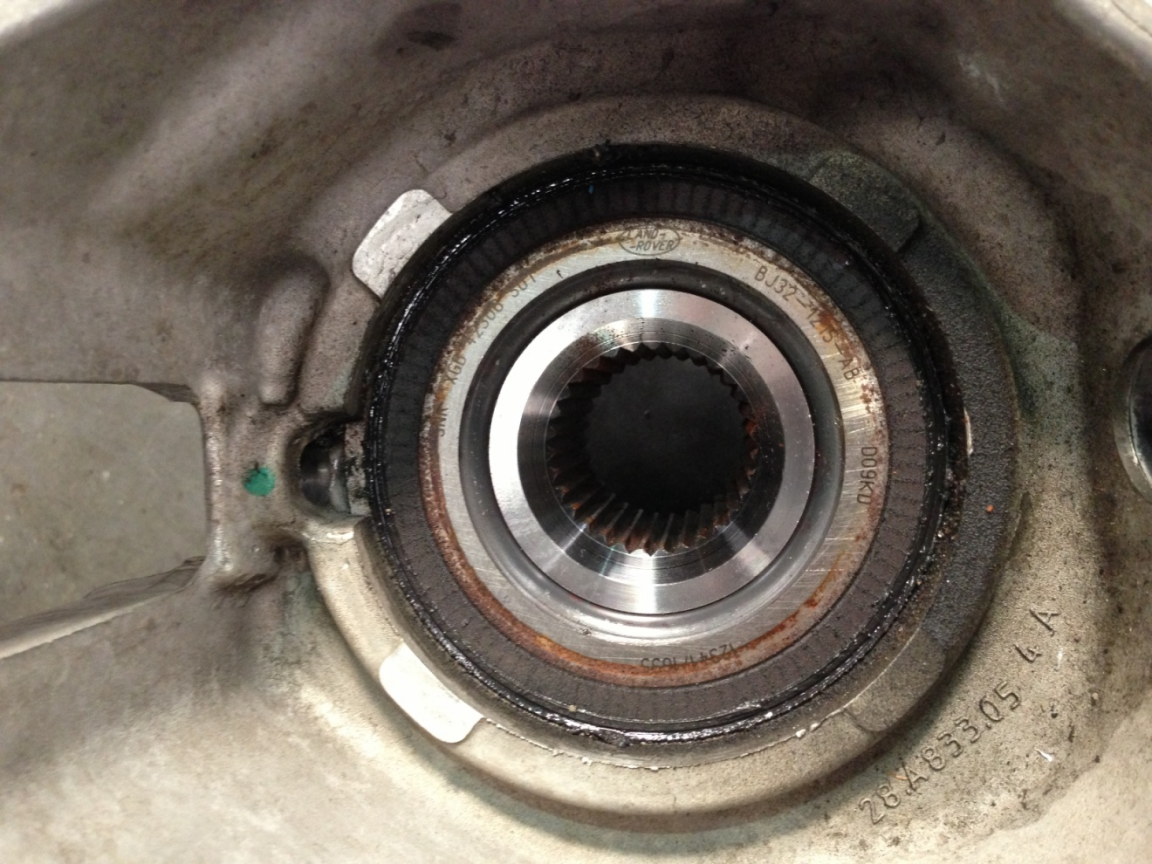
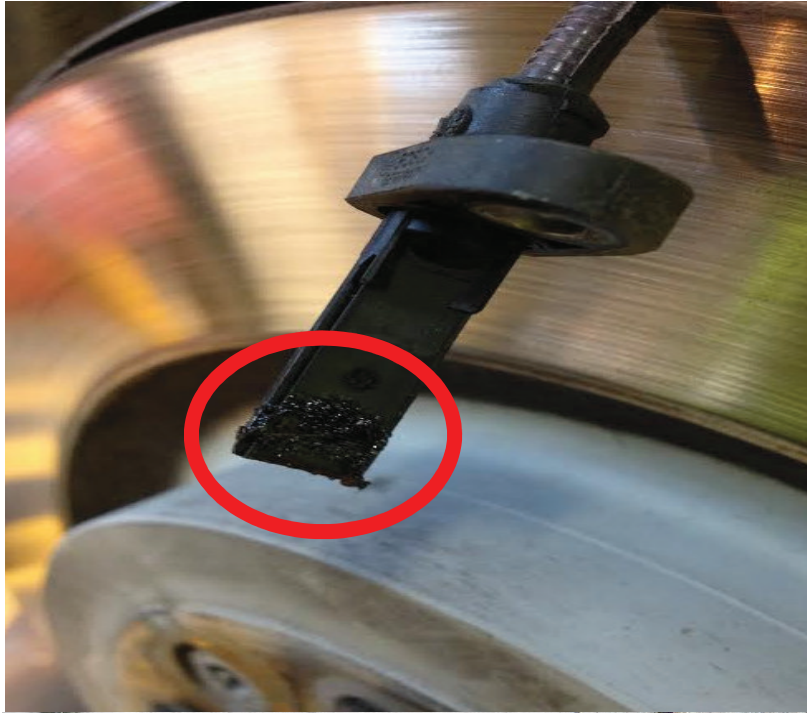
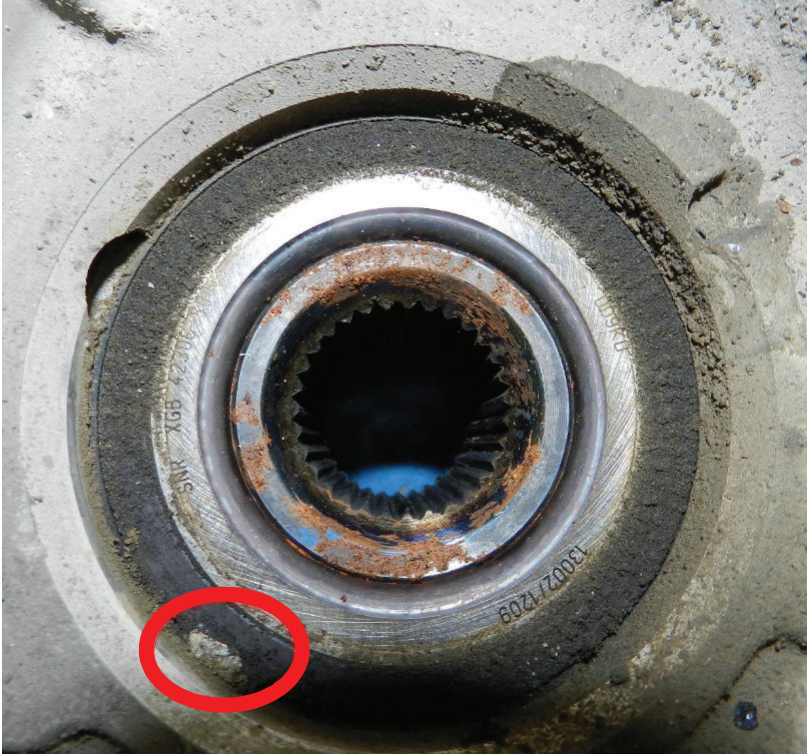
Issue:
Retailers have reported cases where customers may report a Hill Descent Control or Slip Control System warning light showing on the instrument panel. Subsequently, through correct diagnosis, retailers have identified a build up of contaminant evident on the front wheel bearing tone rings. This may then cause an interruption to the signal provided by the Wheel Speed Sensor (WSS). Examples are provided in the attached photographs.

Cause:
Root cause of the contamination is under investigation. However, analysis of parts returned to JLR indicates that cleaning the tone rings and WSS sensors can repair the vehicle to an acceptable condition without the need to replace the bearing and knuckle assembly

Action:
In such instances, retailers are requested to remove the WSS and drive shaft and clean the area with a suitable, locally-sourced wipe. Inspect to ensure contamination has been removed and no visible damage is present on either tone ring or sensor. Re-assembly of the system shall be in accordance with installation procedures detailed in the appropriate section of the Workshop Manual in TOPIX.

Verification that the fault has been rectified may be confirmed by an appropriate road test.
Should the fault re-occur, it may be necessary to replace the wheel bearing and/or knuckle assembly (note, a new shaft retaining nut will be required).
