<b>Reference</b>	SSM73151
<b>Models</b>	Discovery Sport / L550 Range Rover Evoque / L538
<b>Title</b>	L538+L550 - Heated Steering Wheel - Heat Distribution Issues
<b>Category</b>	Body
<b>Last modified</b>	06-Feb-2017 00:00:00
<b>Symptom</b>	107000 Interior Trim
<b>Attachments</b>	Attachment 2.pdf (Attachment 2.pdf) Attachment.pdf (Attachment.pdf)

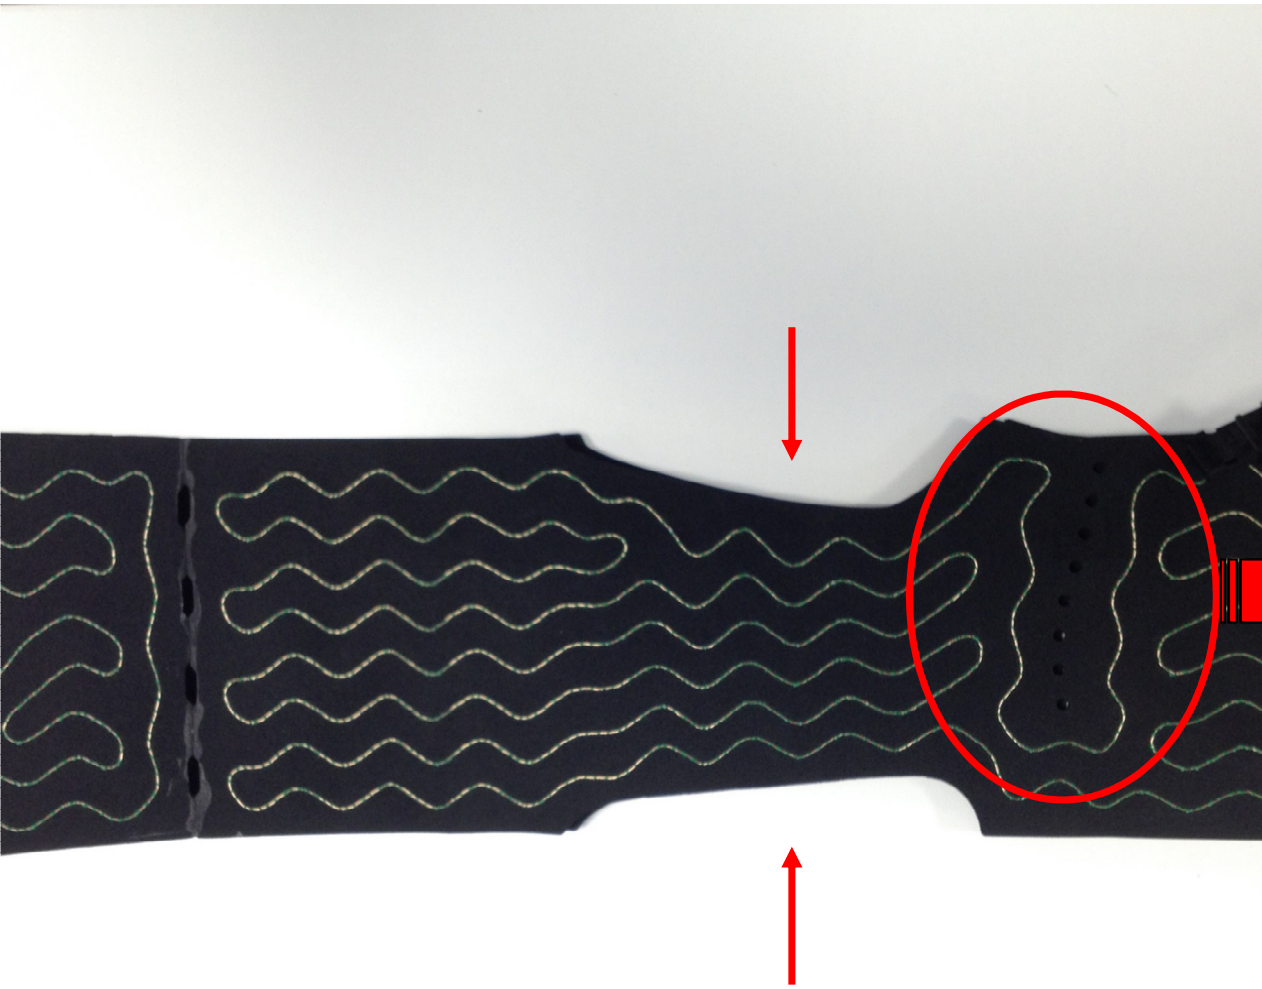
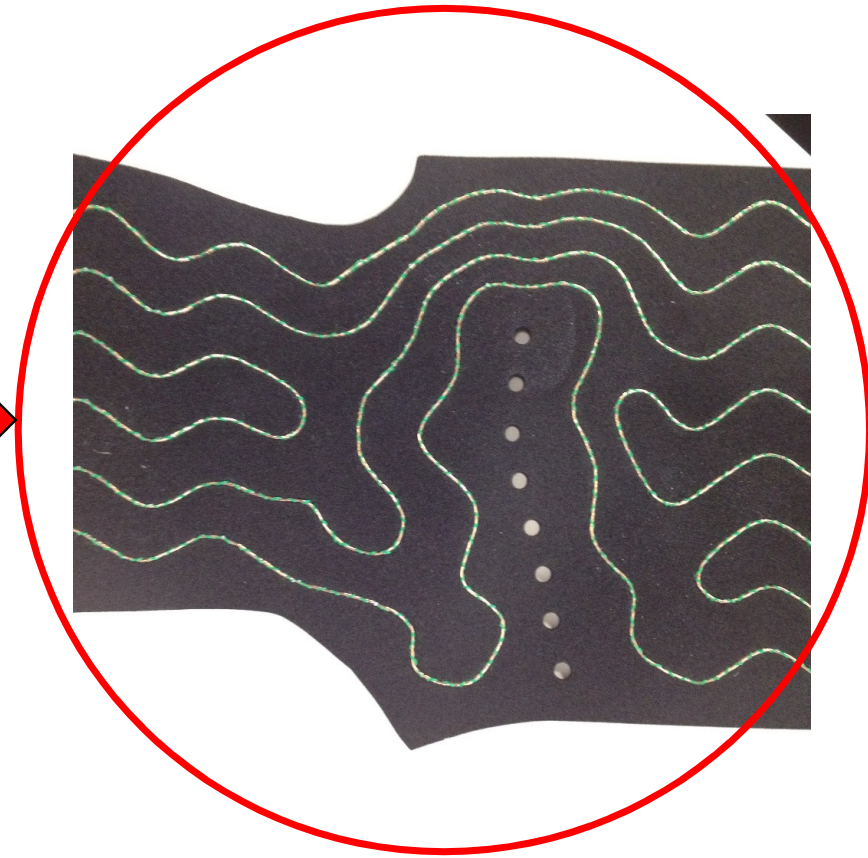
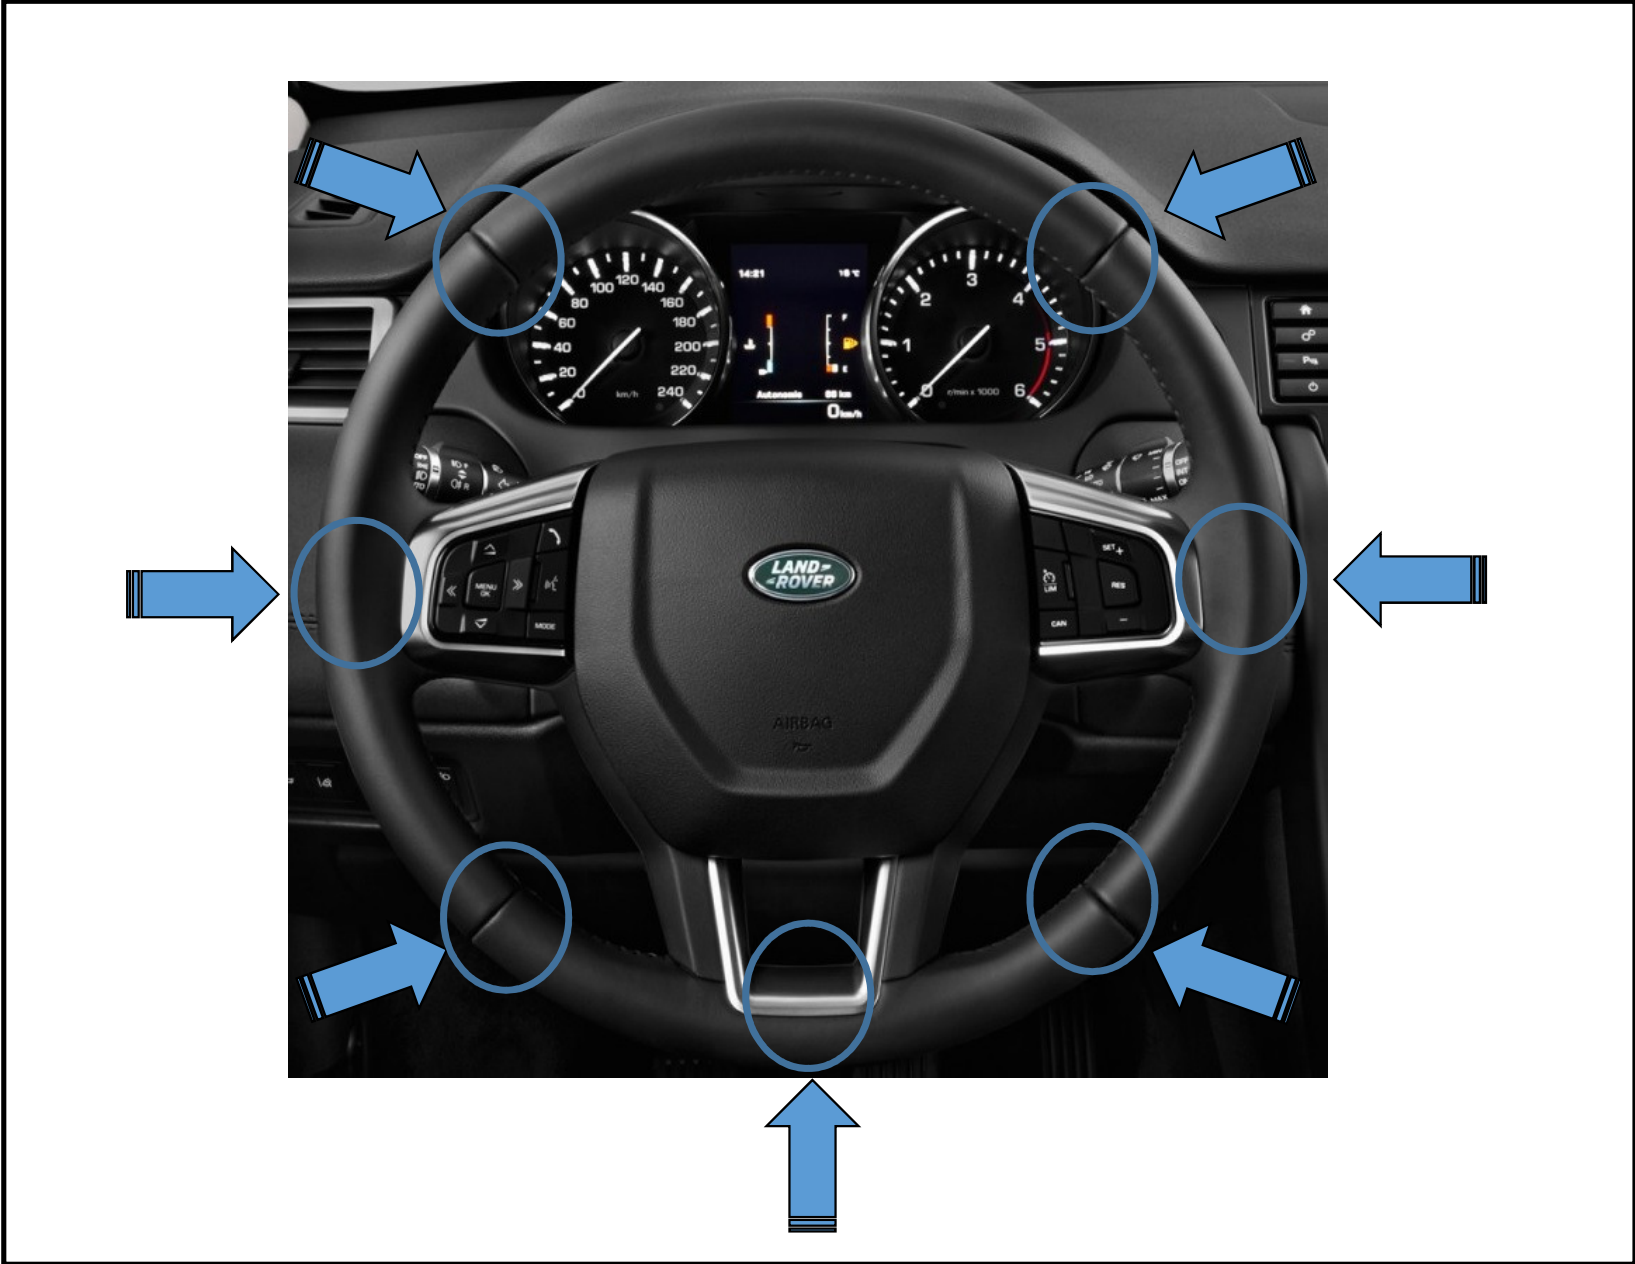
Issue:  
The customer may express a concern that the heat distributed across the surface area of their heated steering wheel is inconsistent. The areas around the stitching and spokes, or the lower half of the steering wheel, may appear cooler than the rest of the wheel.

Cause:  
Due to the construction of the steering wheel heater insert, the distribution of the heater element cannot be uniform across the whole of the steering wheel surface.

The heater element needs to be diverted around the stitched area in order to prevent breakage of the element during assembly of the steering wheel, while the heater insert itself needs to be diverted around the steering wheel spokes to allow it to wrap the steering wheel without bulging or creasing.

Please see the images in the accompanying attachments which illustrate these characteristics and highlight spots which may appear cooler.

Action:  
Vehicles presented with the above issue should NOT have their steering wheels replaced under warranty.

Instead, please manage the customer's expectation of how the steering wheel heater will work, by referring to the information and images supplied in this SSM.
