Update Prior to Sale Notice

Action No.: Q665 UPS0117-4B

Model/Variant	Model Year(s):		VIN Range:		Assembly Plant:
	from	to	from	to	
Range Rover Evoque (LV)	2017	2017	210937	214076	Halewood

Subject: **Right Hand Front Seat - Outer Pod - Spot Weld Locations**

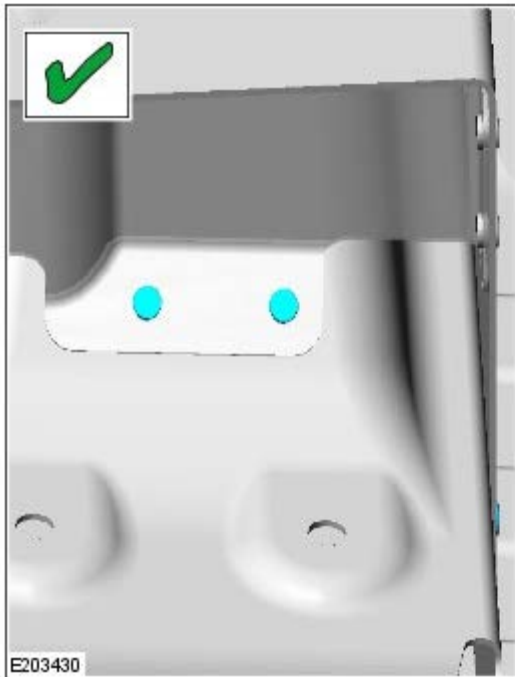
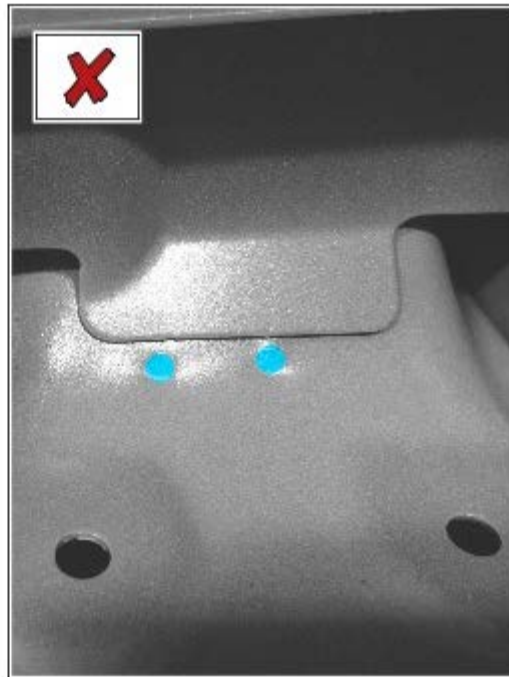
It has been identified that four spot welds on the right hand front floor pan may be incorrectly positioned. As a consequence, the bracket which these welds fix to the floor may not be secured as required.

5. Visually inspect the spot welds. If the spot welds are in the correct position, go to step 9. If the spot welds are in the incorrect position, go to step 6.

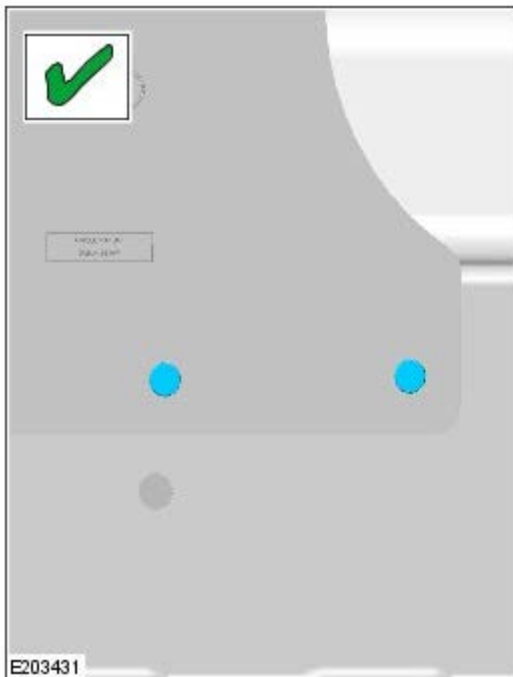
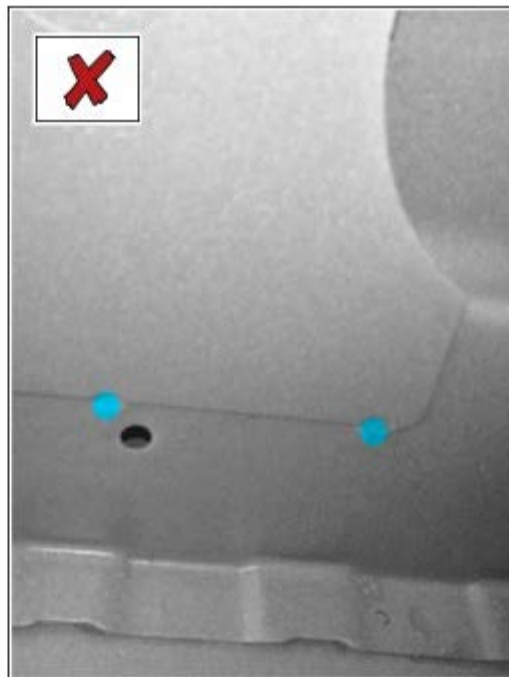
E203431

7. Apply etch primer to the exposed metal in the area drilled.
8. Install blind rivets in both 7mm holes.
9. Visually inspect the spot welds. If the spot welds are in the correct position, go to step 12. If the spot welds are in the incorrect position, go to step 10.
