Update Prior to Sale Notice

Action No.: Q658 UPS9116-4B

Model/Variant	Model Year(s):		VIN Range:	
	from	to	from	to
Range Rover Evoque (LV)	2017	2017	200245	200550

Subject: **Right Hand Side - Rear Wheel-Arch & Rear Tail Lamp Aperture Spot Welds**

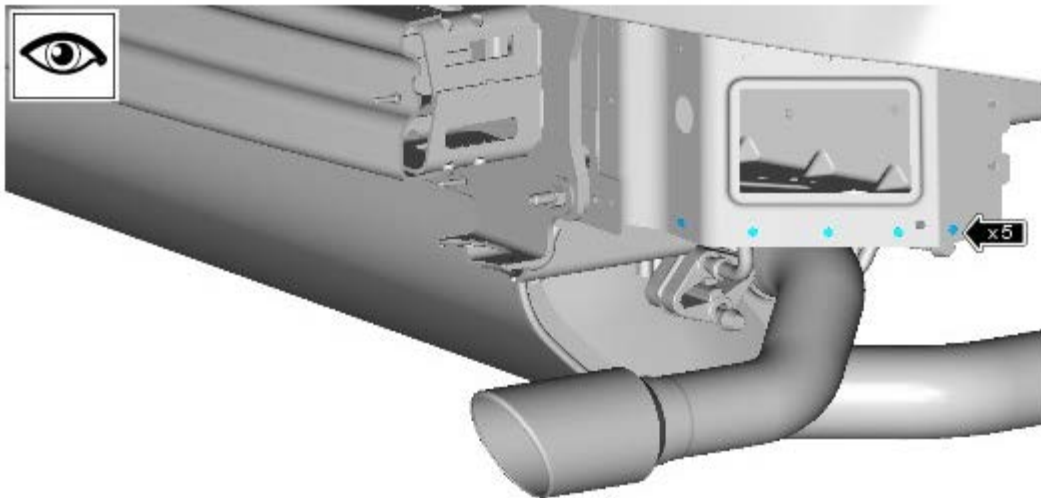
E202844

1. Remove the rear bumper cover (see TOPIx Workshop Manual section: 501-19 - Bumpers - Rear Bumper Cover).
2. Locate the five spot welds around the lower aperture in the right side tail light panel.

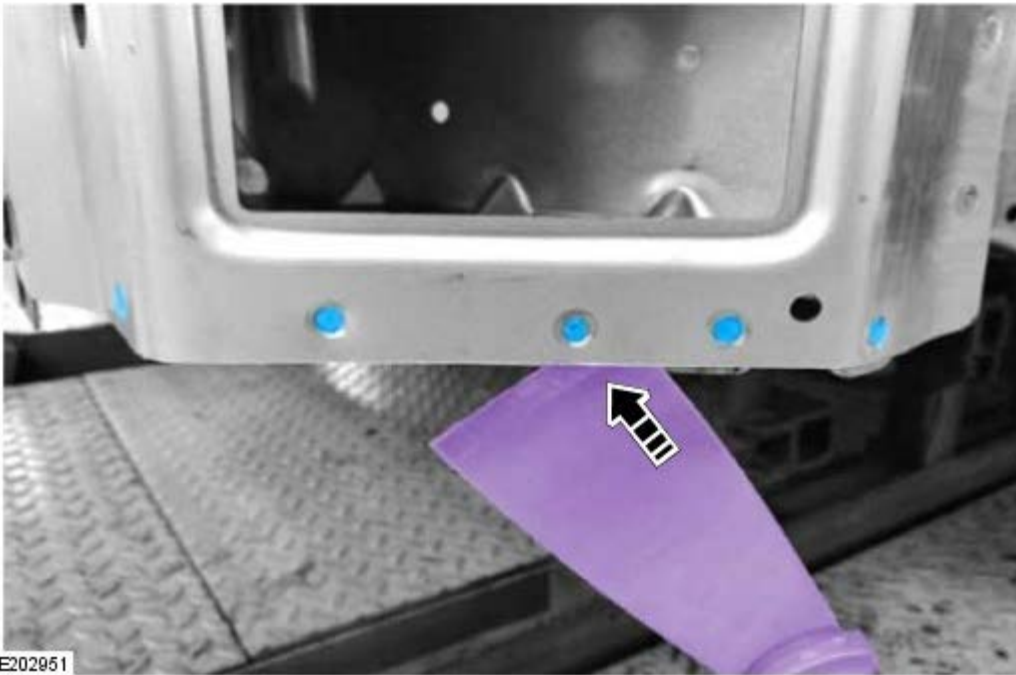
3.

Insert a scraper between the two panels and towards each of the five spot welds to check for defective welds.

- The scraper should be struck twice with suitable force using a hammer in order to test each of the spot welds.
- If any of the five spot welds are broken/defective, mark the defective weld(s) and continue to step 4.

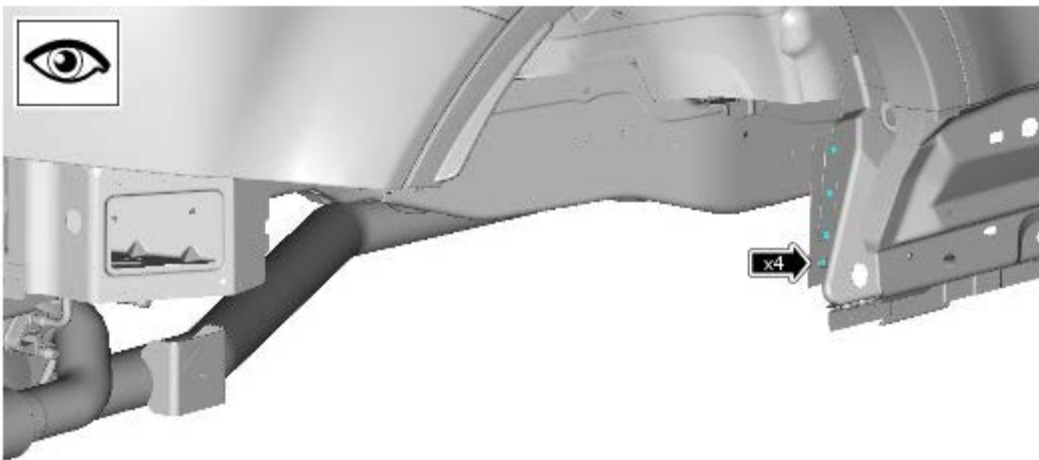
4. Locate the four spot welds at the front of the right side rear wheel arch.

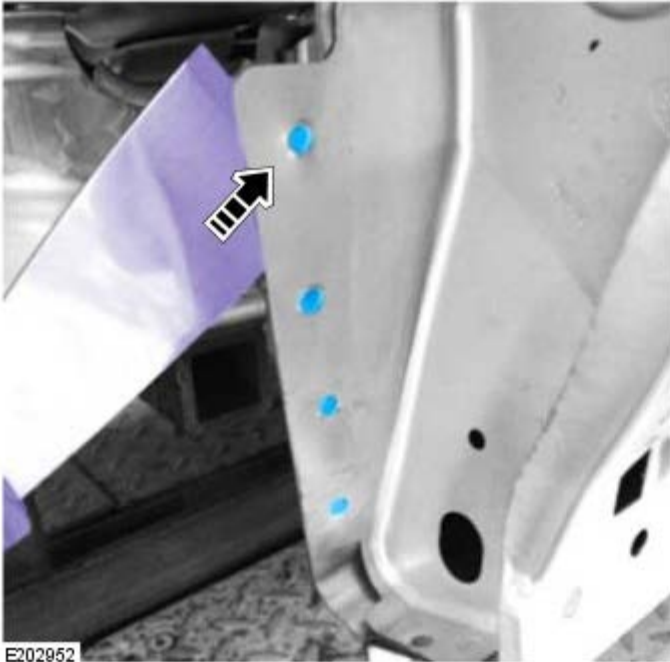
5.

Insert a scraper between the two panels and towards each of the four spot welds to check for defective welds.

- The scraper should be struck twice with suitable force using a hammer in order to test each of the spot welds.
- Mark any broken/defective spot welds.

- If any broken/defective spot welds are found in either of the two locations, continue to step 9.
- If all the checked spot welds are OK, go to step 6.
