Q664NAS1

TECHNICAL BULLETIN

Service Action: Incorrect Bracket Fitted

MODEL:	MODEL YEAR:	VIN:	ASSEMBLY PLANT:	APPLICABILITY:
Range Rover Sport (LW)	2017	667482-671021	Solihull	V6 S/C 3.0L Petrol

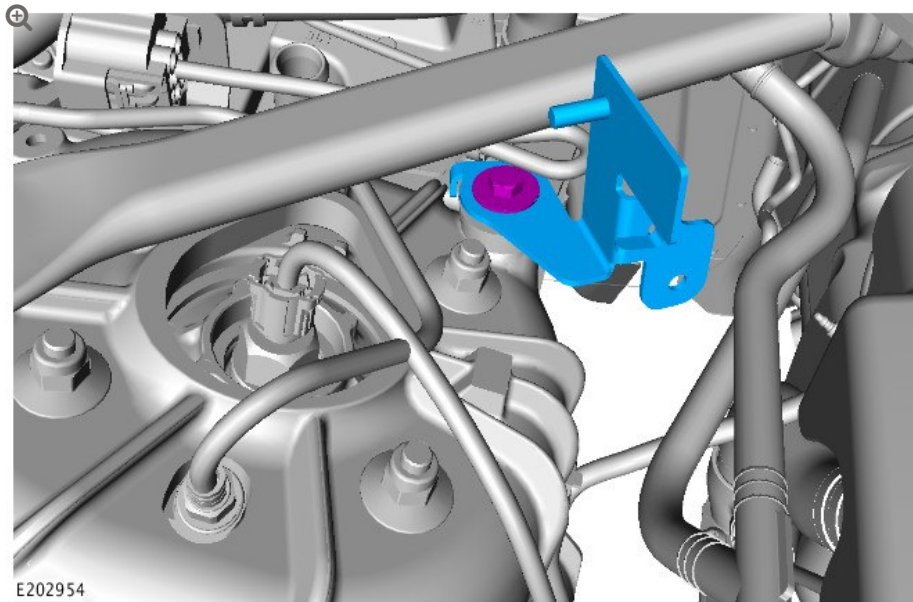
An issue has been identified on certain vehicles within the listed Affected Vehicle Range where a bracket may be fitted in the engine compartment in error. The bracket can come into contact with an underhood coolant hose which over time could chafe and ultimately wear through, leading to loss of coolant.

The bolt must be reused.

Remove the bolt and discard the unused bracket near the front right suspension top mount.
