<b>Reference</b>	SSM73330
<b>Models</b>	Range Rover / L405 Range Rover Sport / L494
<b>Title</b>	Incorrect Diesel Exhaust Fluid Quality Warning Message DTC P2BA9
<b>Category</b>	Engine
<b>Last modified</b>	07-Apr-2017 00:00:00
<b>Symptom</b>	403000 Exhaust System Concerns
<b>Attachments</b>	NAS DEF SSM FILE.pdf (NAS DEF SSM FILE.pdf)
<b>Content</b>	<p><b><u>Issue:</u></b> Reports of 'No Engine Restarts in XXX miles. 'Incorrect Diesel Exhaust Fluid Quality Detected' warning message displayed on the Instrument Cluster (IC) and Diagnostic Trouble Code (DTC) P2BA9-00 and/or P2BA9-92 stored in the Powertrain Control Module (PCM) which may be accompanied by DTCs P2BAE and P2BAF.</p> <p><b><u>Cause:</u></b> Various, investigation work is ongoing.</p> <p><b><u>Action:</u></b></p> <ol style="list-style-type: none"> <li>1) Check the PCM (Powertrain Control Module) has the latest level of software loaded, i.e. SDD/Pathfinder reports no ECU update available.</li> <li>2) Carry out a visual inspection of both the upstream and downstream NOx sensor(s) fitted in the exhaust system. Check for damage, incorrect mounting of sensors, blocked sensors.</li> <li>3) Using the Diesel Exhaust Fluid (DEF) qu

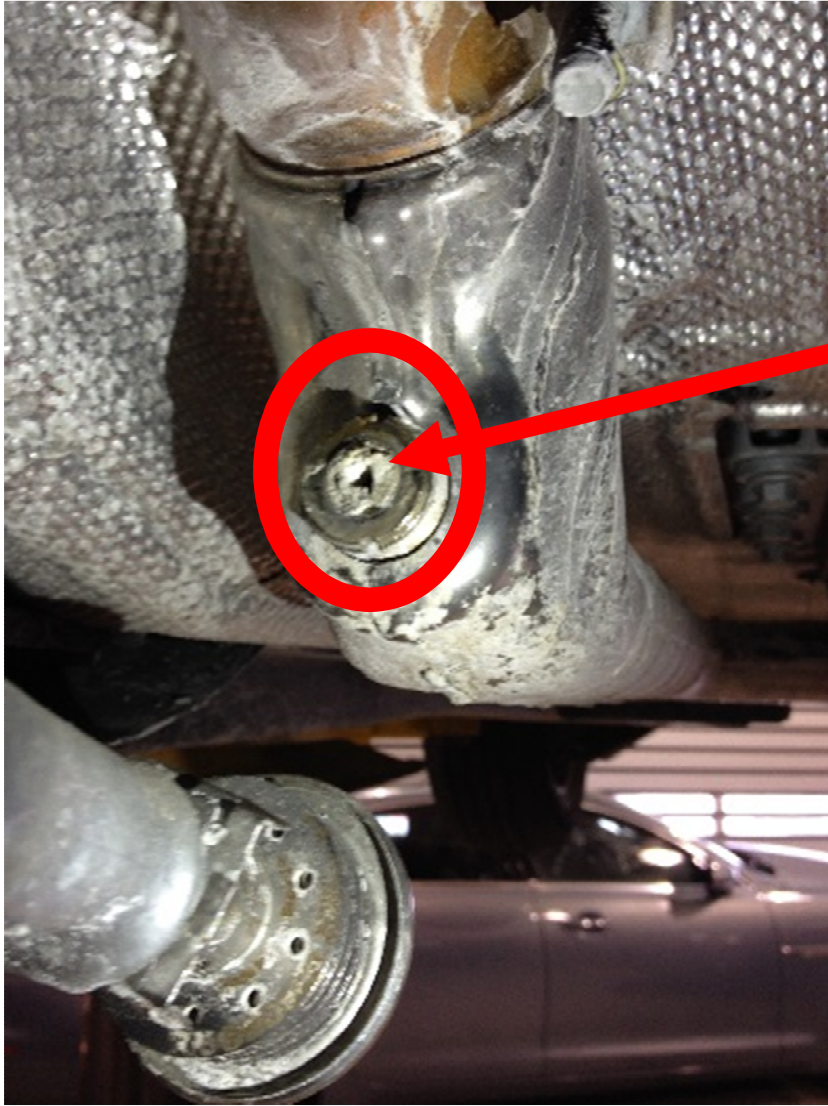
# Picture A

Check for any heavy deposits build-up at the injector seat.

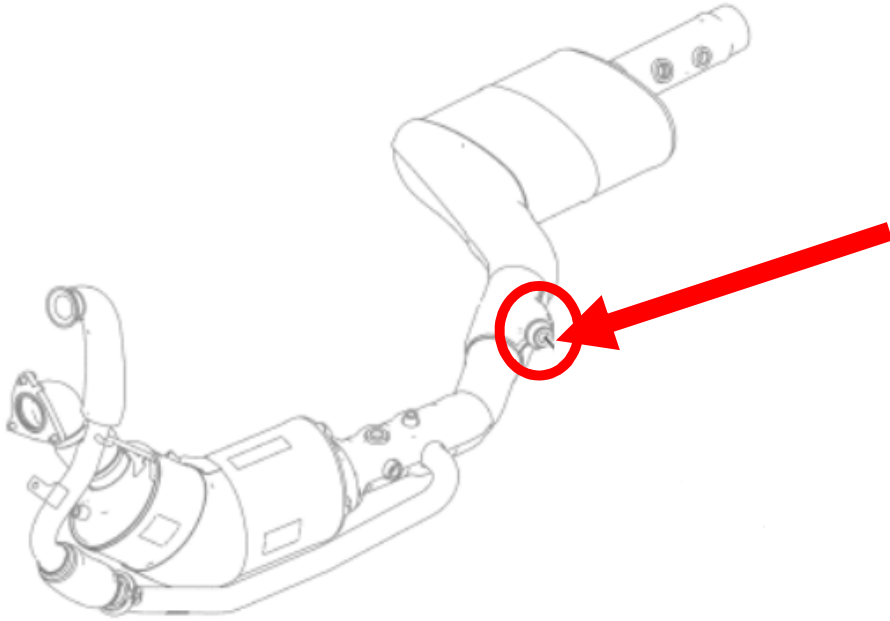
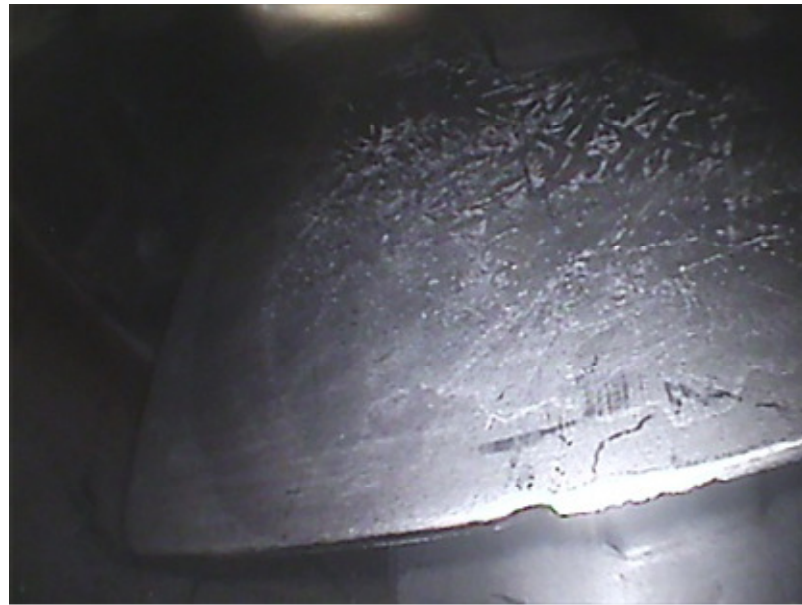
# Picture B

Borescope inspection of the Selective Catalytic Reduction (SCR) catalytic converter (through the DEF injector hole). Check for deposit stains on the mixer brick as shown below.

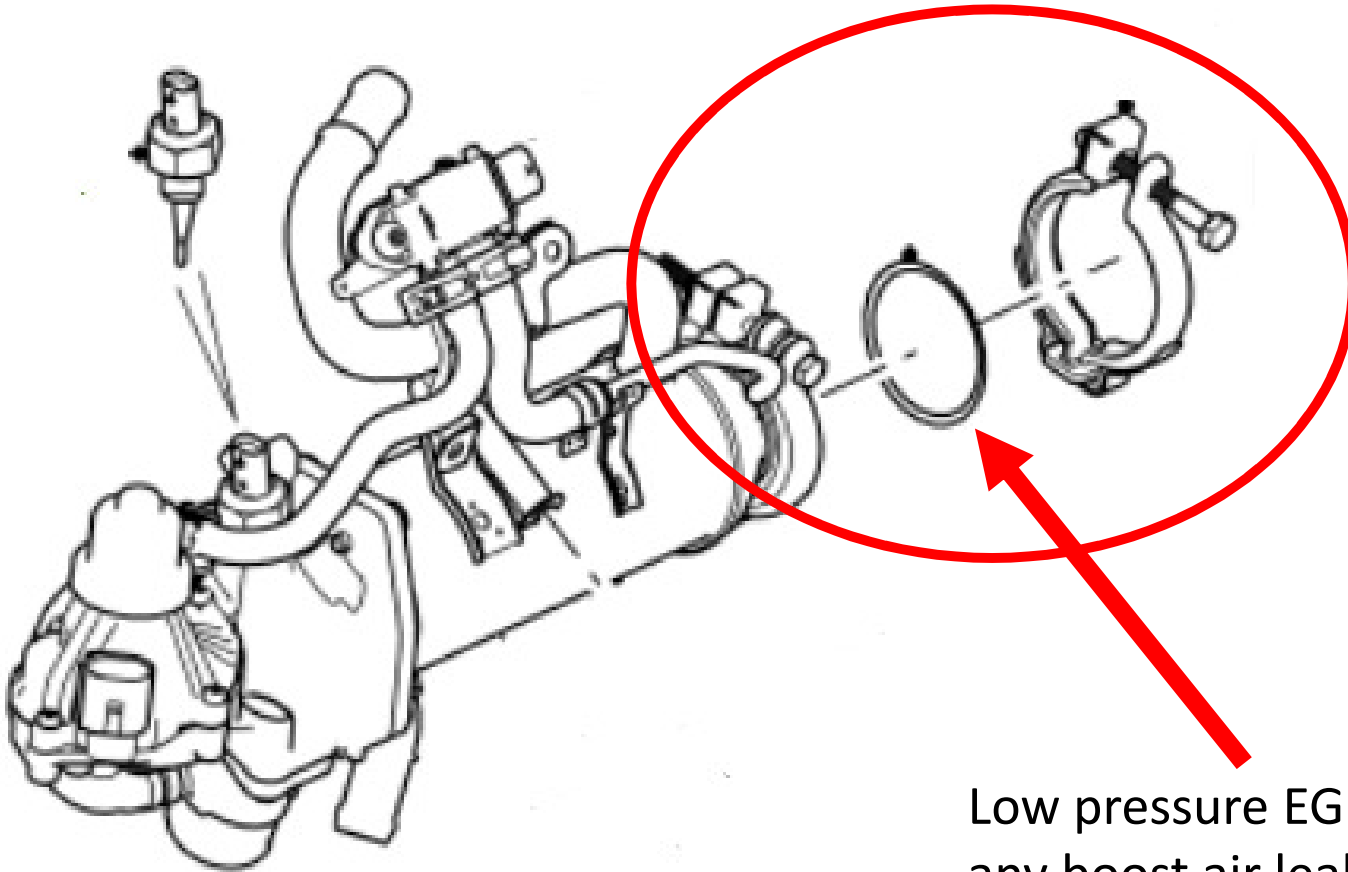
# Picture C

pre the turbocharger and around the charge air cooler clamps. Also pay careful attention to the low pressure EGR cooler joint as a leak was found from this area during a recent engineering visit to a Retailer. Refer to picture C on the attached file.

Low pressure EGR cooler joint, carefully check for any boost air leaks using the high pressure diagnostic leak detector approved kit.

If a defect is found rectify as necessary and using the approved diagnostic tool reset the selective catalyst reduction quality monitor and raise a Quality Report detailing the error state found. **NOTE - Once the reset selective catalyst reduction quality monitor has been successfully executed the warning message in the instrument cluster will extinguish. The remaining inducement DTCs (P2BAE/P2BAF) can now be cleared from the PCM.**
