LTB00827NAS7

TECHNICAL BULLETIN

Ticking Noise From 'B' Pillar Area

MODEL:	MODEL YEAR:	VIN:	ASSEMBLY PLANT:
Discovery Sport (LC)	2015 Onwards	500429 Onwards	Halewood

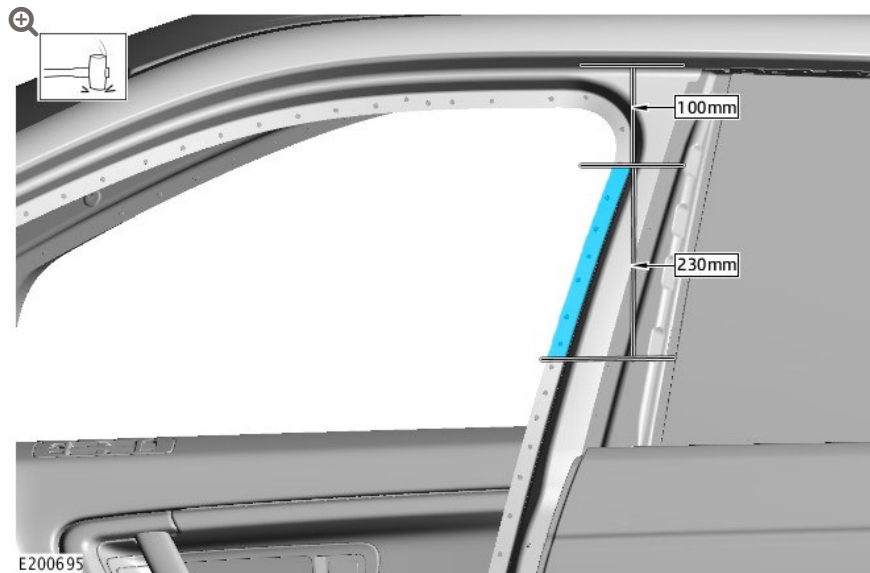
This may be caused by the 'B' pillar panel clearance being incorrect.

Using a suitable tool, strike the panel with as much force as can safely be applied inwards over the highlighted area shown.

- Repeat along the highlighted area shown.
 - This will eliminate the noise from this area.
