Reference	SSM73151
Models	Discovery Sport / L550 Range Rover Evoque / L538
Title	L538+L550 - Heated Steering Wheel - Heat Distribution Issues
Category	Body
Last modified	02-May-2017 00:00:00
Symptom	107000 Interior Trim
Attachments	1Attachment.pdf (1Attachment.pdf) Attachment 23.pdf (Attachment 23.pdf)
Content	Issue: The customer may express a concern that the heat distributed across the surface area of their heated steering wheel is inconsistent. The areas around the stitching and spokes, or the lower half of the steering wheel, may appear cooler than the rest of the wheel.
	The heated steering wheel is otherwise operating correctly, and no DTCs are stored.
	<u>Cause:</u> Due to the construction of the steering wheel heater insert, the distribution of the heater element cannot be uniform across the whole of the steering wheel surface.
	The heater element needs to be diverted around the stitched area in order to prevent breakage of the element during assembly of the steering wheel, while the heater insert itself needs to be diverted around the steering wheel spokes to allow it to wrap the steering wheel without bulging or creasing.

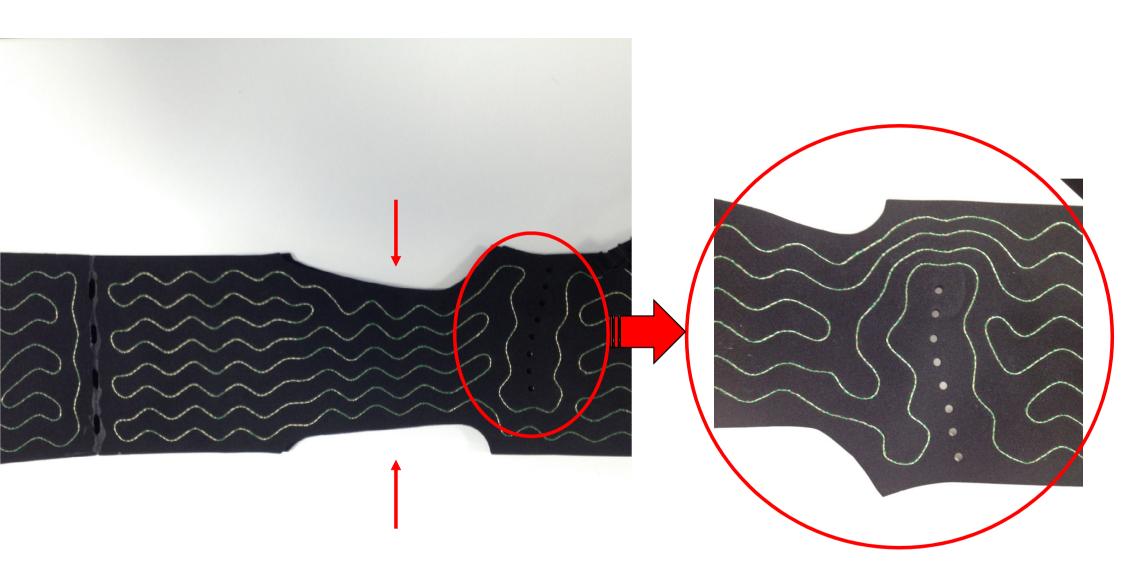
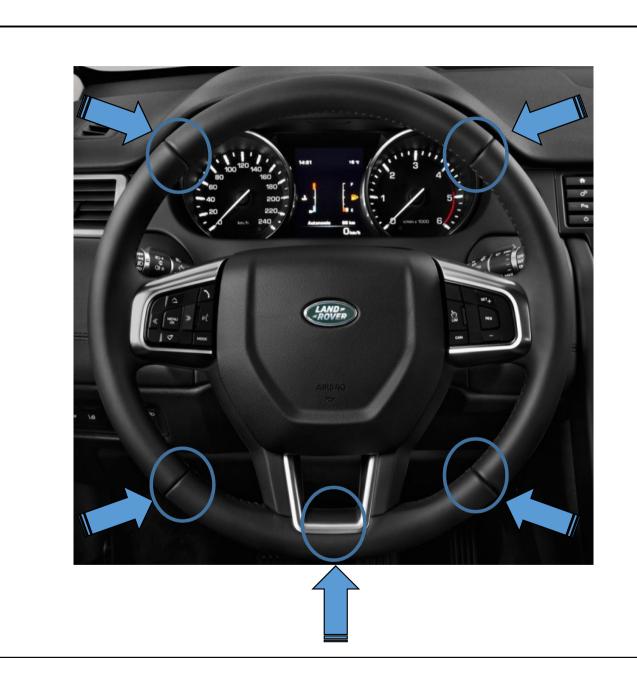
Please see the images in the accompanying attachments which illustrate these characteristics and highlight spots which may appear cooler.
	Action: Vehicles presented with the above issue should NOT have their steering wheels replaced under warranty.

Instead, please manage the customer's expectation of how the steering wheel heater will work, by referring to the information and images

supplied in this SSM.
