Q612NAS2

# TECHNICAL BULLETIN

11 MAY 2017

Service Action: PSIM Card Activation

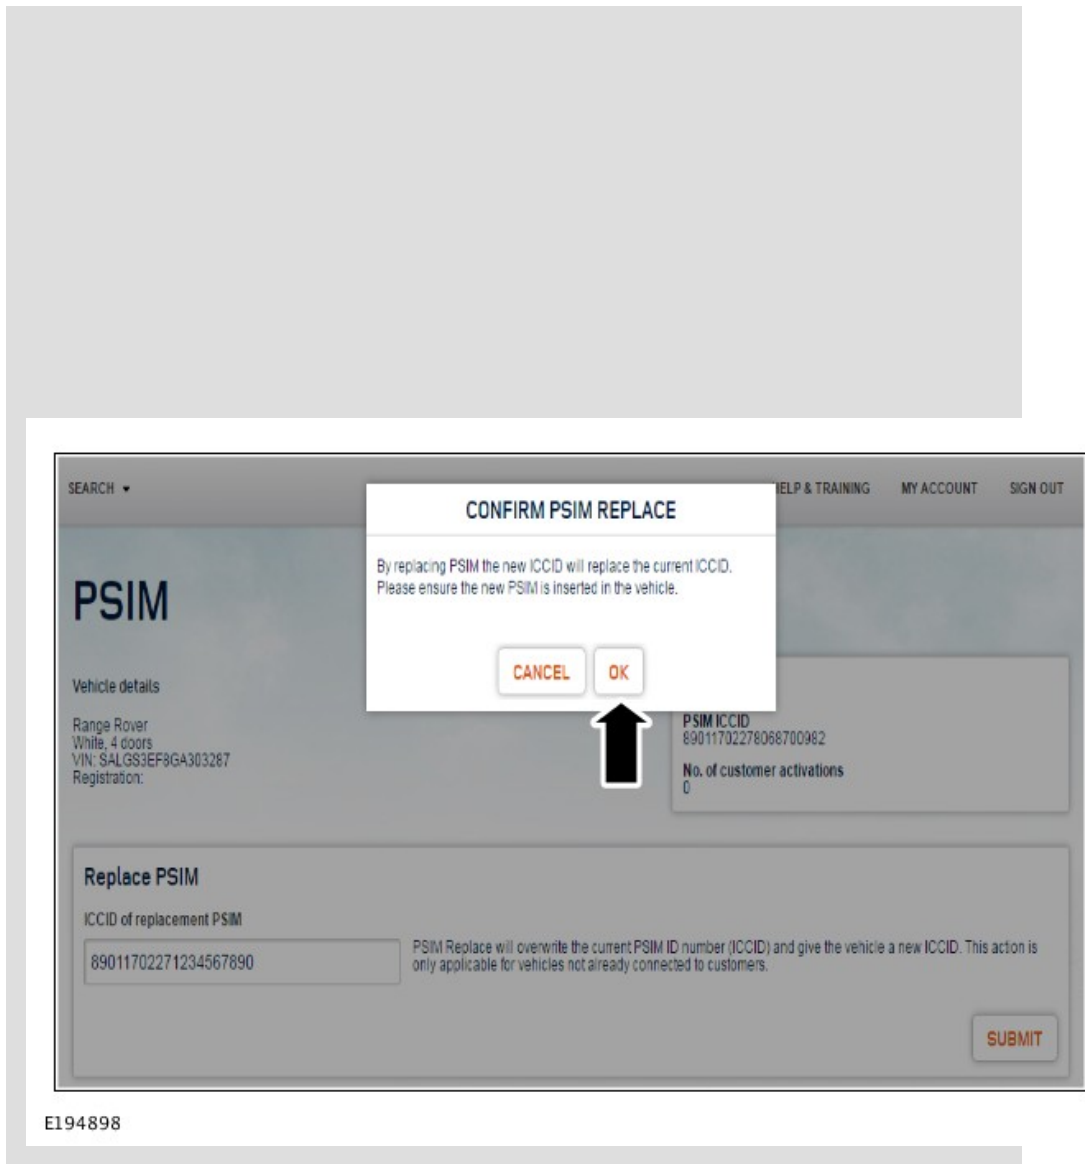
There is a pop-up reminder to fit the PSIM into the vehicle.

Click **OK** .
