LTB01002NAS2

TECHNICAL BULLETIN

501-08: Exterior Trim and Ornamentation

'A' Pillar Finisher Rubber Seal Adrift

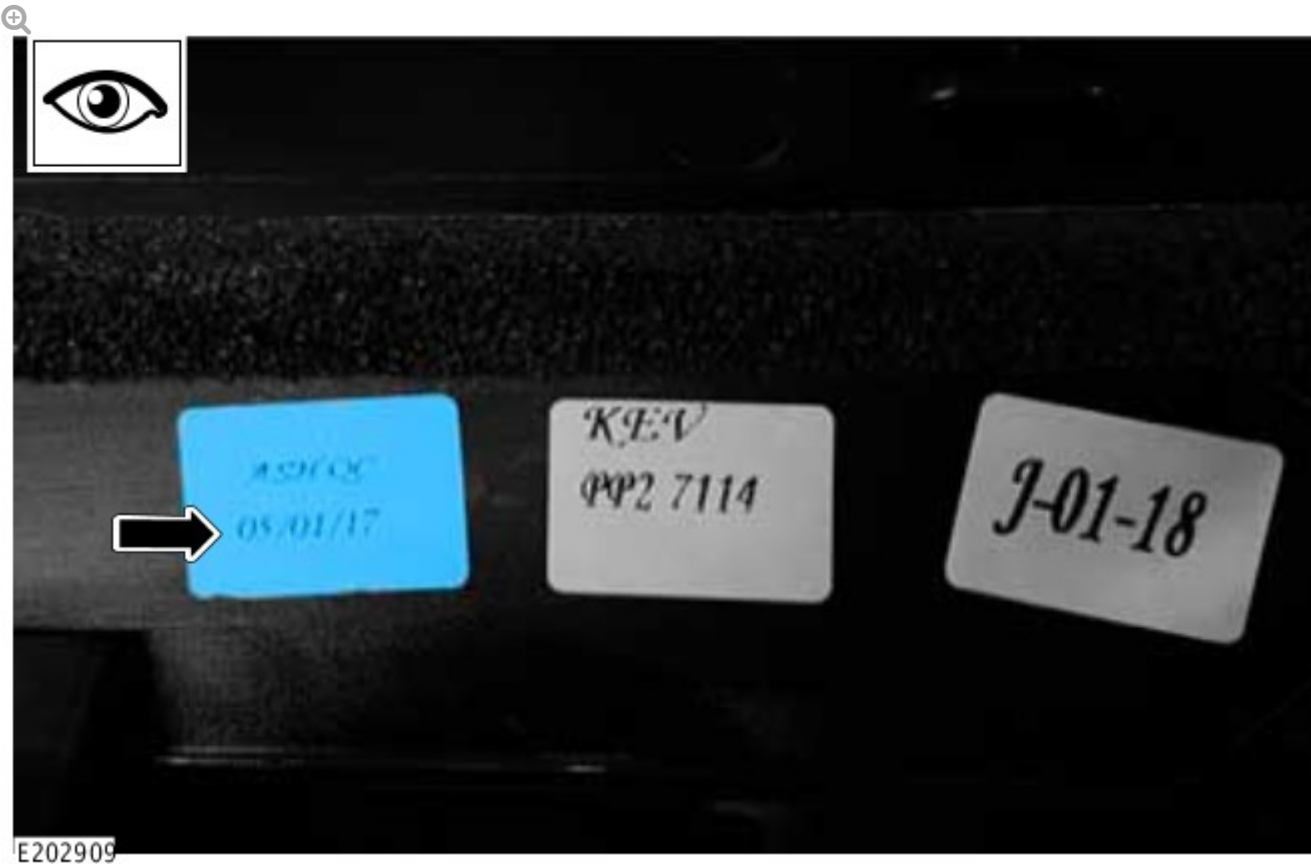
Visually inspect the date printed on the label attached to the new 'A' Pillar finisher.

- If the printed date is **25/11/16** or later, the part can be installed. Go to step 3.
- If the printed date is **24/11/16** or earlier, the part must not be installed.
 - Source a new 'A' Pillar finisher with a printed date of **25/11/16** or later.
 - Go to Step 3.
