<b>Reference</b>	SSM73332
<b>Models</b>	Discovery / L462
<b>Title</b>	L462 All New Discovery Head Lamp Poor Profile
<b>Category</b>	Body
<b>Last modified</b>	16-May-2017 00:00:00
<b>Symptom</b>	108000 Ext. Trim/Accessories
<b>Attachments</b>	L462 Poor headlamp profile.pdf (L462 Poor headlamp profile.pdf)

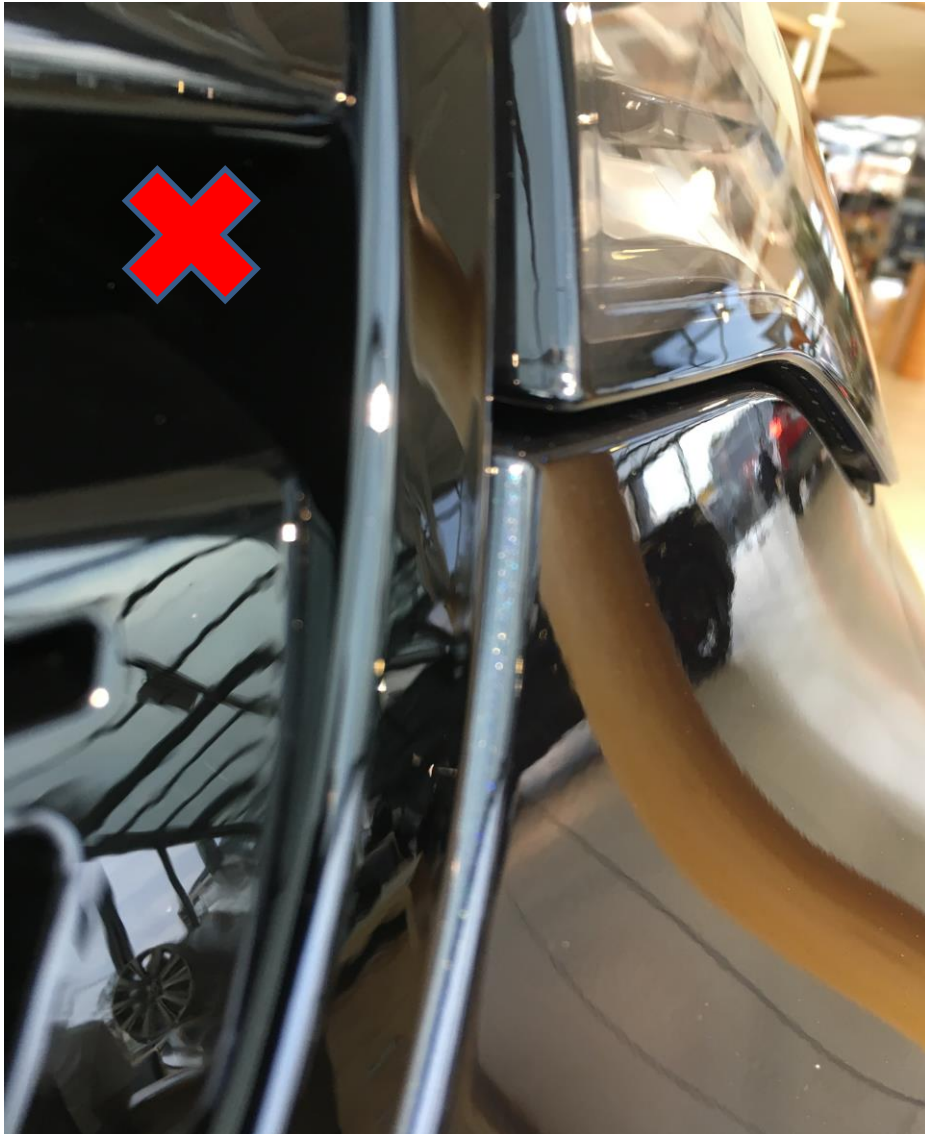
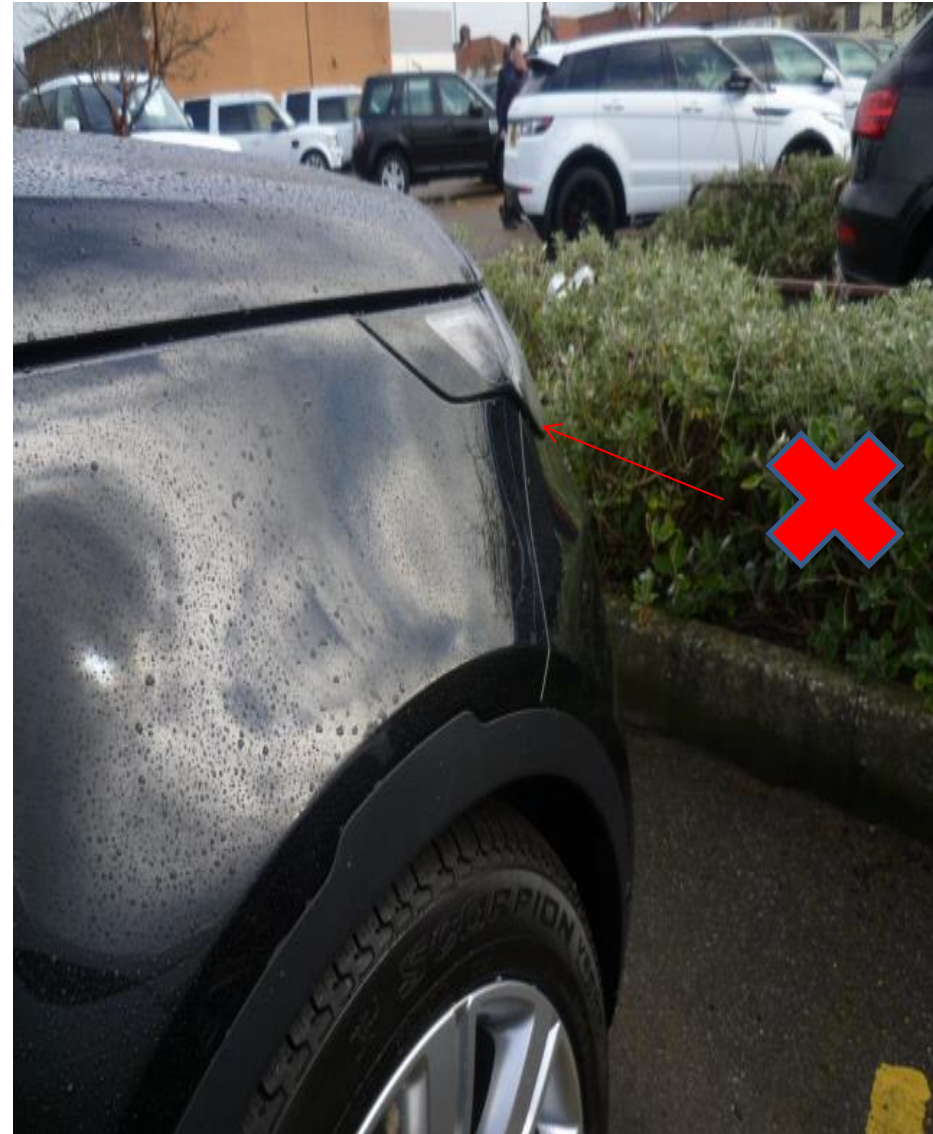
# Example of Poor Profiles

Land Rover Discovery (L462) prior to the vin of LR008316, Customers or Retailers may report that the Headlamp Profile to the fender (Wing) or the Headlamp to Grille / Bumper profile is incorrect – see attached file for examples

Should a customer or retailer report that the profile of the Headlamp to the Grille / Bumper is incorrect then the Technician is requested to first loosen the 3 Headlamp fixings as shown in the attached file and then gentle push inwards on the headlamp until flush or within the standard of 2mm + or – 1.7mm. If this fails to align the profile then please replace the affected headlamp mounting bracket

Should a customer or retailer report the Headlamp profile to the Fender / Wing then the Technician is requested to replace the affected Bumper Mounting Bracket
