Reference	SSM73386
Models	Discovery / L462
Title	L462 All New Discovery Tailgate will not open
Category	Body
Last modified	22-May-2017 00:00:00
Symptom	112000 Latches/Locks & Security
Attachments	1Graphic1.docx (1Graphic1.docx) L462 Spigot bracket yellow dot.JPG (L462 Spigot bracket yellow dot.JPG) Tailgate profiles.docx (Tailgate profiles.docx)

The tailgate fails to open when commanded via the key fob or tailgate release button

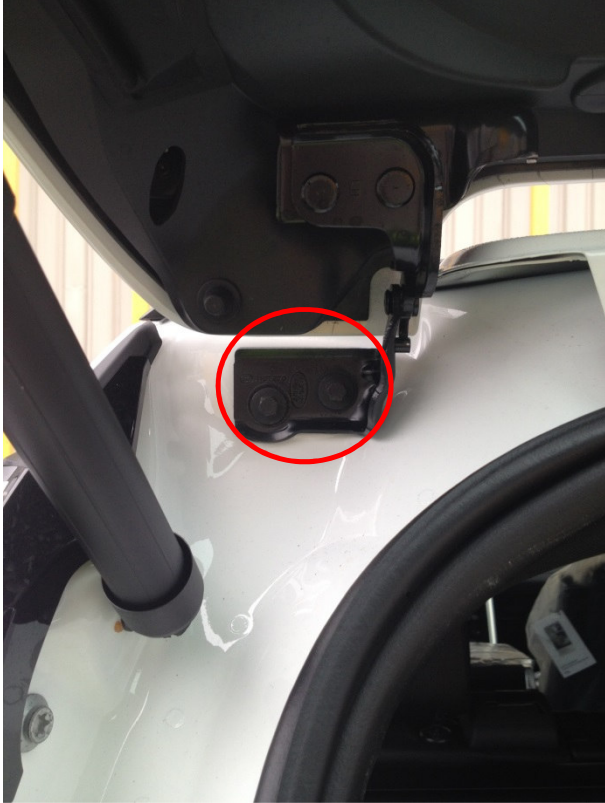
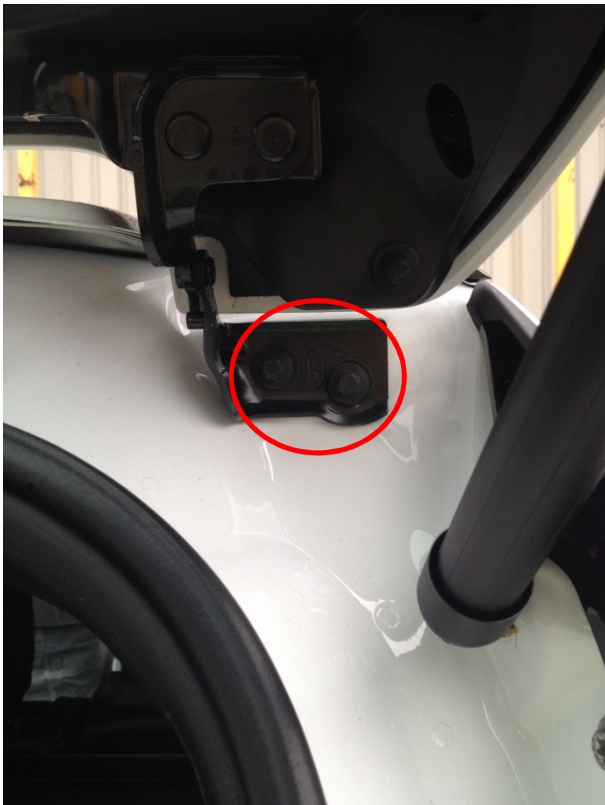
Tailgate profiles

Gap: 4mm +/- 0.5mm
Profile: -1mm +/- 1.1mm

Height: Flush +2mm

- Firstly check the condition of the Lower Deployable Tailgate Spigot Load Lever (LR082856) - if detached (See attached file) please replace (Ensure new part is painted with a Yellow Dot as shown attached) and then continue with steps below
- Loosen the two L/H hinge fixing bolts (hinge to body) (see attached doc)
- Lift the tailgate and retighten the fixing bolts (35Nm) while held in position. Note: this will typically require between 2 and 5mm of upward movement.
- Repeat the process for the R/H hinge
- Check the operation of the tailgate
- Check tailgate alignment (see attached illustration with dimensional guidelines)

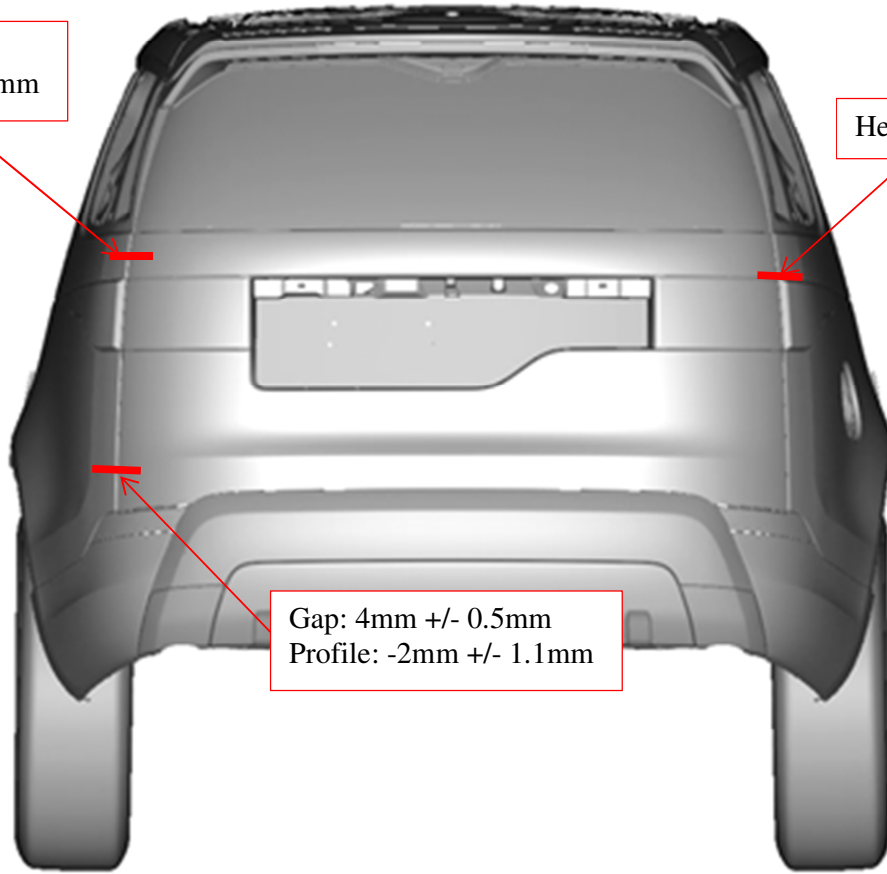
Gap: 4mm +/- 0.5mm
Profile: -2mm +/- 1.1mm

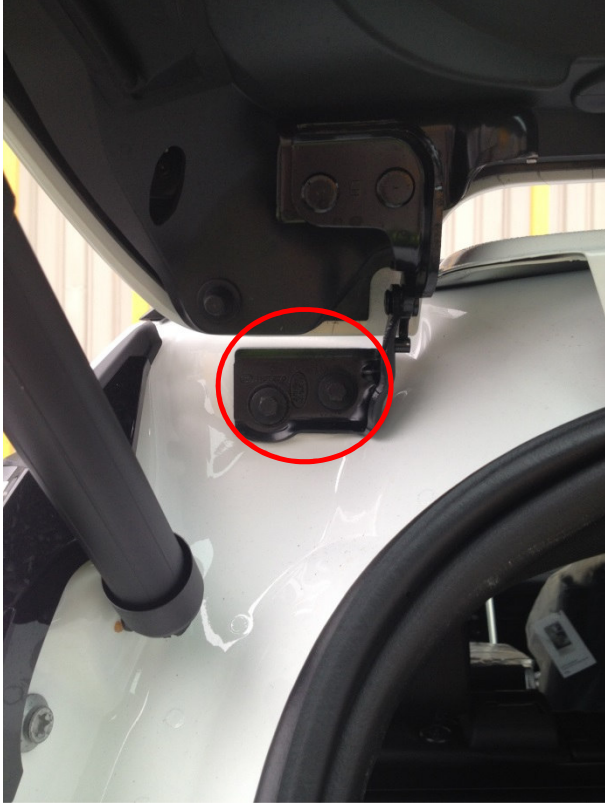
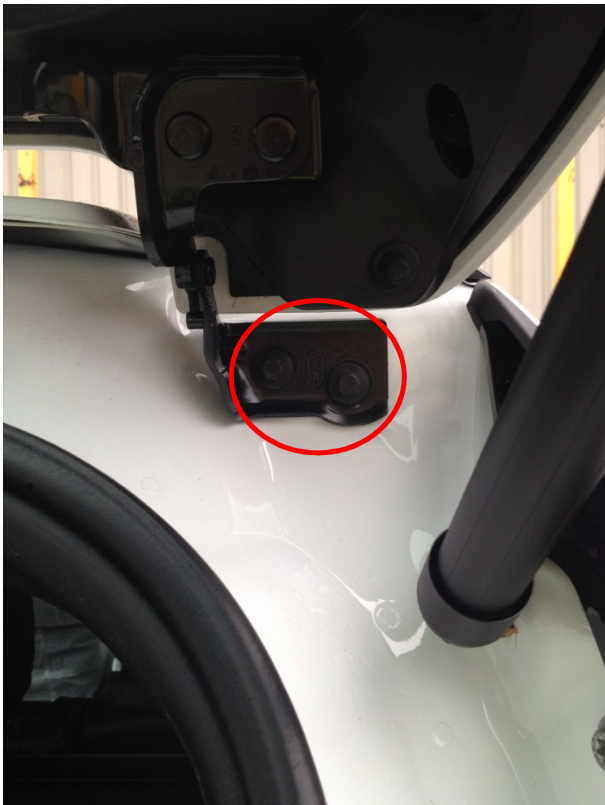
Tailgate profiles

Gap: 4mm +/- 0.5mm
Profile: -1mm +/- 1.1mm

Height: Flush +2mm

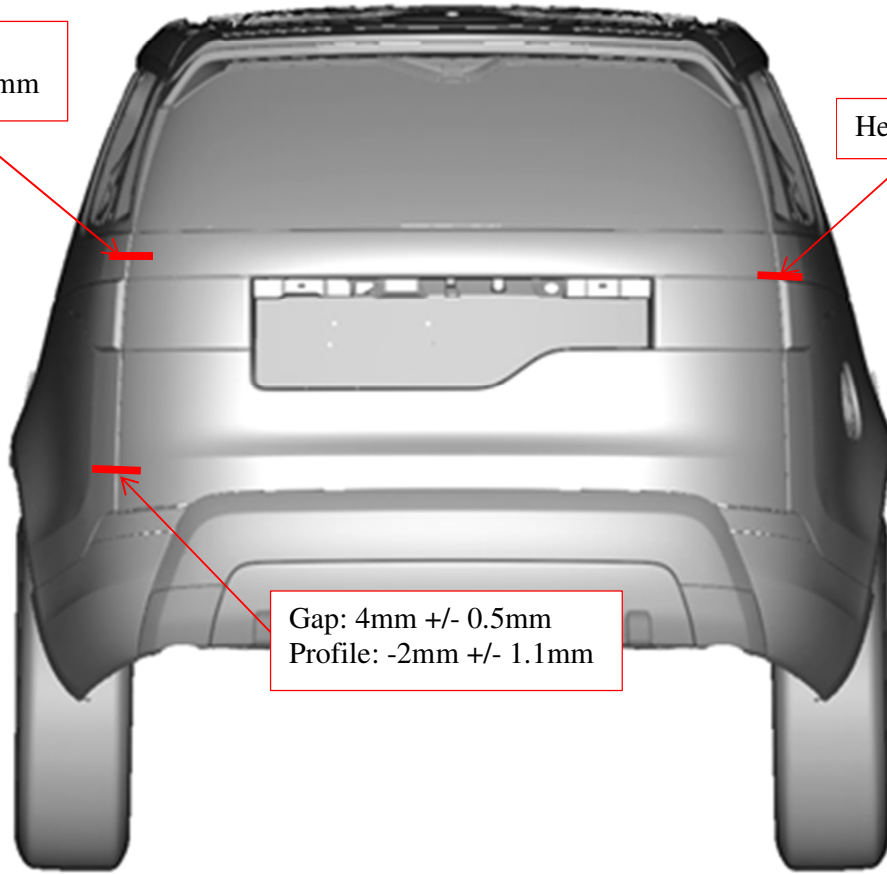
Gap: 4mm +/- 0.5mm
Profile: -2mm +/- 1.1mm
