LTB01069NAS1

TECHNICAL BULLETIN

Air Conditioning (A/C) Pipe Connection Leak / O-Ring Damage on Rear Air Conditioning

MODEL:	MODEL YEAR:	VIN:	ASSEMBLY PLANT:	APPLICABILITY:
Discovery Sport (LC)	2015 Onwards	501001 Onwards	Halewood	Vehicles With: Auxiliary Climate Control

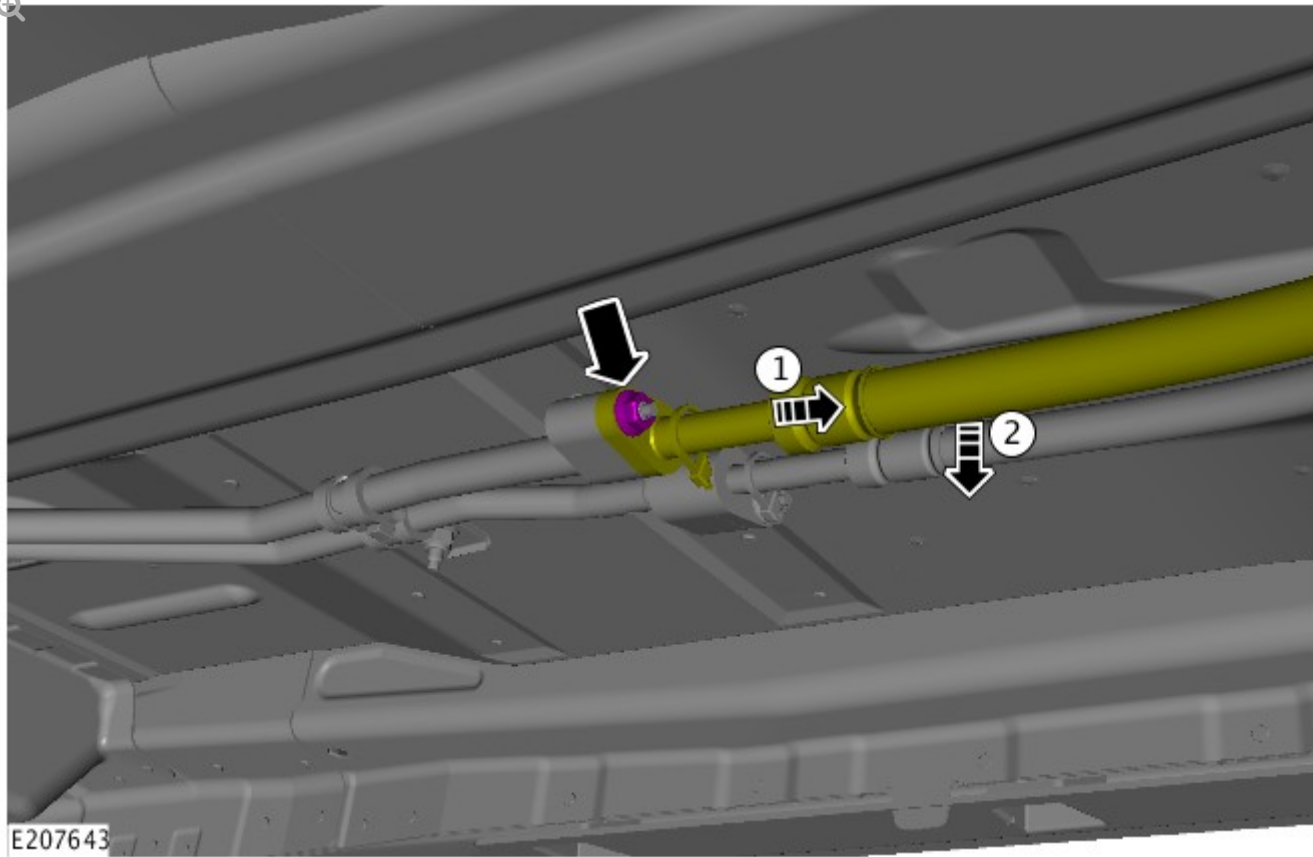
Disconnect the center auxiliary A/C line and check the O-rings for damage.
