Subject: MT-009/17 - CHATTERING NOISE FROM REAR SPOILER WHILE DRIVING ON ROUGH ROADS	M-Tips No.: MT-009/17
	Last Issued: 05/15/2017

2013-2017CX-5

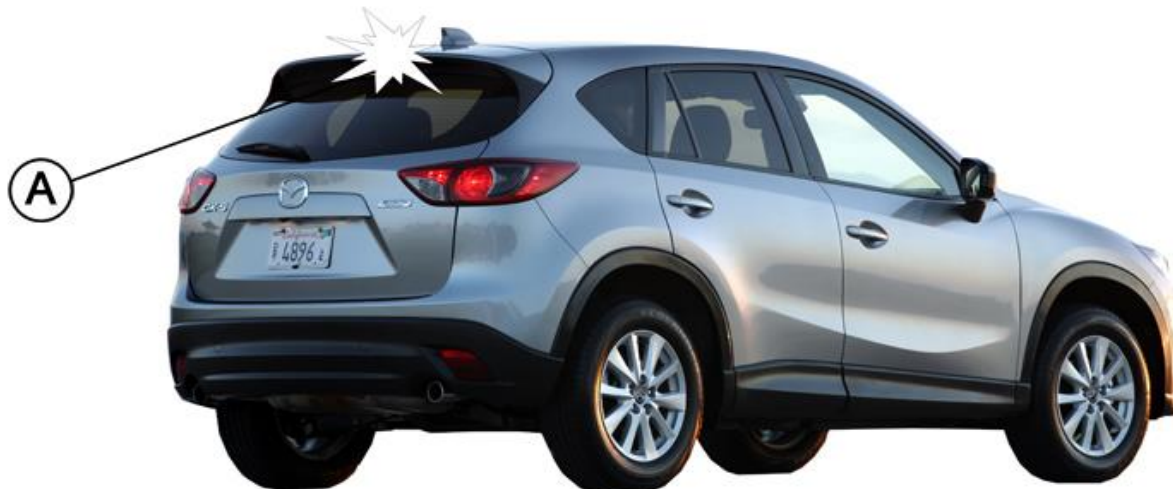
Some vehicles may exhibit a chattering noise from the rear spoiler (A) while driving on a rough road. This may be caused by loose rear spoiler installation nuts.
