Reliability Driven®  
**Service Bulletin No. 446**

| MODEL<br><b>J4500</b> | TYPE<br><b>Field Change Program</b> | SECTION/GROUP<br><b>3-Body</b> | DATE<br><b>June 14, 2017</b> |
| SUBJECT<br><b>A/C COMPRESSOR SUPPORT TUBE</b> | | | |

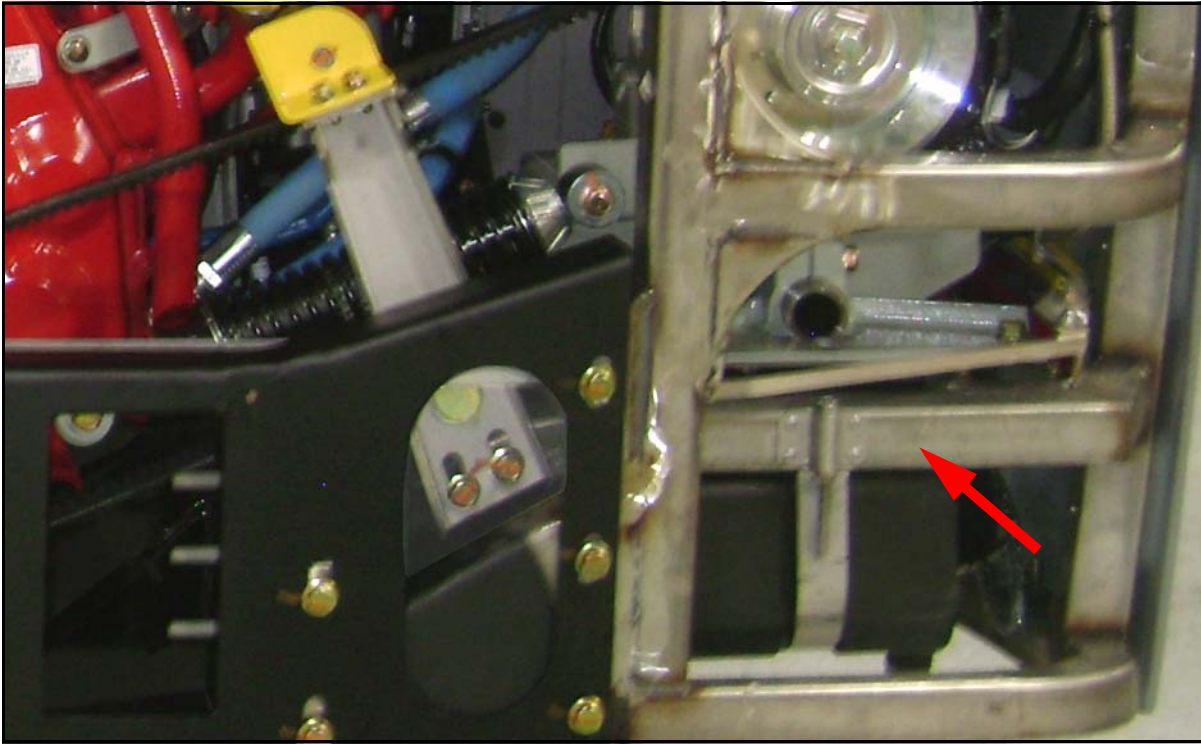
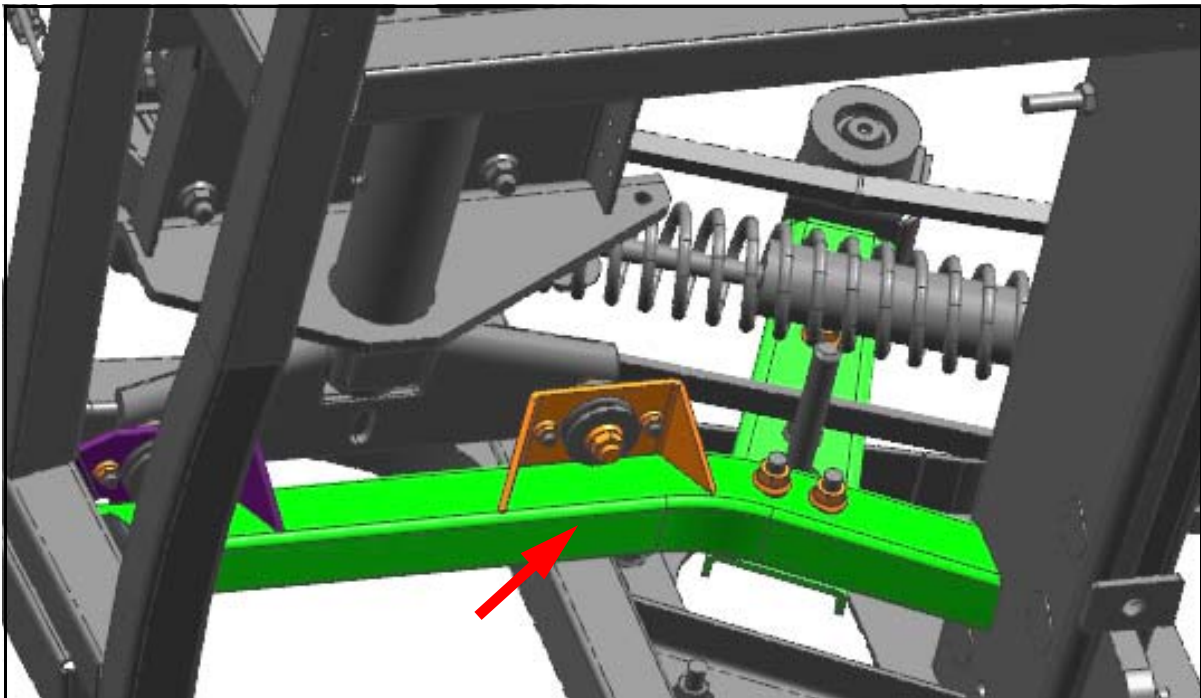
4. Visually inspect both faces of the A/C compressor support tube for stress damage ( refer to Figures 1 and 2). Carefully inspect the area of the idler pulley mounting bracket.

**Figure 1. Reference view of front face of A/C compressor support tube.**

**Figure 2. Reference view of rear face of A/C compressor support tube.**

***If no cracks are found on the A/C compressor support tube upon visible inspection, proceed to Page 6 / Step 5, using retrofit kit 26-03-0111.***

***If a crack is found on the A/C compressor support tube upon visible inspection, proceed to Page 9 / Step 14, using retrofit kit 26-03-0111.***

***If the A/C compressor support tube assembly exhibits cracks that have completely propagated through the tube, proceed to Page 23 / Step 54, using retrofit kit 26-03-0110.***

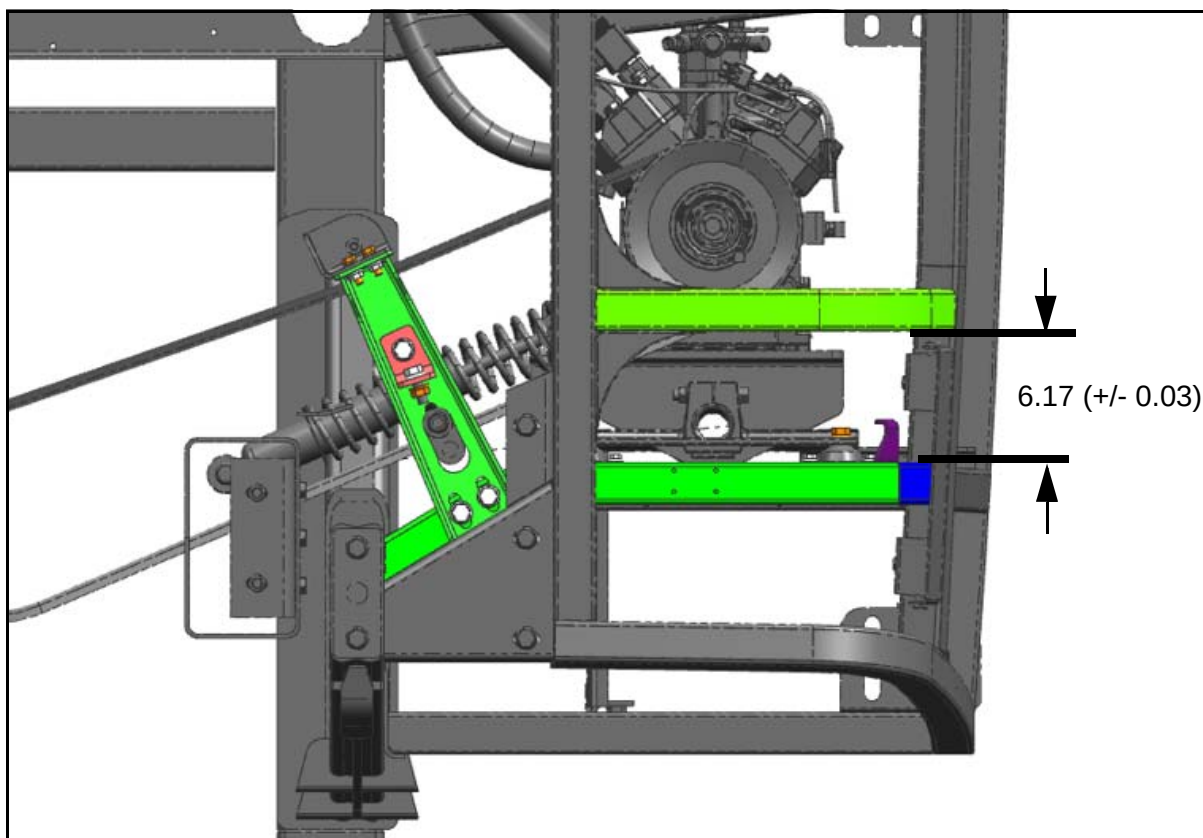
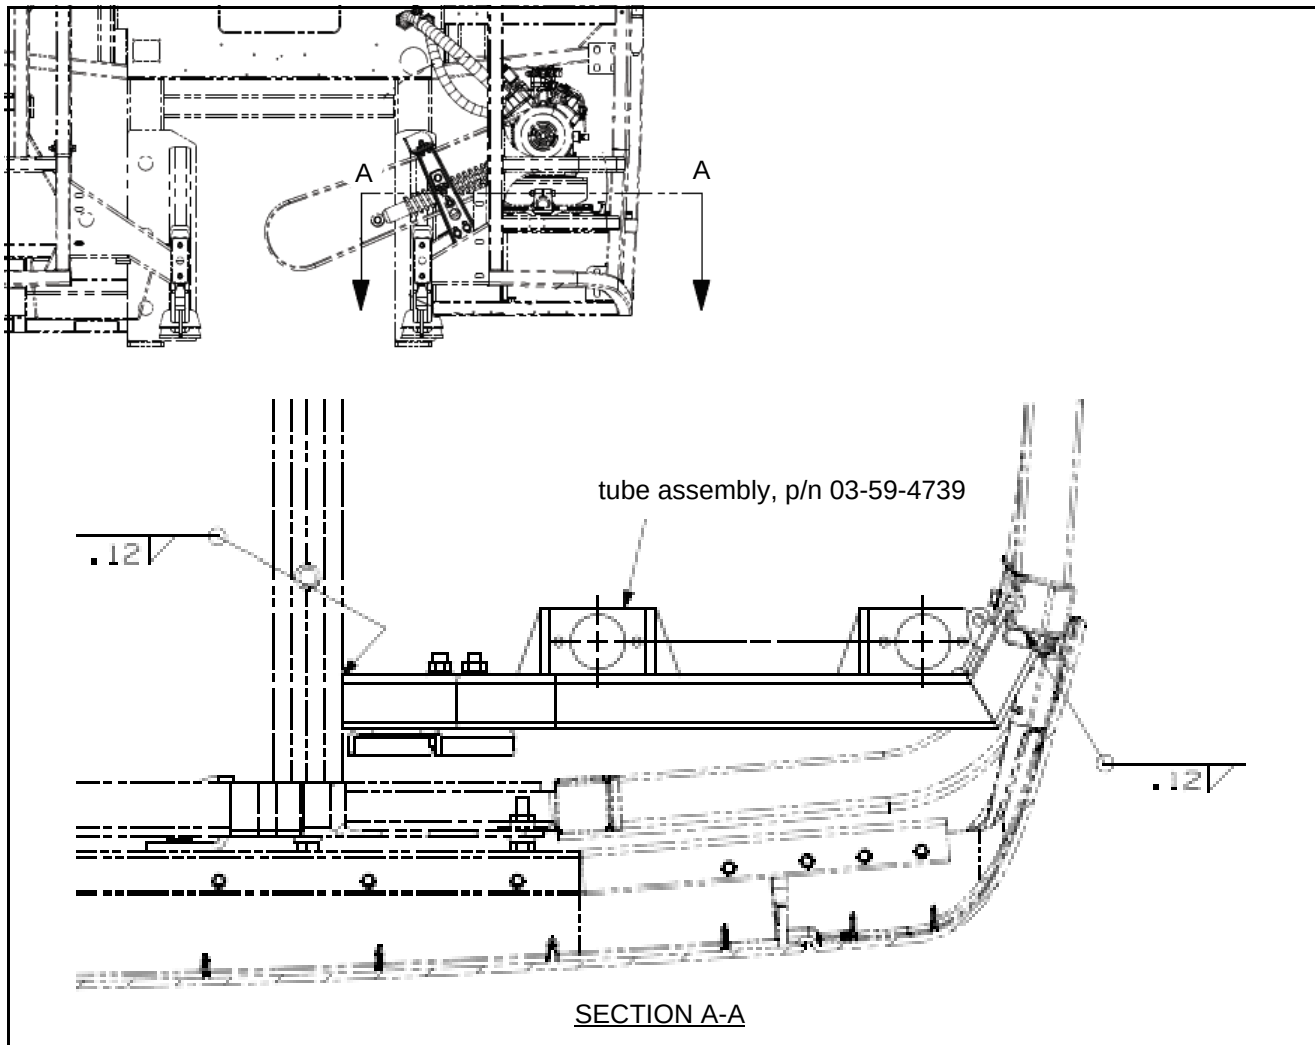
**Figure 30. New tube assembly orientation.**

Figure 31. Weld information for new tube assembly.

67. Perform the weld disconnect procedure.
68. Carefully cut and grind away existing cracked support tube shown in Figures 30 and 31.
69. Orient and weld the new tube assembly, p/n 03-59-4739, to the existing structure and engine rail as shown in Figures 30 and 31.
