SERVICE BULLETIN

Classification: EC16-032	Reference: NTB17-060	Date: June 8, 2017
-----------------------------	-------------------------	-----------------------

2016 TITAN XD; MIL ON WITH P207F STORED

APPLIED VEHICLES: 2016 Titan XD (A61)
APPLIED ENGINE: Cummins 5.0L V8 Diesel

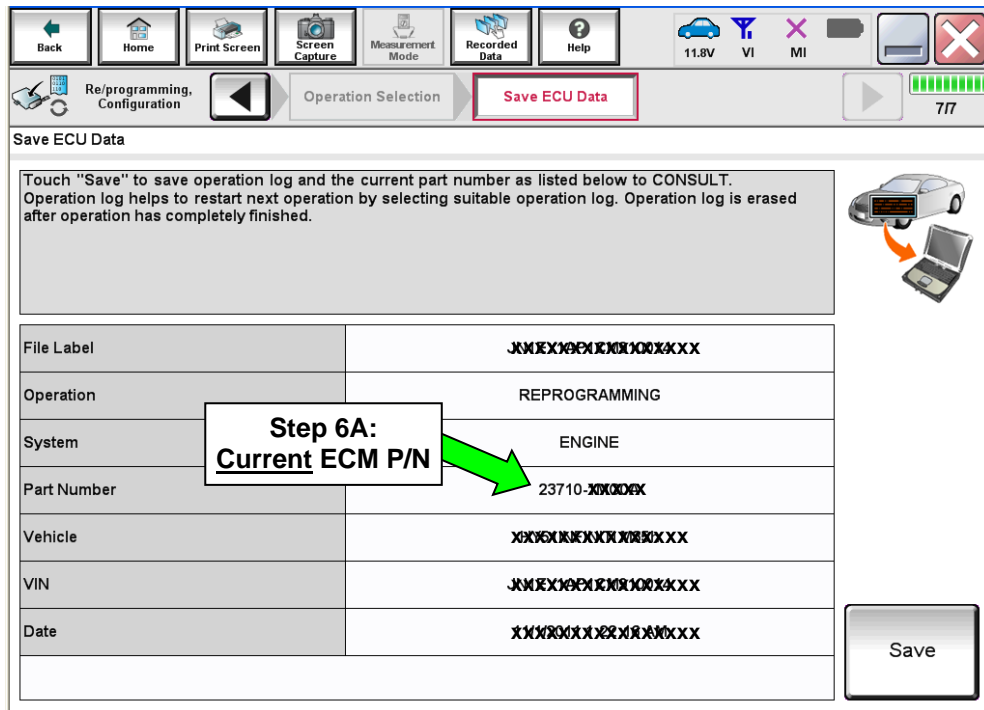
Figure 2

A. Find the ECM **Part Number** and write it on the repair order.

B. Compare the P/N you wrote down to the numbers in the **Current ECM Part Number** column in **Table A** below.

- If there is a match, this bulletin applies. Continue with the reprogramming procedure.
- If there is no match, this bulletin does not apply. Close C-III plus and refer to ASIST for further diagnostic information.

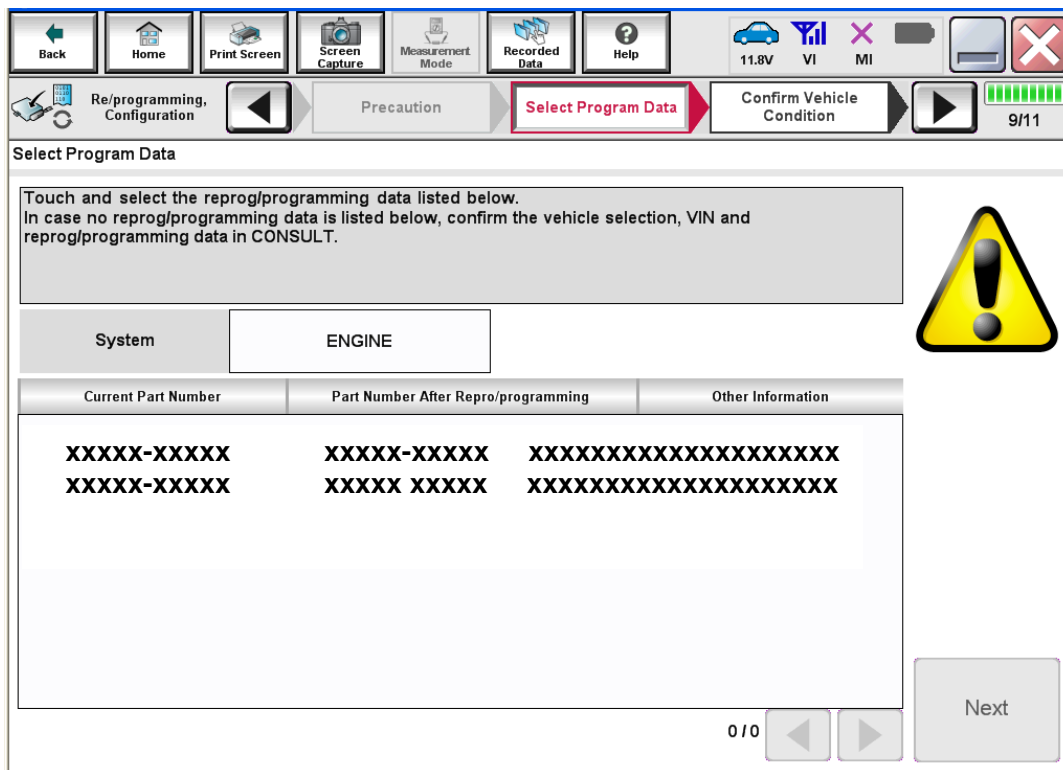
- In some cases, more than one new P/N for reprogramming is available.
 - If more than one new P/N is available, the screen in Figure 3 displays.
 - Select and use the reprogramming option that **does not** have the message “Caution! Use ONLY with NTBXX-XXX”.
- If you get this screen and it is blank (no reprogramming listed), it means there is no reprogramming available for this vehicle. Close C-III plus and refer back to ASIST for further diagnosis.

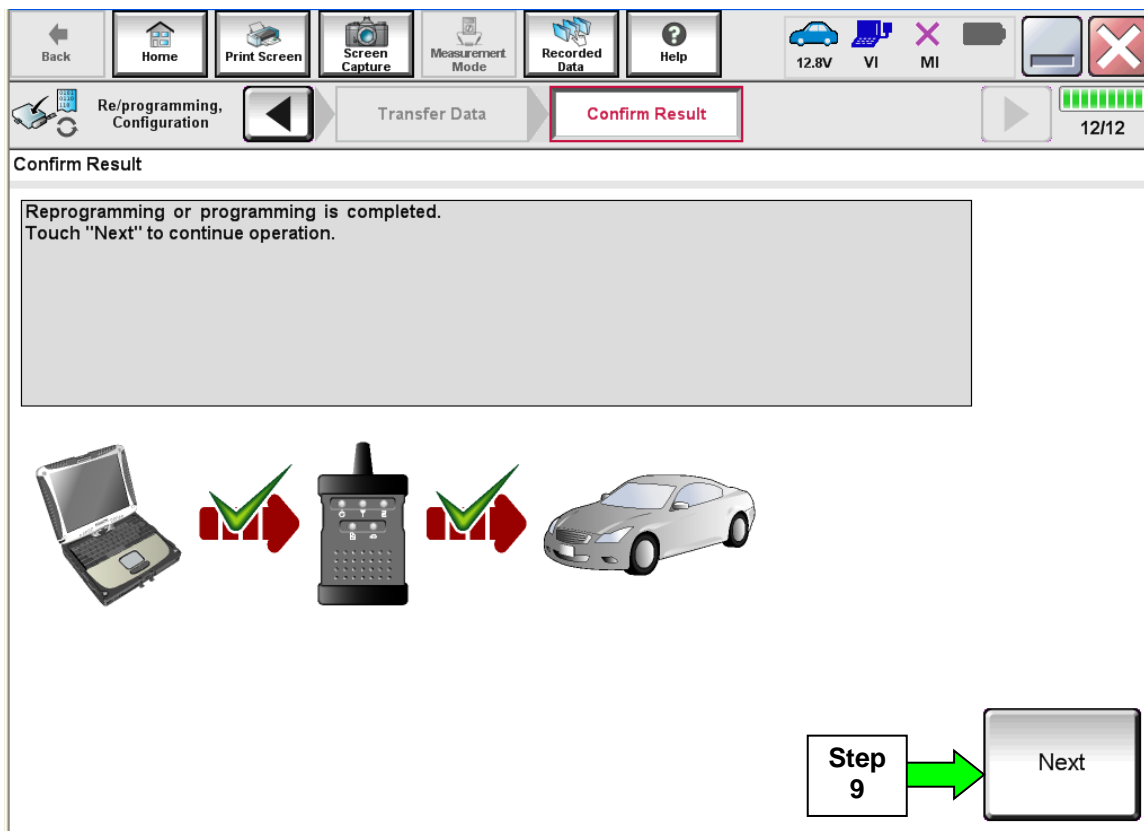
8. When the screen in Figure 4 displays, reprogramming is complete.

NOTE: If the screen in Figure 4 does not display (indicating that reprogramming did not complete), refer to ECM recovery on the next page.

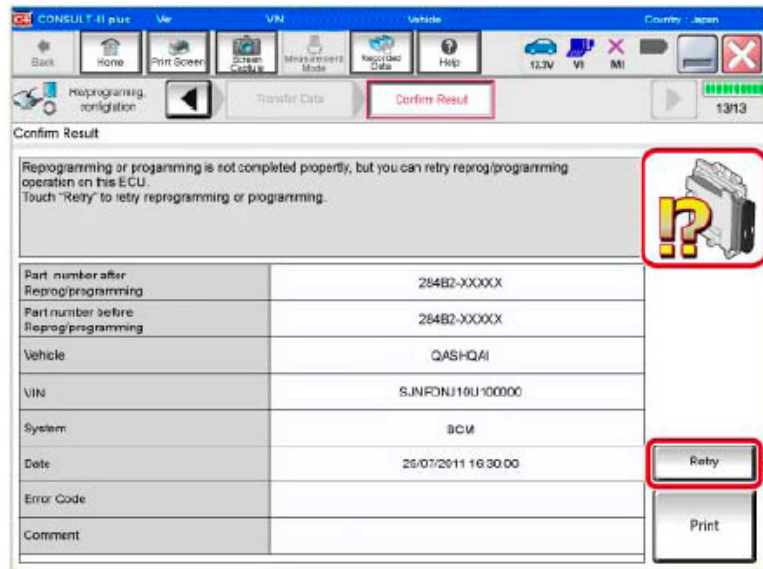
Figure 5

If reprogramming does not complete and the “!?” icon displays as shown in Figure 5:

- Check battery voltage (12.0 - 15.5 V).
- Ignition is ON, engine OFF.
- External Bluetooth® devices are OFF.
- All electrical loads are OFF.
- **Select retry and follow the on screen instructions.**
- **“Retry” may not go through on first attempt and can be selected more than once.**

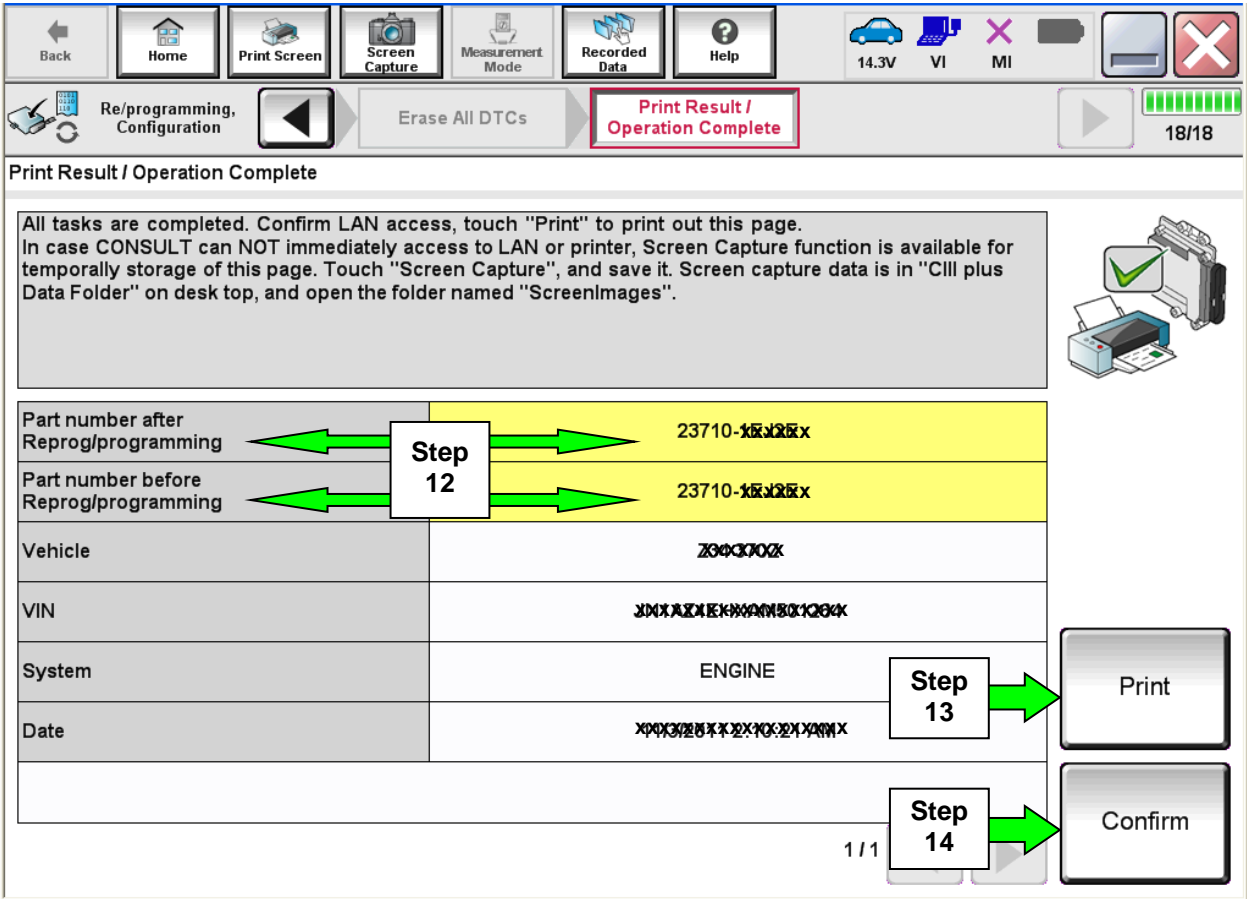
- 10. Follow the on-screen instructions to **Erase DTCs**.
- 11. When the entire reprogramming process is complete, the screen in Figure 7 will display.
- 12. Verify the before and after part numbers are different.
- 13. Print a copy of this screen (Figure 7) and attach it to the repair order for warranty documentation.
- 14. Select **Confirm**.

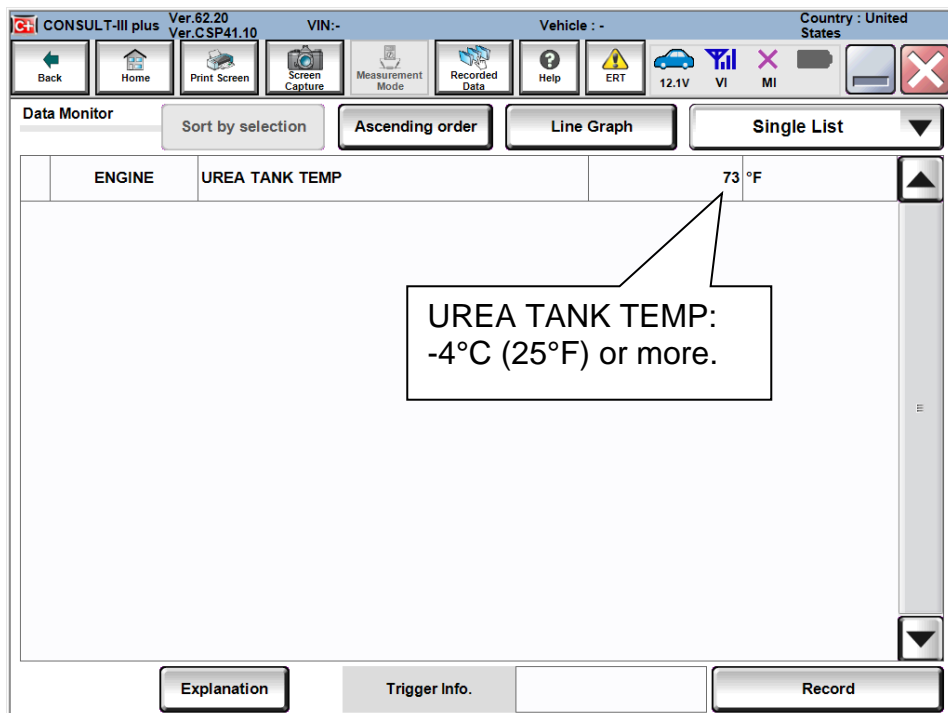
Figure 2B

3. Confirm UREA TANK TEMP is -4°C (25°F) or more.
 - If needed, start the engine and let it run until the UREA TANK TEMP warms to -4°C (25°F) or more.
