DRIP GUARD ADDITION - FRONT COMPARTMENT

Prevost vehicles

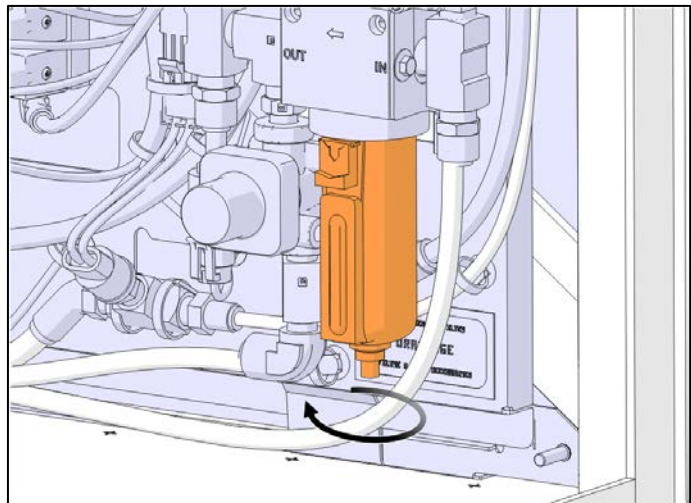
Figure 2: Accessory System Drain

3. Open the drain valve (clockwise) on the bottom of the accessory filter to drain the accessory system

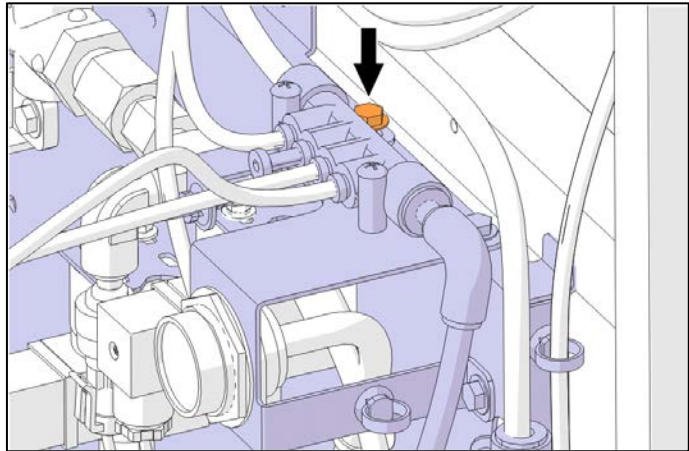
Figure 3: Loosen left screw

4. On the air distributor mounting bracket, loosen the left screw a few turns.

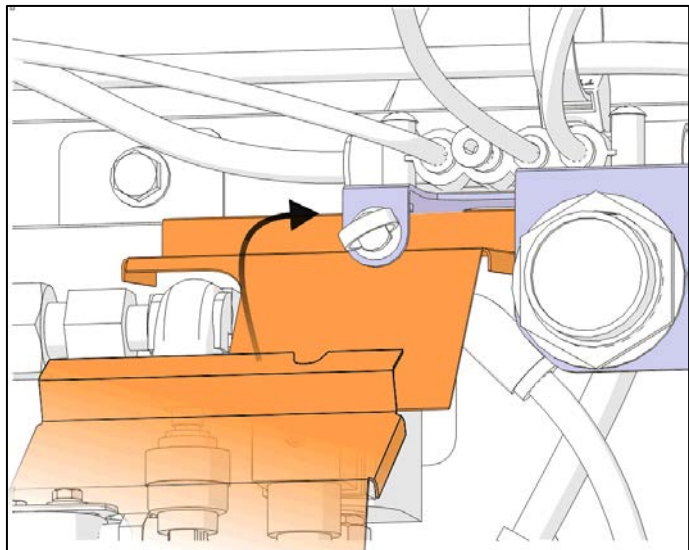
Figure 4: Slide in

5. Insert drip guard under distributor mounting bracket.

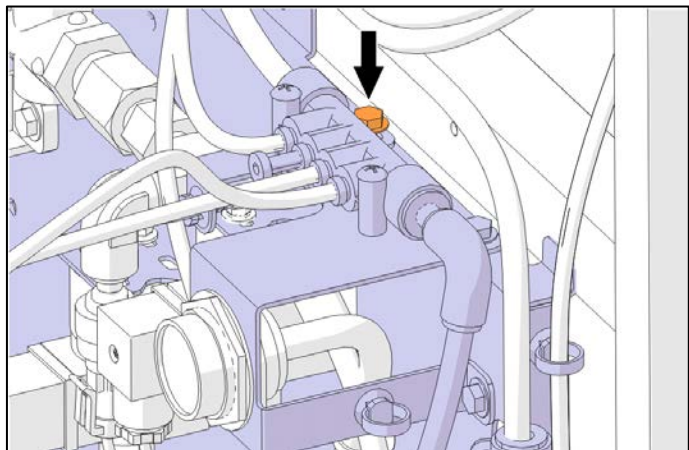
Figure 5: Tighten screw

6. Tighten screw to **7 lb-ft.**
