**PREVOST**

## WARRANTY BULLETIN

**WB17-14 A**

| SUBJECT : | INSPECTION/REPLACEMENT OF ALTERNATOR<br>POWER CABLE STUD ADAPTER | | |

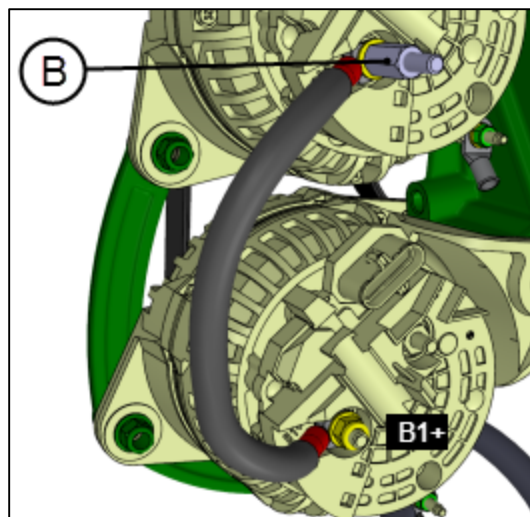
Figure 3

4. Inspect the distance between flats on the stud adapter. There are only two possibilities; 1/2" or 5/8".
5. First, use a 1/2" open wrench and check if you can engage the wrench between the flats of the stud. If you cannot engage the 1/2" open wrench on the stud, try a 5/8" open wrench and check if you can engage this second wrench between the flats of the stud and if it fits tight.

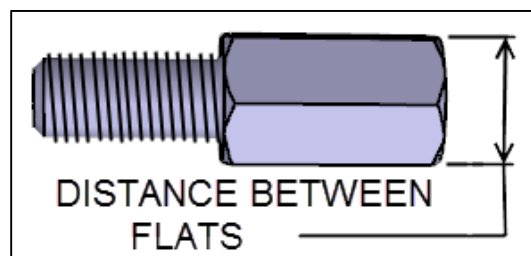
Figure 4

6. If the distance between flats is 5/8", you have the correct stud. Move to step 7.

If the distance between flats is 1/2", you have the wrong stud and you need to change it. Move to step 10.
