# Service Bulletin

**Subject:** Tire Slowly Goes Flat, Tire Air Loss, Low Tire Pressure Warning Light Illuminated, Aluminum Wheel Bead Seat Corrosion (Clean and Resurface Wheel Bead Seat)

**Models:** 2005-2018 GM Passenger Cars and Light Duty Trucks

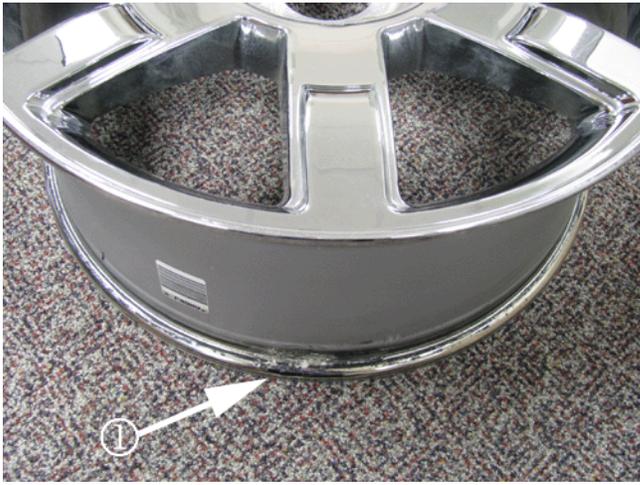
### Typical Location of Bead Seat Corrosion

Abrasive elements in the environment may intrude between the tire and wheel at the bead seat. There is always some relative motion between the tire and wheel (when the vehicle is driven) and this motion may cause the abrasive particles to wear the wheel and tire materials. As the wear continues, there may also be intrusion at the tire/wheel interface by corrosive media from the environment. Eventually a path for air develops and a 'slow' leak may ensue. This corrosion may appear on the inboard or outboard bead seating surface of the wheel. This corrosion will not be visible until the tire is dismantled from the wheel.

1. Remove the wheel and tire assembly for diagnosis. Refer to *Tire and Wheel Removal and Installation* in SI.
2. After a water dunk tank leak test, if you determine the source of the air leak to be around the bead seat of the wheel, dismantle the tire to examine the bead seat. Shown below is a typical area of bead seat corrosion.

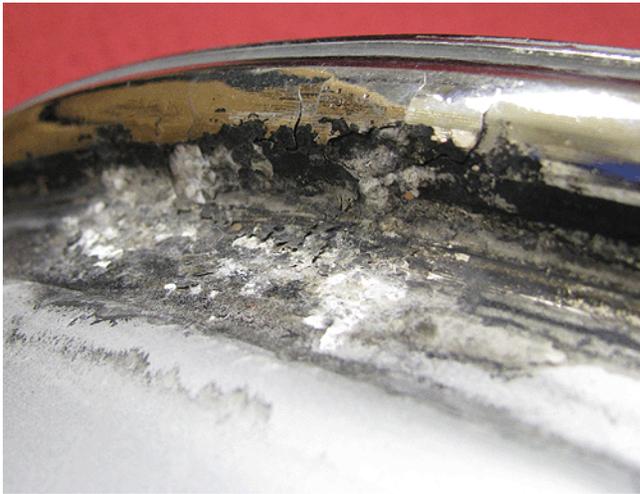
### Close-Up of Bead Seat Corrosion

3. Bead seat corrosion is identified by what appears like blistering of the wheel finish, causing a rough or uneven surface that is difficult for the tire to maintain a proper seal on. Below is a close-up photo of bead seat corrosion on an aluminum wheel that was sufficient to cause slow air loss.

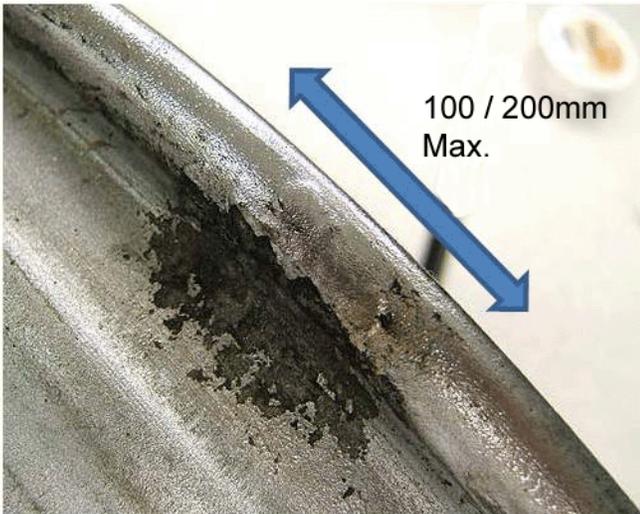
4. If corrosion is found on the wheel bead seat, measure the affected area as shown below.

- For vehicles with 32,186 km (20,000 mi) or less, the total allowable combined linear area of repairable corrosion is 100 mm (4 in) or less. If the total area(s) of corrosion exceed these dimensions, the wheel should be replaced.
- For vehicles that have exceeded 32,186 km (20,000 mi), the total allowable combined linear area of repairable corrosion is 200 mm (8 in) or less. If the total area(s) of corrosion exceed these dimensions, the wheel should be replaced.
