Service Bulletin

Subject: Transmission May Not Shift Out of Park, Shifter Knob Indicators May Not Illuminate, DIC Messages May Say to Service Transmission, Service Transmission Now, Unable to Shift Soon

Brand:	Model:	Model Year:		VIN:		Engine:	Transmission:
		from	to	from	to		
Buick	LaCrosse	2017	2017				
Cadillac	XT5						
Chevrolet	Bolt EV	2017	2017

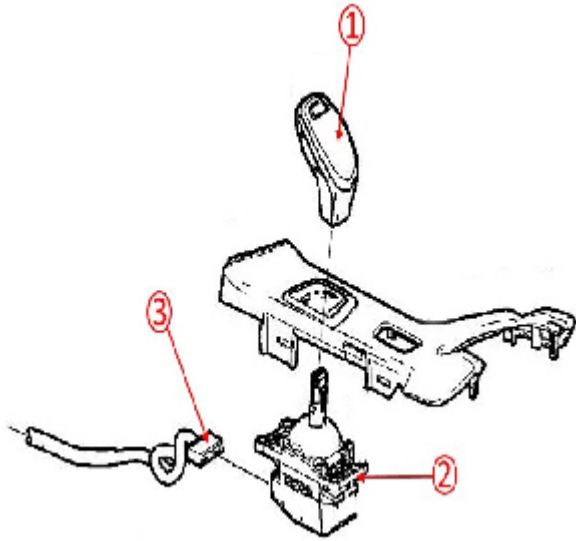
Involved Region or Country	North America and N.A. Export Regions
Condition	<p>Some customers may comment on one or more of the following conditions:</p> <ul style="list-style-type: none"> • Transmission may not shift out of park. • DIC messages say to Service Transmission and/or Service transmission now, Unable to Shift Soon. • The shift indicator knob doesn't illuminate. <p>The Technician may find one or more of the following DTCs set:</p> <ul style="list-style-type: none"> • P07B4 • P07BA • P07BB • P17A4 • P17A5 • P17A8 • P26C8 • U0077 • U156D
Cause	<p>This may be caused by the following conditions:</p> <ul style="list-style-type: none"> • Transmission Control Lever Knob assembly not fully seated onto the shifter. • Electrical connector not fully engaged into the Automatic Transmission Electronic Control.

1. While pressing downward on the shifter knob (1) firmly with both hands, validate any movement felt and the bottoming out of the knob to shifter (2).

- If movement was confirmed while pressing downward on the shifter knob, an audible click may be heard.
 - Verify the shift knob lighting is illuminated and the shifter assembly moves freely.

2. Clear the codes set in the Chassis Control Module and test drive the vehicle.
 - If the codes did not return, no further repairs are needed.
 - If the codes return, validation of the wiring harness connector (3) for the transmission electronic control (2) needs to be done.
