# Service Bulletin

**Subject:** No-Start, Dead Battery, Battery Drain or Autostop Inoperative

Brand:	Model:	Model Year:		VIN:		Engine:	Transmission:
		from	to	from	to		
Chevrolet	Malibu (VIN Z)	2016	2016			All	All

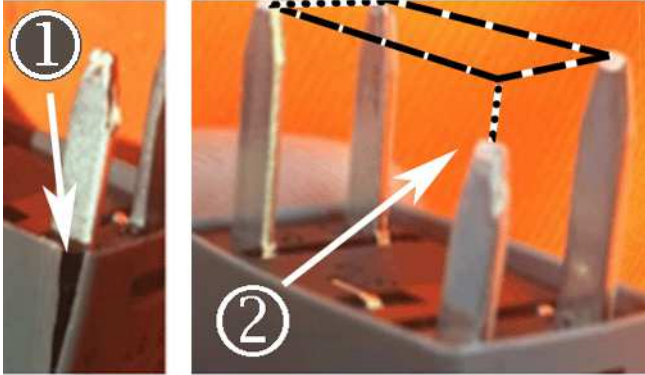
If normal diagnostics do not resolve the customer concern, inspect the KR76 Retained Accessory Power (RAP) relay in the X51A Instrument Panel Fuse Block for uniform relay blade length and position.

Inspect the relay case for cracks (1) or obvious damage. If one blade (2) appears to be pushed into the relay body, this can cause an electrical short.

To correct this concern, replace the RAP relay and verify repairs.
