Service Bulletin

Subject: Right Hand Steering Wheel Controls Inoperative, Outside Ambient Temperature Reading on Radio Display Inoperative, Rear Camera Gridlines Inoperative, OnStar Menu Screen is Not Showing When Pressing OnStar Button, and/or Smart Phone Link App Icon Not Showing Since New or after Performing Radio Reprogramming

Brand:	Model:	Model Year:		VIN:		Engine:	Transmission:
		from	to	from	to		
Chevrolet	Sonic Trax	2013	2016			All	All
Chevrolet	Spark	2013	2015			All	All

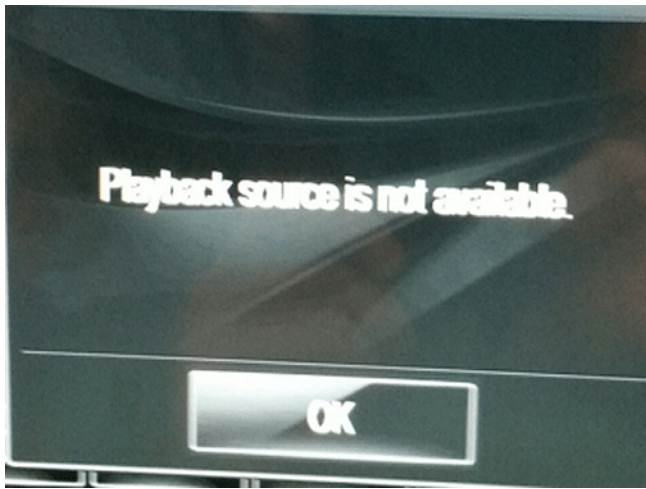
If you can't perform USB programming first because of the "playback source is not available" message above remaining on the screen and preventing you from continuing, skip to SPS programming and complete it first instead. Once the SPS programming is complete, it should repair the pop up message so you can then complete USB programming but this should only be performed in this order if the "playback source is not available" message remains displayed.

If you encounter a vehicle with the above concern, USB and then SPS program the radio again by following the programming procedure and tips outlined in SI and the latest version of bulletin 17130.

The USB and SPS radio calibrations available in TIS2web since October 10, 2016 are designed to repair and prevent this concern.
