# Service Bulletin

**Subject:** Body Creak Noise or Flexing Panels from A-Pillar During Acceleration and Deceleration Events

Brand:	Model:	Model Year:		VIN:		Engine:	Transmission:
		from	to	from	to		
Chevrolet	Trax	2016	2016	SOP	Oct. 31, 2016	All	All

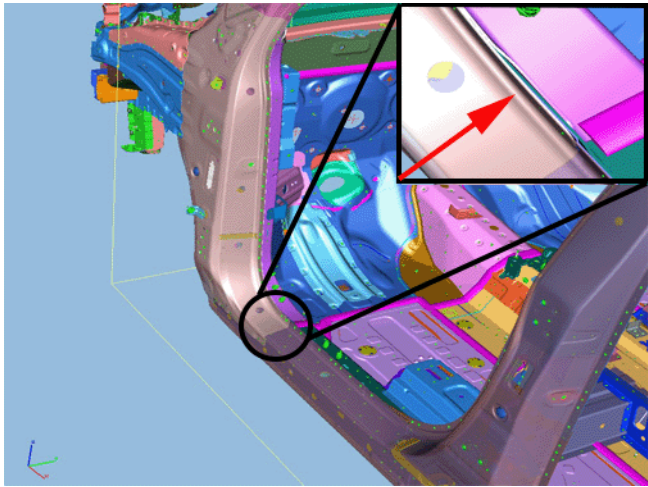
<b>Involved Region or Country</b>	North America and N.A. Export Regions
<b>Condition</b>	Some customers may comment on a faint creak noise, or panel flexing, from the A-pillar during acceleration or deceleration events. The noise is faint and may not be heard over the radio or talking.
<b>Cause</b>

<p>This may be due to metal thicknesses flexing at the rocker panel where different metal thicknesses are welded together.</p>
