Service Bulletin

Subject: Rear 60% Seatback Locked in Down Position When Folded, Will Not Return to Upright Position

Brand:	Model:	Model Year:		VIN:		Engine:	Transmission:
		from	to	from	to		
Buick	Encore	2013	2016			All	All
Chevrolet	Trax	2013	2016

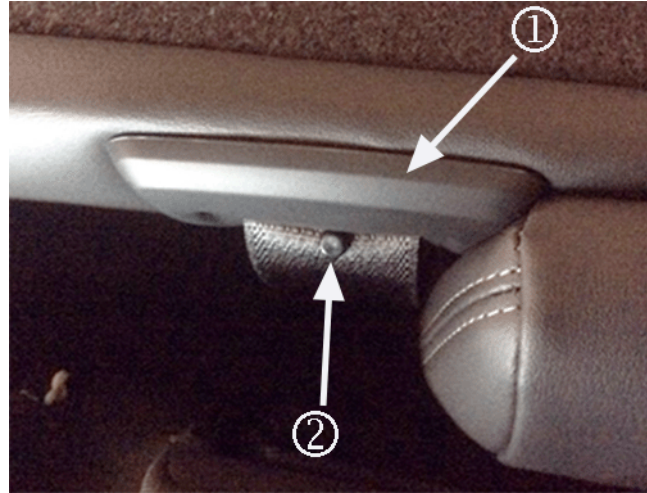
The cause of the condition may be a broken or missing seat belt button/stop on the rear center seat shoulder belt and/or a broken seat belt bezel.

When the front seat is all the way back and the rear 60% seatback is lowered, the added weight of the front occupant puts extra pressure on the seat belt bezel (1) and button/stop (2). This may allow the seat belt to fully retract past the stop, and the retractor may lock because there is not enough seat belt slack to unlock the retractor.

DO NOT replace the shoulder belt assembly for this condition until first attempting to disengage the locking mechanism by following the recommendation listed below.

Pull hard on the locked webbing and then release. The hard pull extracts a small amount of webbing from the retractor which, in turn, permits a small amount of retraction to occur when released. This is all that is needed to disengage the locking mechanism. The safety belt will now function properly.

In cases where the locking mechanism will not disengage, cut the shoulder belt and replace the shoulder belt assembly as directed in the *Service Procedure* below.
