Service Bulletin

Subject: Active Shutters Inoperative, Malfunction Indicator Lamp (MIL) Illuminated

Brand:	Model:	Model Year:		VIN:		Engine:	Transmission:
				from	to		
Buick	LaCrosse	2017	2017				
Chevrolet	Malibu (VIN Z)	2016	2017

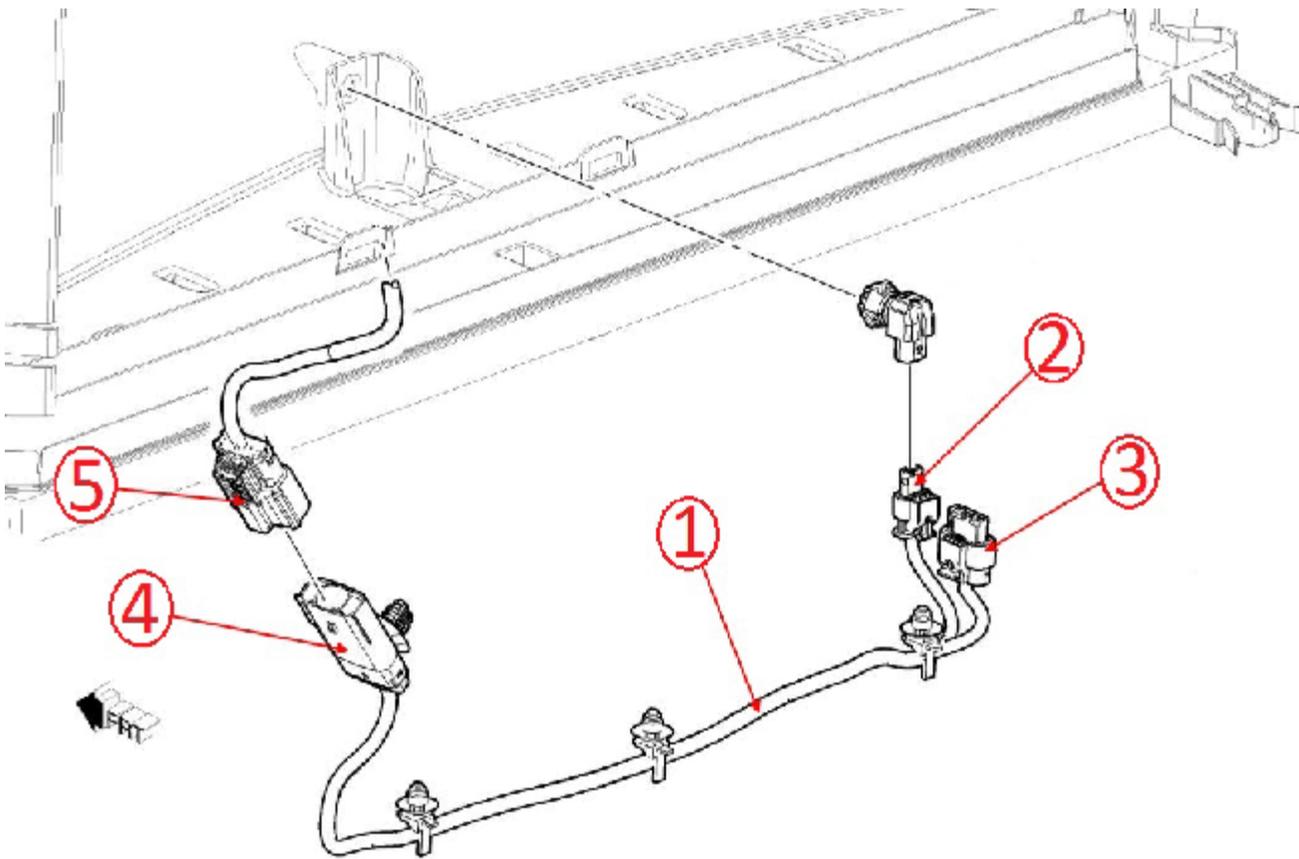
Inspect the Ambient Air Temperature Sensor Wiring Harness connectors B9 (2), M60B (3) and the X119 (4, 5) for any signs of corrosion.

- If any corrosion was found on the Ambient Air Temperature Sensor Wiring Harness (1), it must be replaced.
- If the corrosion was found at the X119 connector (5), the main body wiring harness connector must be repaired as needed.
- If the corrosion was found on the B9 connector (2), the Ambient Air Temperature Sensor must be replaced.
- If the corrosion was found on the M60B connector (3), the active shutter must be replaced.
