Service Bulletin

Subject: Information for Dead Battery After Exiting Vehicle Following Bluetooth Call

This bulletin replaces PIC6198A. Please discard PIC6198A.

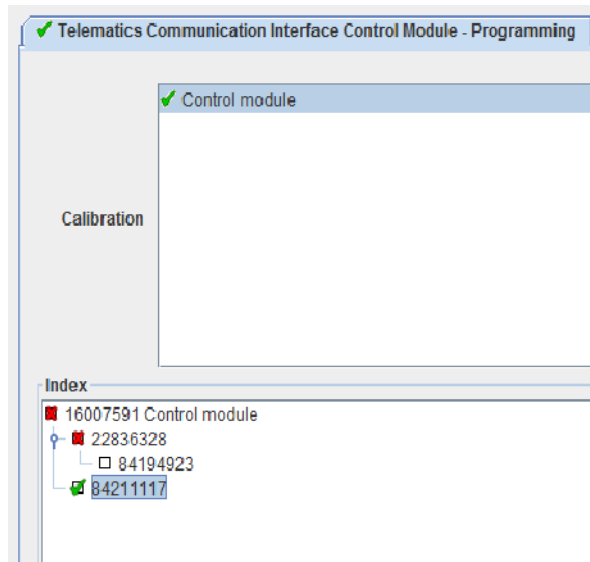
Note: The screenshot and software numbers are just one example of what is listed under the Telematics Communication Interface Control Module, depending on the year, make, and model, the screen may look slightly different and different software part numbers may be listed as well.

1. Select J2534 MDI or MDI2.
2. Select Reprogram ECU.
3. Enter VIN.
4. Select Telematics Communication Interface Control Module as the controller.
5. Select Programming & Service Activation as the Function/Sequence.
6. Select Telematics Communication Interface Control Module- Programming tab.

- In some cases, TIS will automatically select the most recent software designed to address this concern. However, if prompted to select a specific software part number, select the part number that is described as being designed to address Bluetooth battery drain.
