# Service Bulletin

**Subject:** Wires Felt Under Leather of Steering Wheel

Brand:	Model:	Model Year:		VIN:		Engine:	Transmission:
		from	to	from	to		
Buick	LaCrosse	2017	2017			All	All

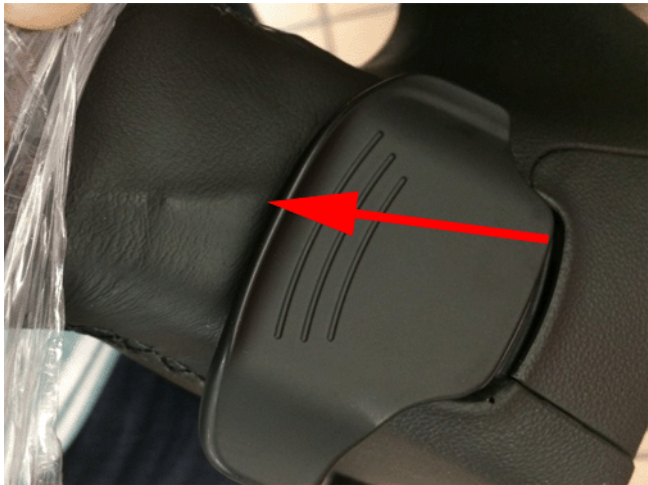
<b>Involved Region or Country</b>	North America
<b>Additional Options (RPOs)</b>	Equipped with Heated Steering Wheel (RPO UVD)
<b>Condition</b>	Some customers may comment on a bump under the leather of the heated steering wheel.
<b>Cause</b>

<p>This is due to the electrical wires running to the heating element of the steering wheel.</p>
<b>Correction</b>	<p>This is considered normal characteristic of the vehicle.</p> <p>No repairs should be completed.</p>

Please communicate to the customer this condition is a normal characteristic of their vehicle. It will not impact the designed performance or reliability of the vehicle. Please share this information with the customer, including a copy of this bulletin.
