# Service Bulletin

**Subject:** Malfunction Indicator Lamp On - DTC P1B3F High Voltage System Interlock Circuit 2 Low Voltage

| Brand: | Model: | Model Year: | | VIN: | | Engine: | Transmission: |
|---|---|---|---|---|---|---|---|
| Chevrolet | Bolt EV | 2017 | 2017 | | | All | All |

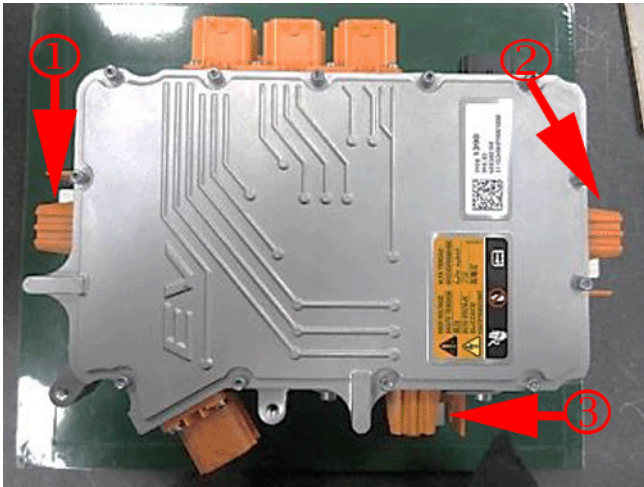
1. Disconnect the RESS-X3 (1), Charging-X2 (2), and Battery Positive Cable Extension Cable (3) connectors by following the *High Voltage Battery Control Wiring Junction Block Replacement* procedure in SI.

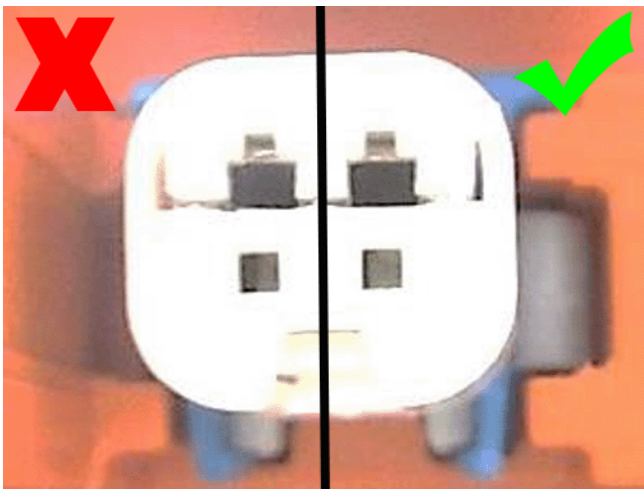
2. Visually inspect hooks using a light. If it is already broken, separating surface can be seen as illustrated above.

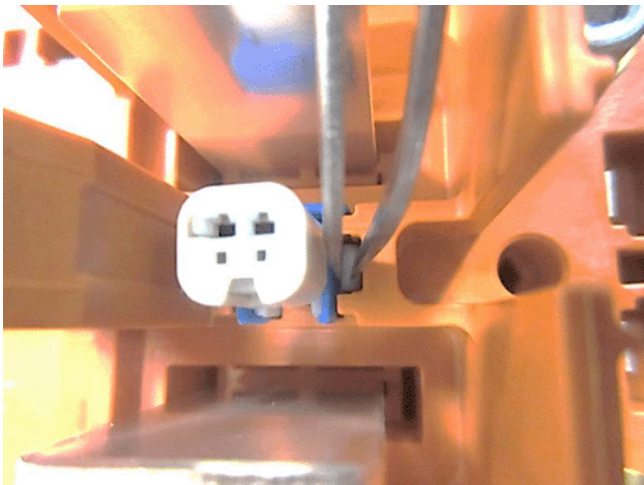
3. After visually inspecting the hooks, touch the hook with tweezers to check if the hook is secure.
4. If any of the hooks are loose or broken replace the High Voltage Battery Control Wiring Junction Block. Refer to *High Voltage Battery Control Wiring Junction Block Replacement* procedure in SI.
