Service Bulletin

Subject: Supplemental Inflatable Restraint (SIR) Light On - DTC B0014, B067F, B0680, B0081, B059A Set

Brand:	Model:	Model Year:		VIN:		Engine:	Transmission:
		from	to	from	to		
Chevrolet	Impala (VIN 1)	2016	2016				
	Impala	2017	2017

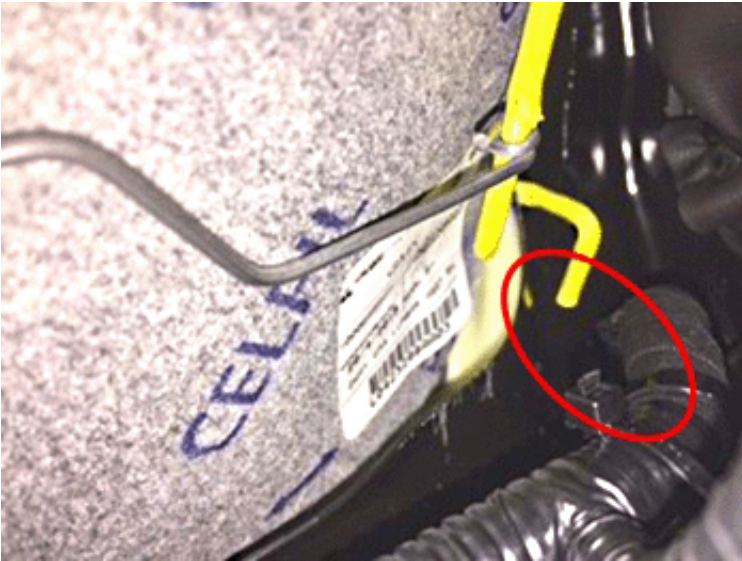
7. Validate the wiring harness showing evidence of a short caused by contacting the recliner motor.
- Important:** If the wiring harness Does Not need to be repaired, proceed to step 10 for wiring harness positioning and installation.
8. Repair the wiring harness as needed. Refer to *Wire-to-Wire Repair* in SI.
9. Using Woven Polyester Electrical Tape (PET), tape the harness ensuring that the tape is applied in a double layer extending along the harness past the contact points.

6. Separate the wiring harness from the forward seat frame.

Note: When installing the tie straps, ensure they are installed in a position where they will not damage the seat cover.
