# Service Bulletin

**Subject:** Creak Noise Coming from Rear of Vehicle While Turning into Driveway or Driving Over Bumps

Brand:	Model:	Model Year:		VIN:		Engine:	Transmission:
		from	to	from	to		
Buick	Verano	2016	2017			All	All

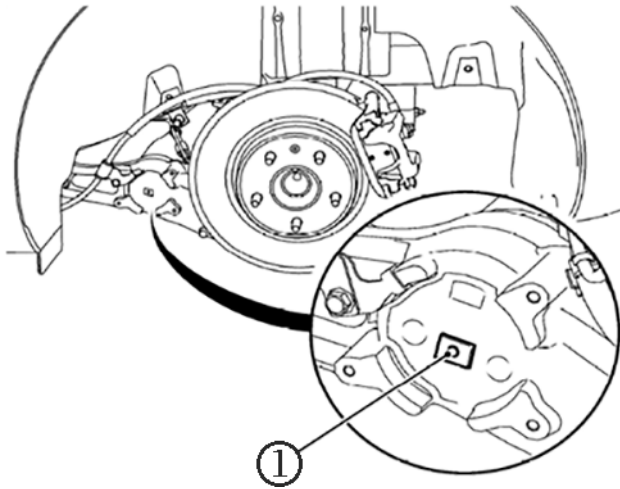
<b>Involved Region or Country</b>	North America
<b>Condition</b>	Some customers may comment on hearing a creak noise coming from the rear of the vehicle, noted while turning into a driveway or driving over bumps.
<b>Cause</b>	The cause of the condition may be the rear axle cross tube is creaking internally when any vehicle twist is applied.
<b>Correction</b>	Drill holes in the axle tube caps, apply WD40 internally to the axle and seal the drilled holes following the steps in the Service Procedure below.

- Using a 7/32 inch drill bit, drill a 5.55 mm (0.21875 in) hole into the center (1) of the axle tube cap, on BOTH sides of the rear axle.
