Service Bulletin

Subject: Front Floor Console Armrest Latch Inoperative

Brand:	Model:	Model Year:		Date Breakpoint:		Engine:	Transmission:
		from	to	from	to		
GMC	Acadia (VIN N)	2017	2017	SOP 2017	Prior to September 1, 2016	All	All

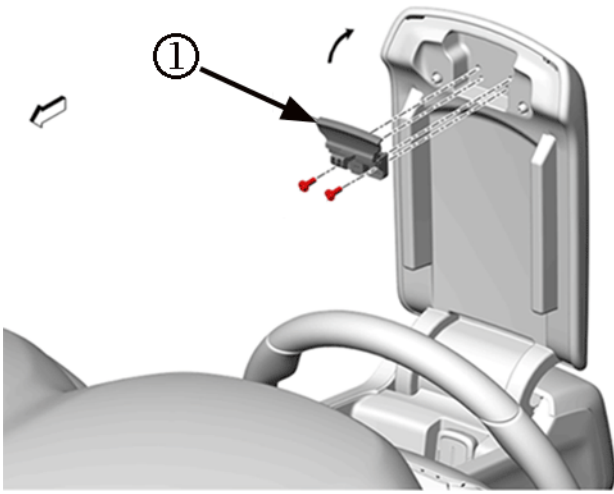
Involved Region or Country	North America, Middle East
Condition	Some customers may comment that the front floor console door/armrest will not latch and/or stay closed.
Cause	The cause of the condition may be a flashing in the latch plastic housing, which does not allow the spring retention tab to fully seat. When the spring tab height is at the lower end of the spec, there is insufficient overlap to retain the spring.
Correction	Replace the floor center console latch assembly.

Important: During replacement of the latch, ensure the fasteners are tightened to the torque specification noted in the SI procedure.

Replace the front floor console armrest latch (1). Refer to *Front Floor Console Armrest Latch Replacement* in SI.
