Subject: Engineering Information – Both Front Low Beam, High Beam, Day Time Running Lamps (DRL) and Turn Signals Inoperative

Brand:	Model:	Model Year:		VIN:		Engine:	Transmission:
		from	to	from	to		
GMC	Sierra	2016	2017			All	All

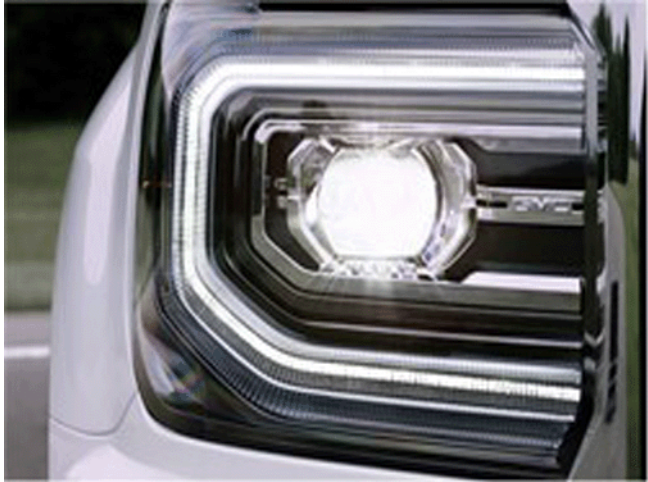
<p>Some customers may comment that the front right hand and left hand low beam, high beam, DRL, and turn signals are inoperative but the side markers still work as intended.</p> <p>If the turn signals are used, a turn signal bulb out message will be displayed.</p>
Cause	GM Engineering is attempting to determine the root cause of the above condition. Engineering has a need to gather information on vehicles PRIOR to repair that may exhibit this condition. As a result, this information will be used to "root cause" the customer's concern and develop/validate a field fix.

If you encounter a vehicle with the above concern, document the following information and contact one of the engineers listed below:

- Is there any aftermarket electrical equipment installed on the vehicle?
- Ask the customer about any aftermarket electrical devices that may have been recently connected to the vehicle.
- Ask the customer about any high beam use or use of the headlamps in manual mode.

- Ask the customer about the recent use of the remote start feature.
